| Report Title: Geotechnical Report <b>1 Kanimbla Crescent, Bilgola Plateau</b> |
| Report Date: 5/05/21 |

## **GEOTECHNICAL INVESTIGATION:**

### **Additions and Alterations at 1 Kanimbla Crescent, Bilgola Plateau**

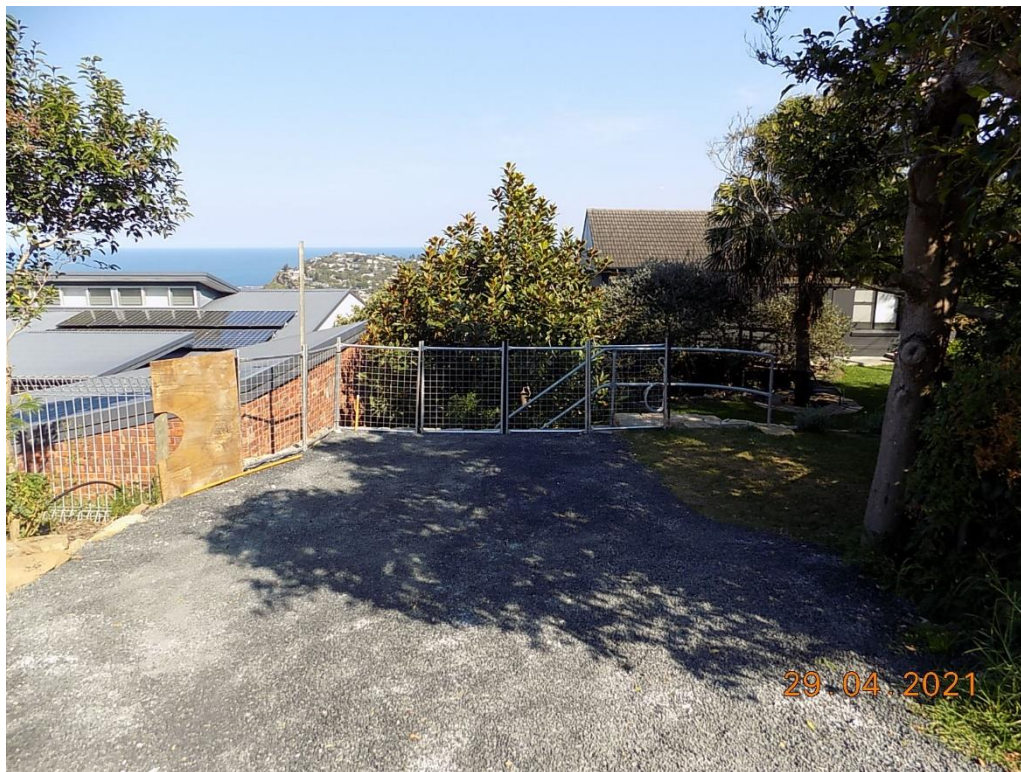
Photo 1

- 2.3** At the road frontage, a gravel driveway runs to a parking area on the uphill side of the property (Photo 1). The slope between the road frontage and the house has been terraced with a series of stable stack rock retaining walls, reaching ~1.5m high (Photo 2). One of these walls was observed to be partially supported directly onto outcropping Medium Strength Sandstone (Photo 3). The part two-storey brick house is supported on brick walls and steel posts. The supporting walls show no significant signs of movement and the supporting posts stand vertical (Photo 4). A stable stack rock wall reaching ~1.2m high and lining the E neighbouring boundary supports the cut for the neighbouring property. A moderate to steeply sloping lawn falls to the lower boundary. A large dislodged sandstone joint block was observed to be sitting in a stable position on the slope under the W side of the house (Photo 6).

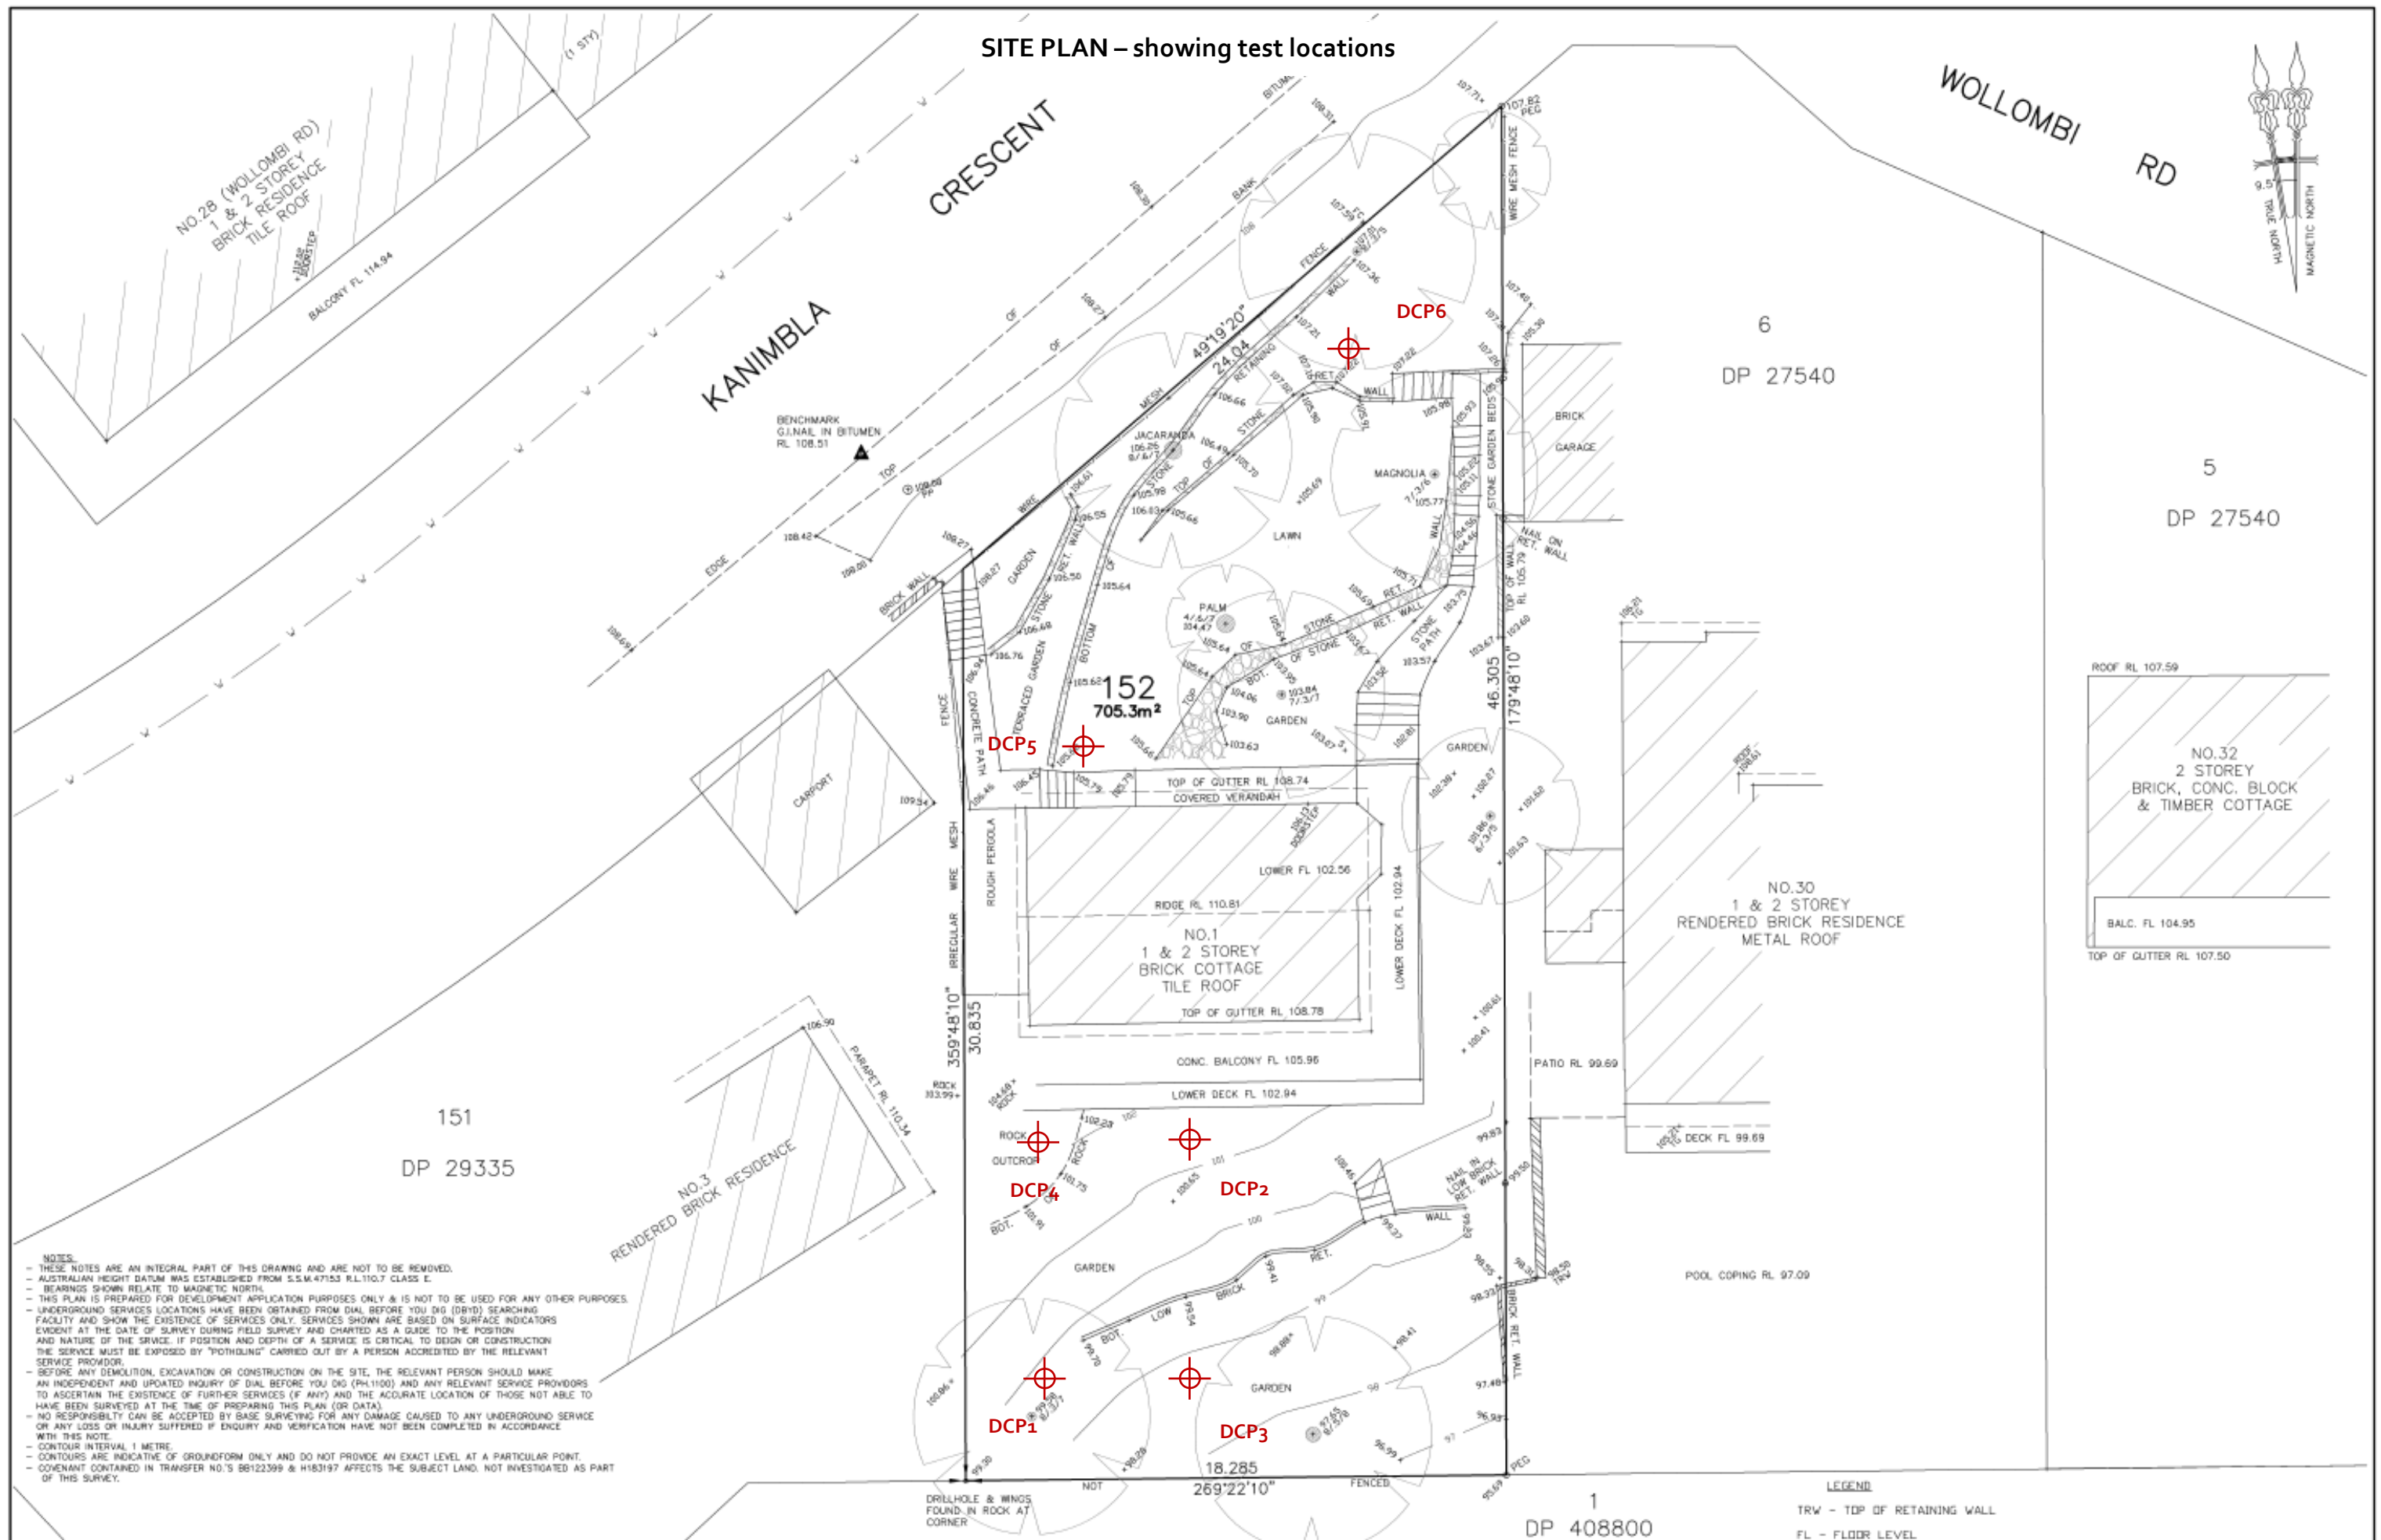
# SITE PLAN – showing test locations

Six Dynamic Cone Penetrometer (DCP) tests were put down to determine the relative density of the overlying soil and the depth to bedrock. The locations of the tests are shown on the site plan attached. It should be noted that a level of caution should be applied when interpreting DCP test results. The test will not pass through hard buried objects so in some instances it can be difficult to determine whether refusal has occurred on an obstruction in the profile or on the natural rock surface. This is not expected to be an issue for the testing on this site. However, excavation and foundation budgets should always allow for the possibility that the interpreted ground conditions in this report vary from those encountered during excavations. See the appended "Important information about your report" for a more comprehensive explanation. The results are as follows:

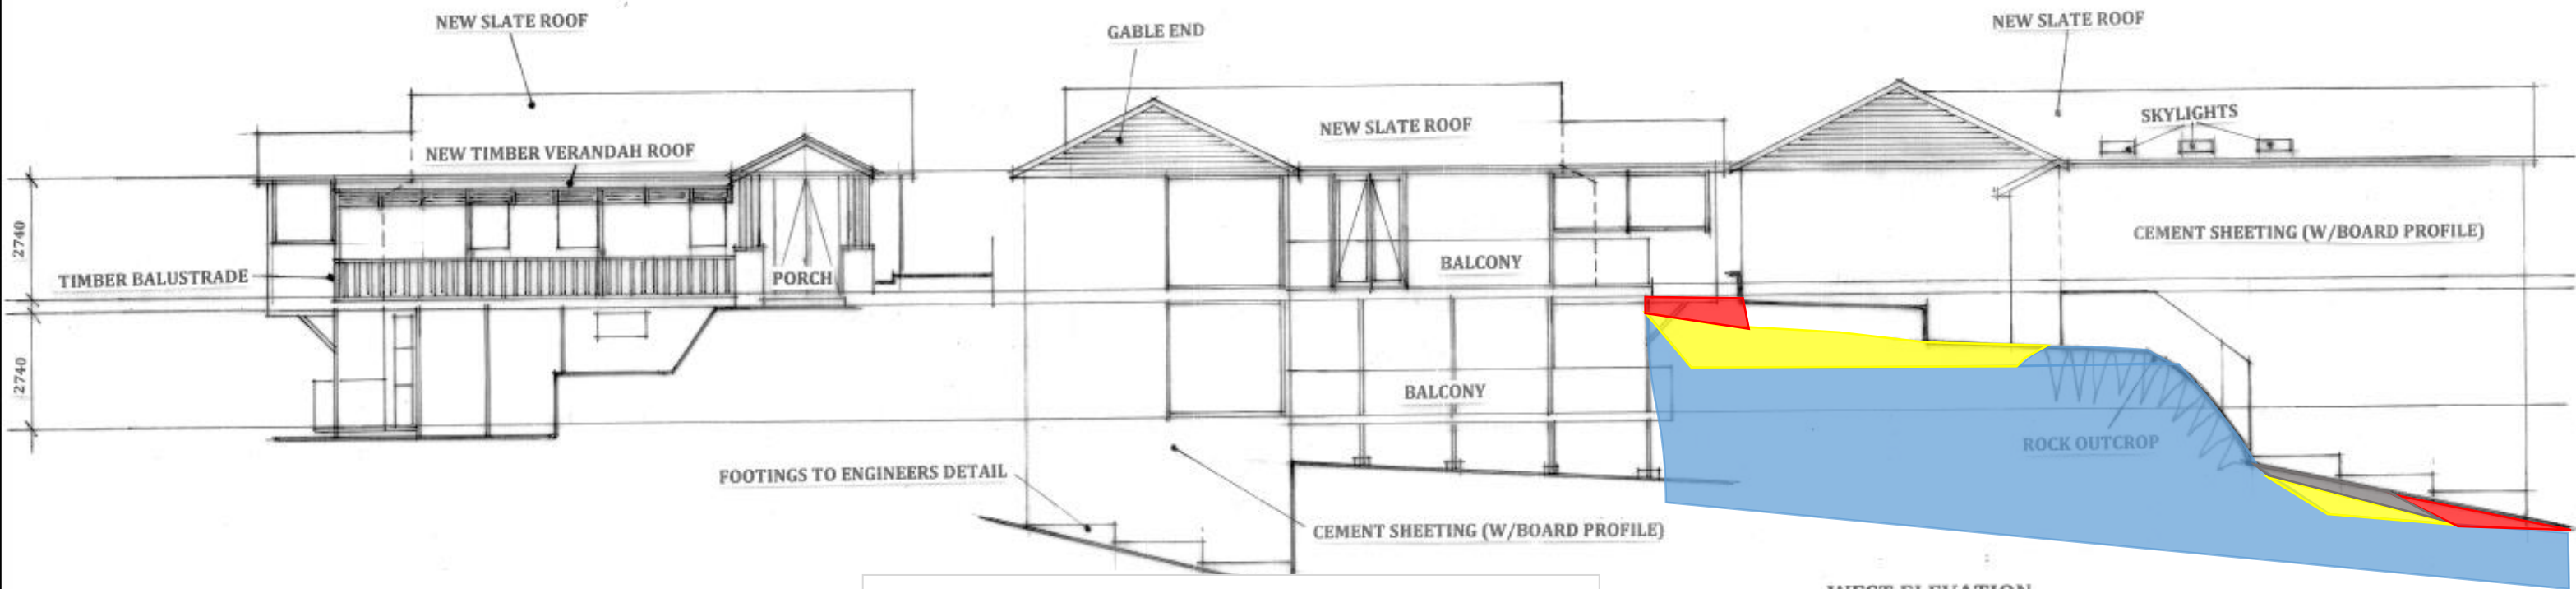
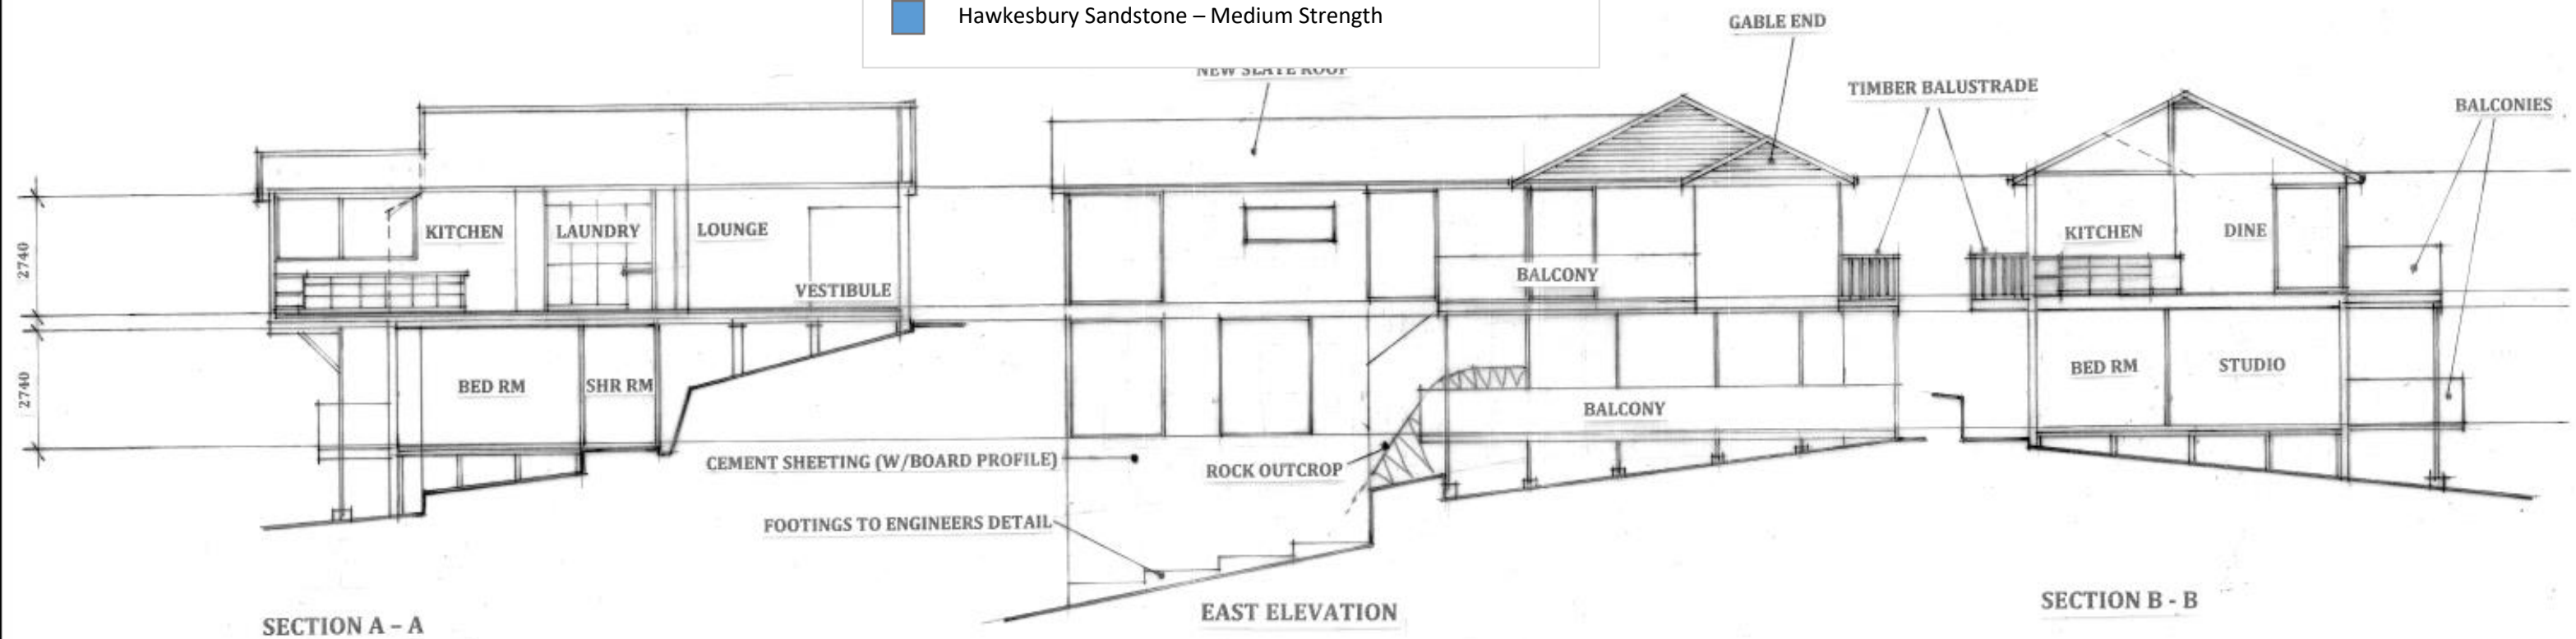
# TYPE SECTION – Diagrammatical Interpretation of expected Ground Materials

house for landscaping. In the test locations, the depth to rock ranged between 0.1 to 1.8m below the current surface, being slightly deeper due to the presence of fill and the stepped nature of the underlying bedrock. The outcropping sandstone on the property is estimated to be medium strength or better and similar strength rock is expected to underlie the entire site. See Type Section attached for a diagrammatical representation of the expected ground materials.
