**Proposed Residence**  
**30A Addison Road, Manly NSW**

**Preliminary Geotechnical Assessment**

Our ref: 6082-G1  
14 November 2021

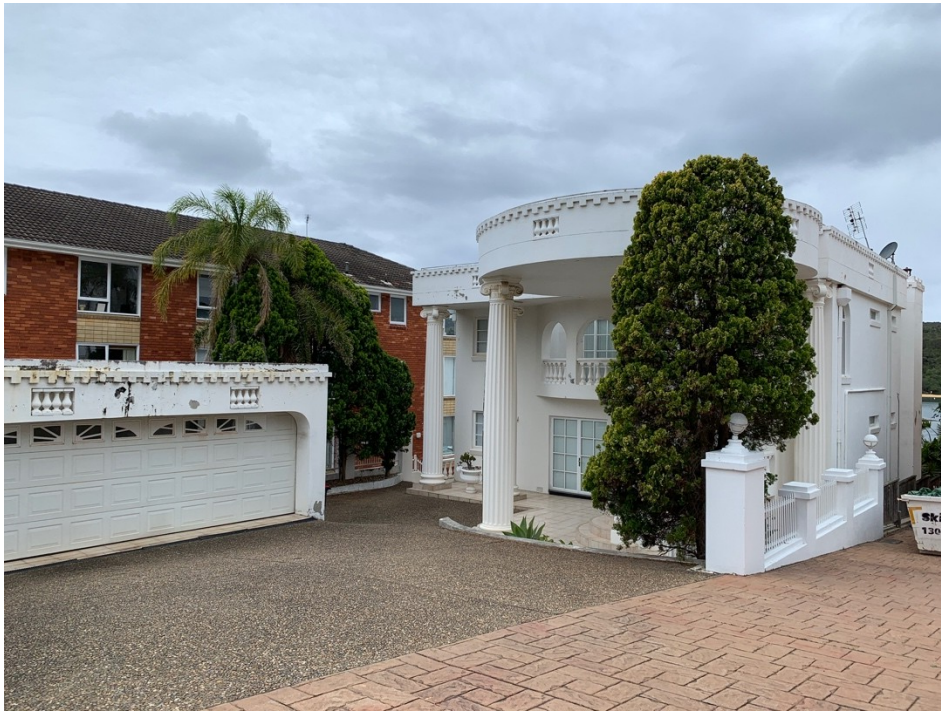
**Photo 1**  
Overview of existing residence.

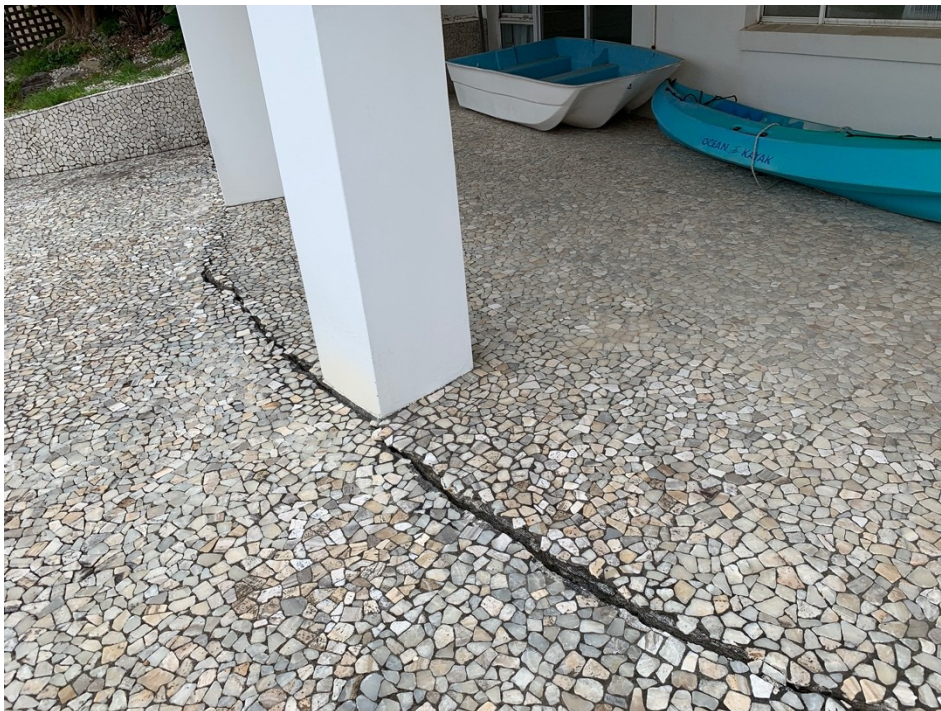
We consider the ground settlement encountered upslope on the paved terrace could be caused by soil being washed away within the soil-rock interface, or by settlement of poorly compacted fill beneath the paved terrace surfacing.

**Photo 2**  
Evidence of ground settlement at rear terrace of the Site.

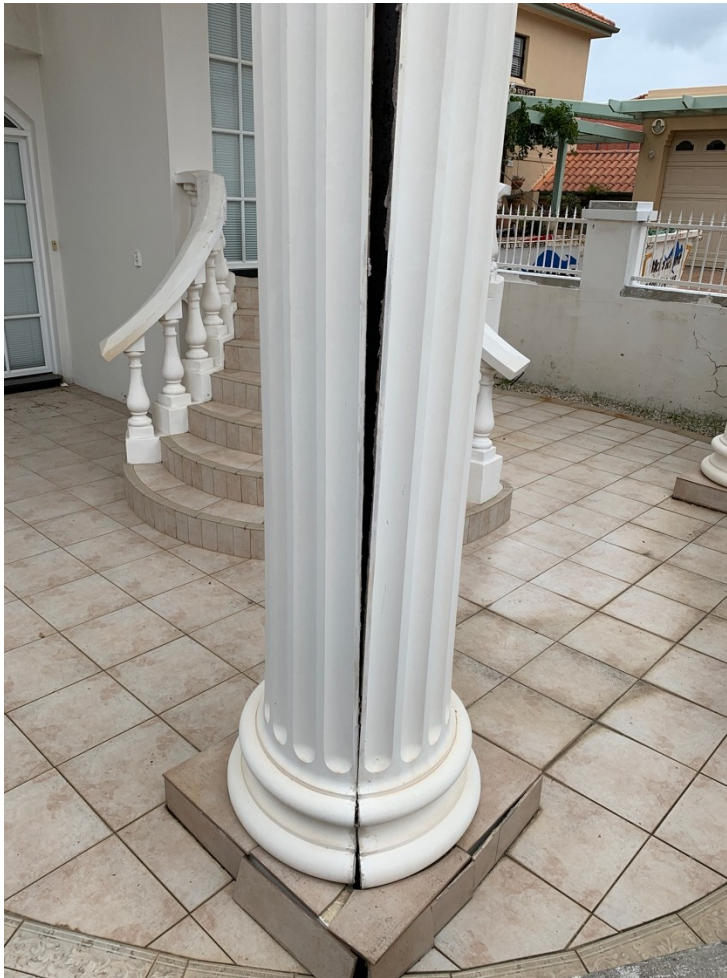
**Photo 3**

Acoustic failure in  
column footing  
observed at front of  
dwelling.

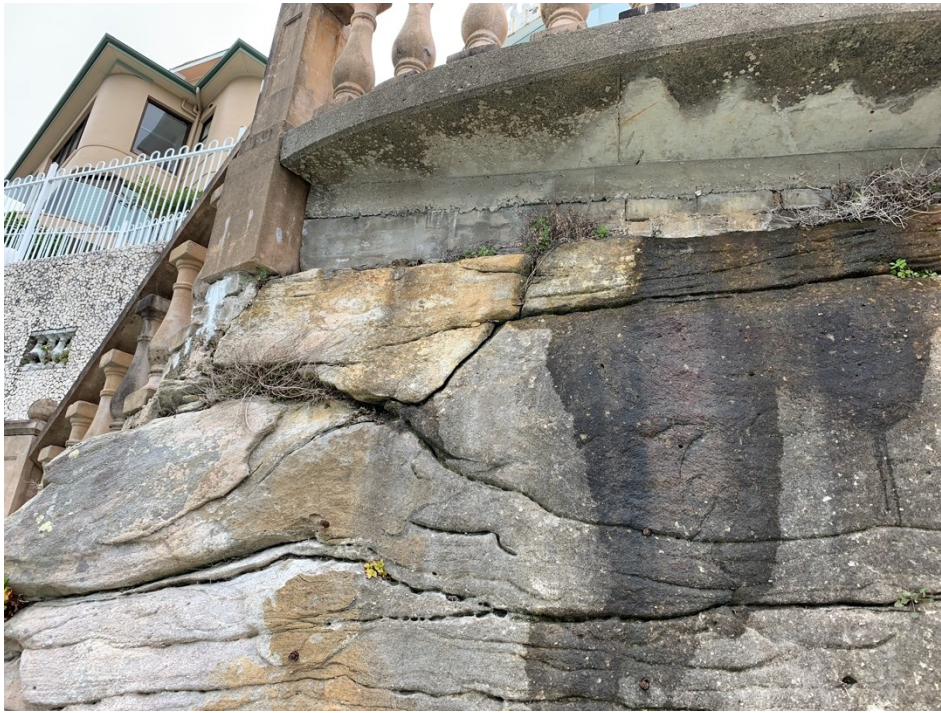
**Photo 4**

There is no evidence of permanent groundwater on-site. Minor groundwater seepage was observed within the rock cliff face at the rear of the dwelling, within beddings and fractures (see Photo 4).

Evidence of groundwater seepage observed at the rock cliff face at rear below the terrace.
