Development Application for Jennifer Hempton  
Name of Applicant  
Address of site 89 Marine Parade, Avalon Beach, NSW

**REPORT ON GEOTECHNICAL SITE INVESTIGATION  
AND RISK ASSESSMENT  
FOR PROPOSED NEW DWELLING**

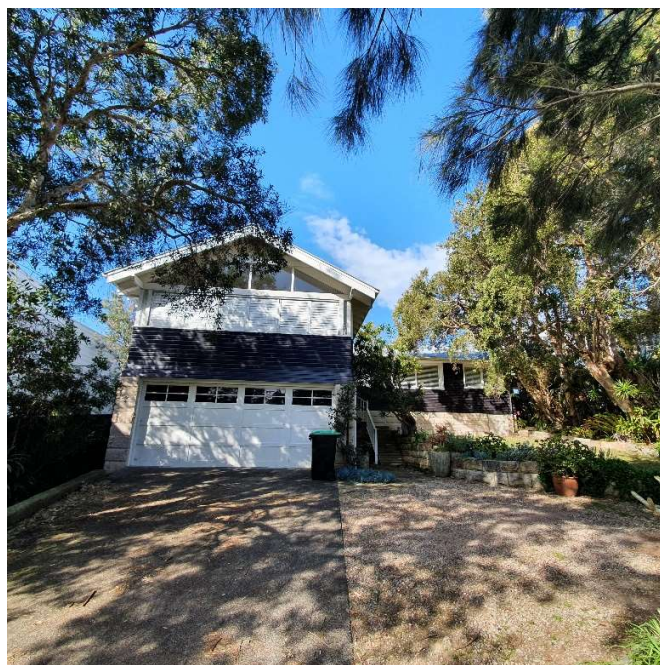
*Photograph-2: Site-dwelling frontage. View looking east.*

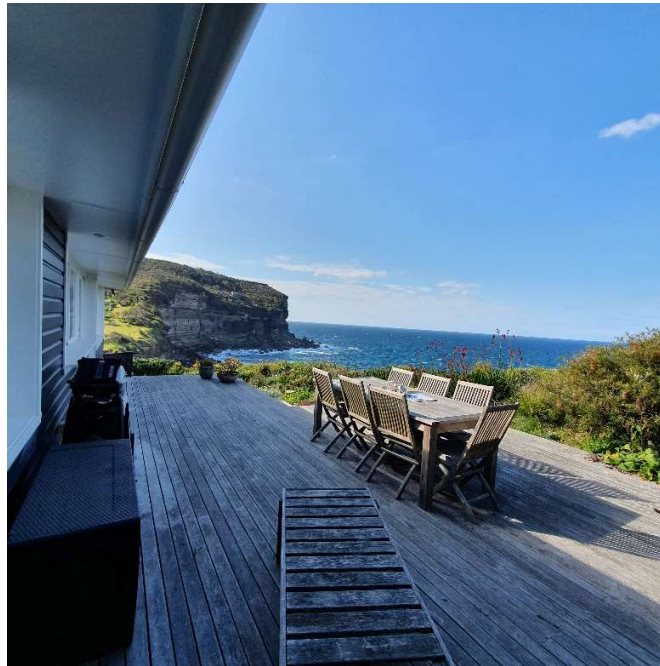
*Photograph-3: Rear view of the site. View looking north.*

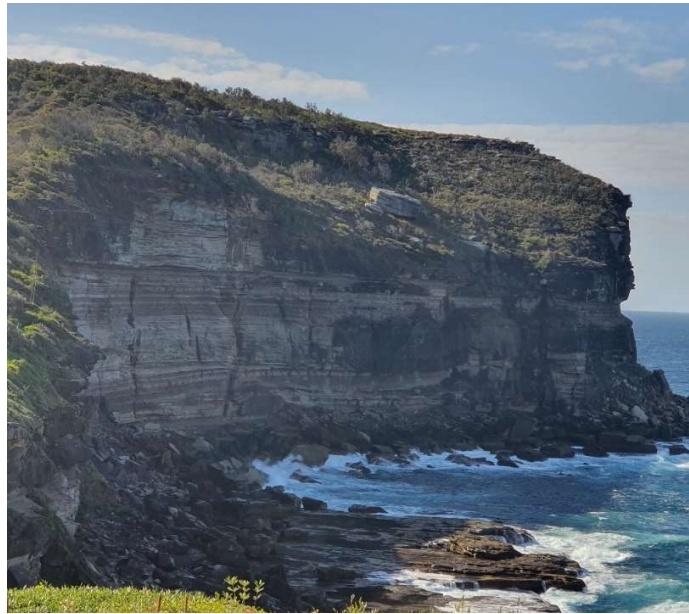
*Photograph-4: Bangalley Head cliff face located to the north of the site.*

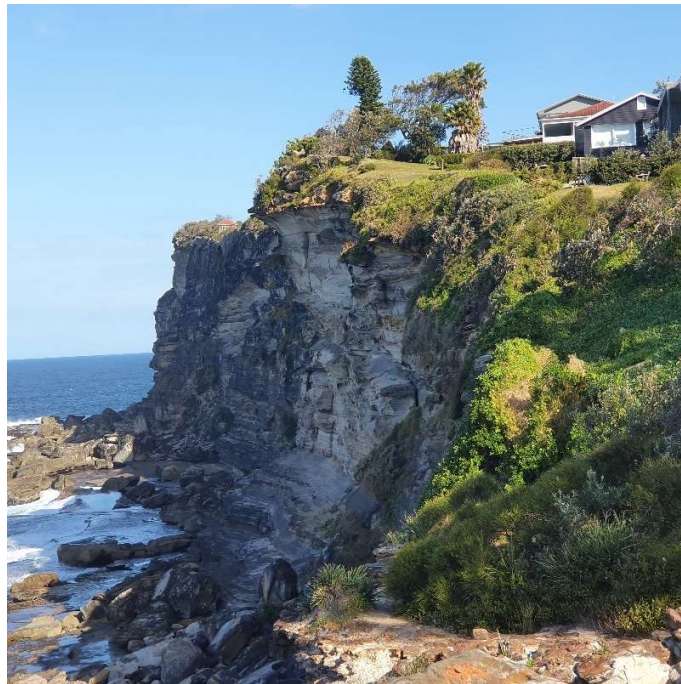
*Photograph-5: Full cliff face located below the site. View looking south from Bangalley Park estimated height  $\geq 25\text{m}$*

Observations of the cliff face below the site identified generally sub-horizontally bedded siltstone and sandstone with an undercut which extended west to a distance unable to be confirmed from the point of observation (Photograph-5) however it is estimated at  $\leq 3\text{m}$  laterally between cliff crest and base.

The geotechnical inspection did not identify any signs of previous or impending large scale or deep-seated landslide instability within the site or the observed portions of the adjacent properties. There is a minor undercut on the cliff face and potential for instability in the upper cliff over time, but only with an estimated potential for instability extending to a limited distance ( $\leq 5$ m) from the eastern end of the cliff.

Due to the proximity of the proposed works to the rear boundary, it is recommended that the eastern cliff face be inspected by a professional geotechnical consultant using a drone to assess for any unfavorable defects, significant undercuts or potential for instability impacts. CGC can assist for this type of cliff face stability assessment and should be conducted prior to the Construction Certificate (CC).

It is recommended that the eastern cliff face be examined via the use of drone footage/photography to assess for any unfavourable defects. An additional core drilling investigation to below excavation depths is also recommended to assess bedrock condition and strength, prior to construction.

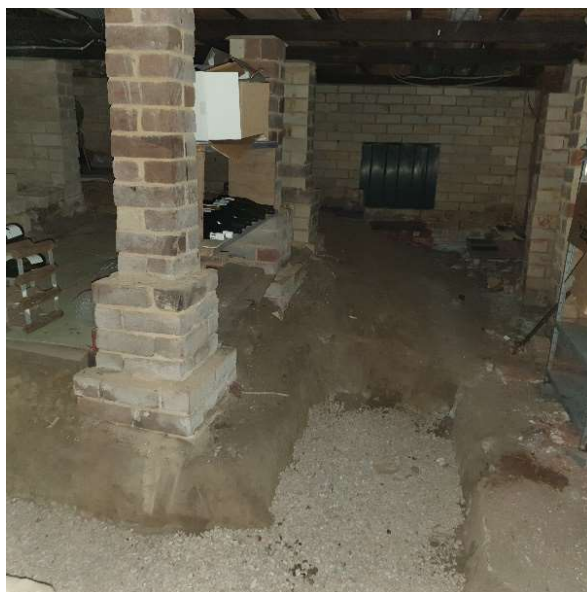
The eastern portion of the site contains a one and two storey sandstone block and cladding dwelling with a garage below the north-western corner of the structure. Observation below the existing Ground Floor (GF) identified that the dwelling is supported by brick columns/walls (Photograph-6) and sandstone block walls. Bedrock outcrop was not identified below the dwelling. Whilst footings and foundations could not be viewed,

the supporting structures appeared in good condition. Signs of cracking, differential settlement or underlying geotechnical issues were not observed within the site-dwelling.

*Photograph-6: Brick columns and walls supporting the site-dwelling. View looking east from below the site-dwelling.*

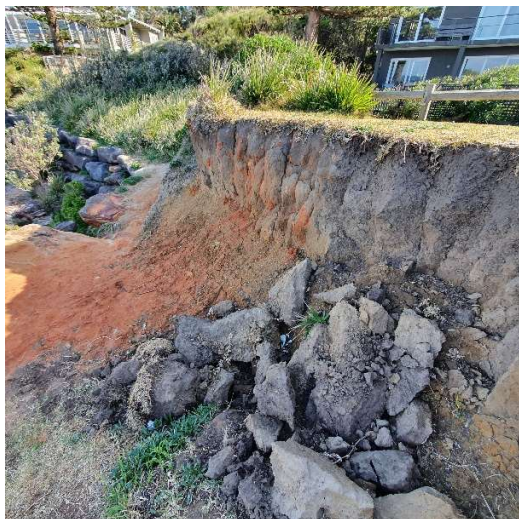
Observation of the cliff face from Bangelly Park identified an iron rich sandy clay soil near surface with sandstone cobbles/boulders, conglomerate, underlaid by sub-horizontally bedded grey shale with a few bands of lithic sandstone (Photograph-7 and Photograph-8).

*Photograph-7: Iron rich sandy clay unit observed under Bangelly Park. View looking south.*

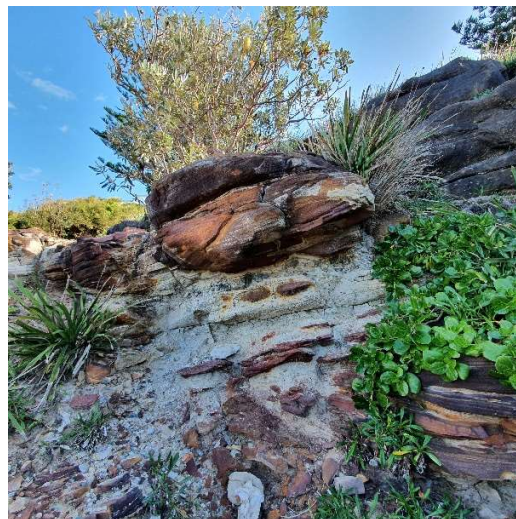
*Photograph-8: Sandstone cobbles/boulders and conglomerate under Bangelly Park. View looking south.*
