GEOTECHNICAL INVESTIGATION REPORT

PROPOSED RSL CLUB REDEVELOPMENT
20 - 22 MELWOOD AVENUE, FORESTVILLE NSW

PREPARED FOR THE FORESTVILLE RSL CLUB LTD
REPORT ID: E24016FOR-R01F

Date: 18th September 2024

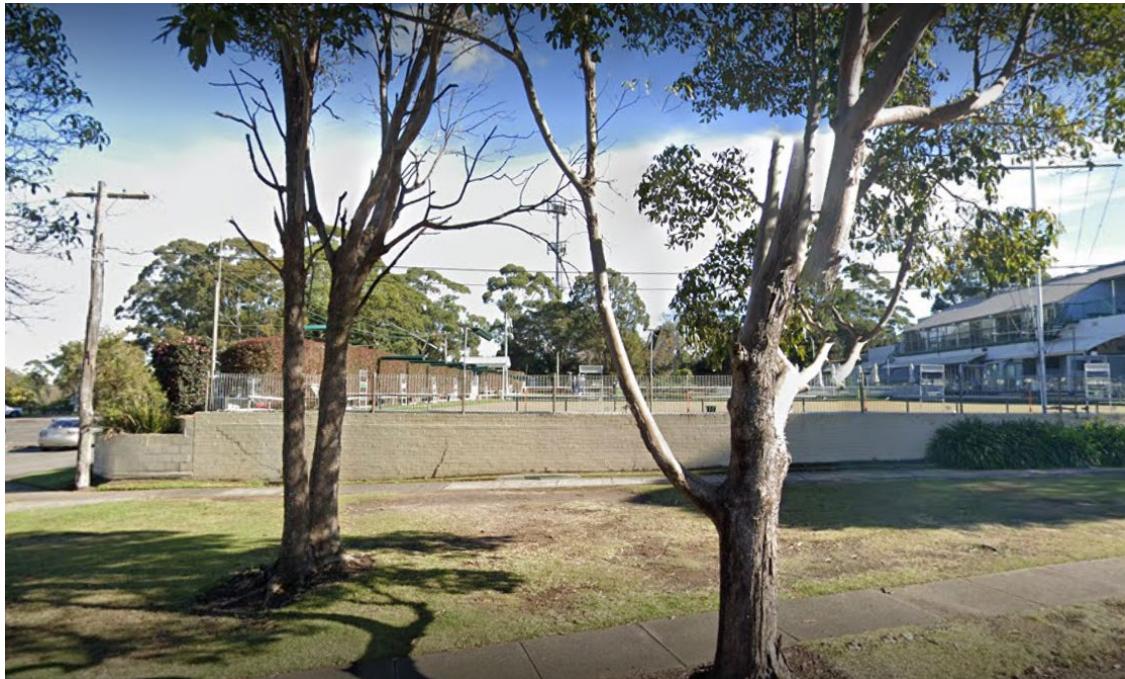
Plate 9 – Google Maps view of the mortared brick retaining wall at the southeastern corner of the site, prior to painting, detailing existing cracking.

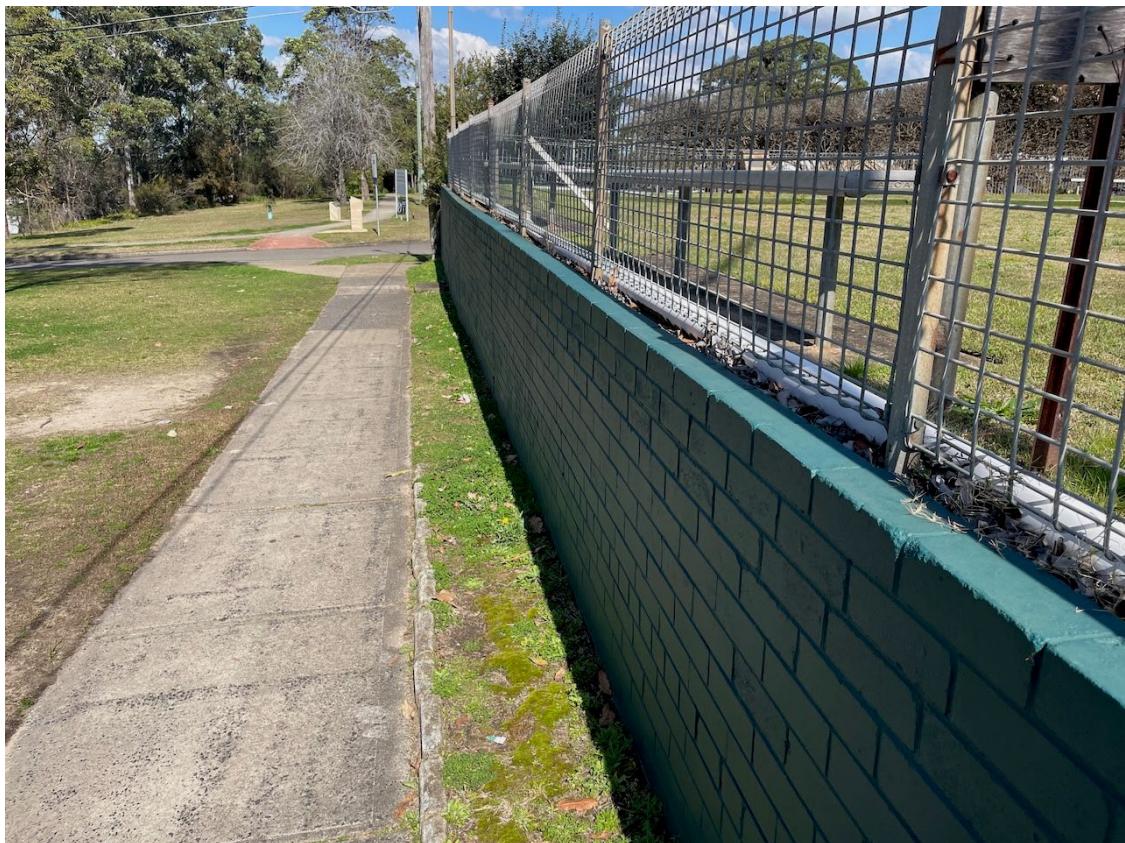
Plate 10 – Developed lean in highest section of the mortared brick retaining wall, viewed to south.
