## **GEOTECHNICAL INVESTIGATION:**

### **Alterations and Additions and New Pool at 5 Lae Place, Allambie Heights**

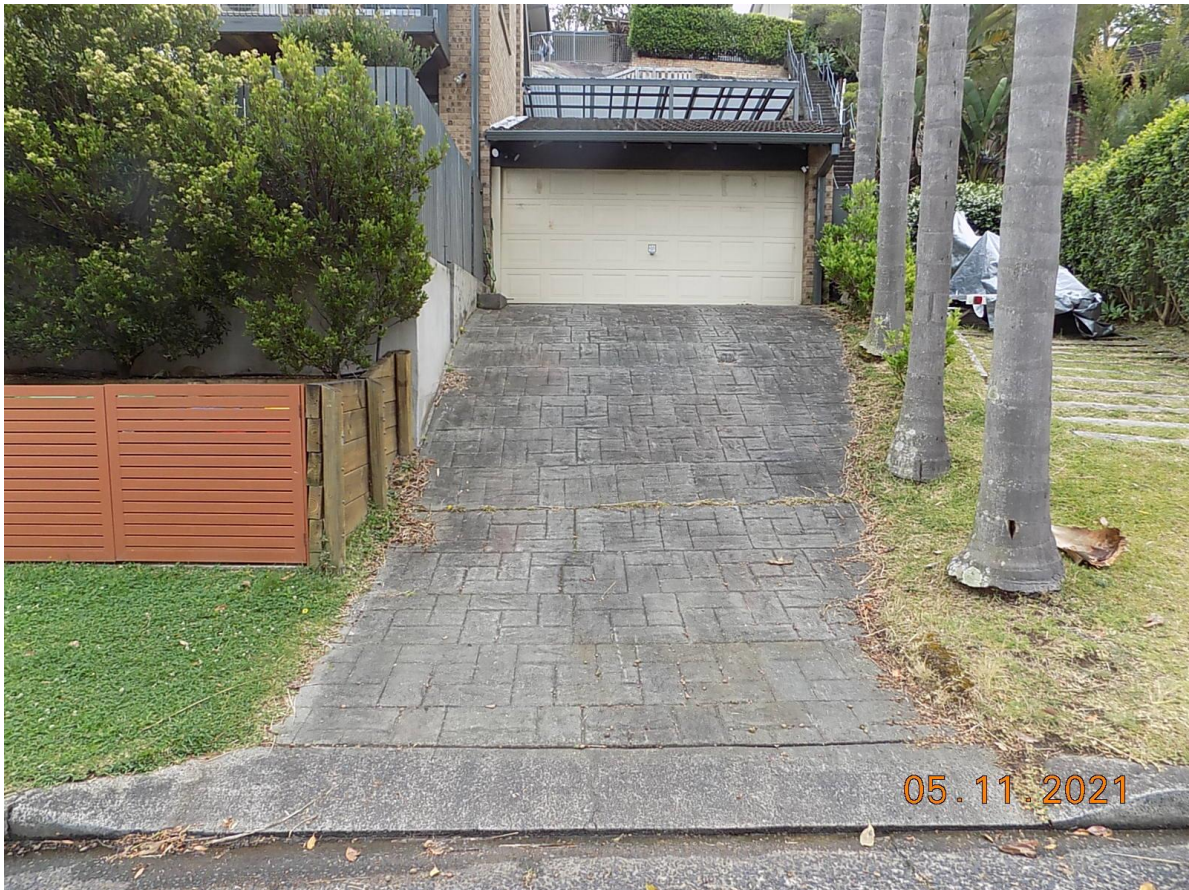
Photo 1

- 2.1** The site was inspected on the 5<sup>th</sup> November, 2021, and previously on the 15<sup>th</sup> December, 2020, and 23<sup>rd</sup> September, 2014.
- 2.2** This residential property is on the high side of the road and has an E aspect. The block is located on the steeply graded lower middle reaches of a hillslope. The slope rises across the site at an average angle of ~23°. The slopes above and below the property continues at easing angles.
- 2.3** At the road frontage, a concrete driveway runs to a garage attached to the N side of the house (Photo 1). The slope between the road frontage and the house is

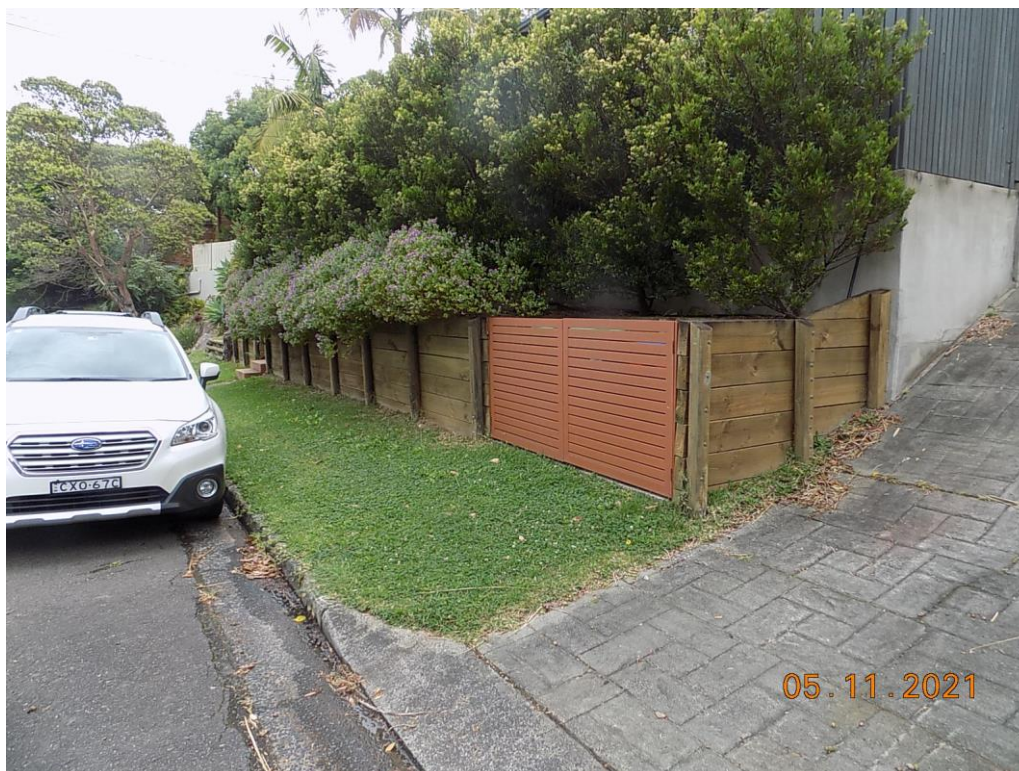
Photo 2

terraced with a stable timber retaining wall and with a stable rendered masonry retaining wall (Photo 2). The part two-storey brick house is supported on brick walls (Photo 3). No significant signs of movement were observed in the supporting brick walls of the house. Competent Medium Strength Sandstone outcrops and steps up the slope immediately above the house (Photos 4 & 5). The majority of the rock displays no significant geological defects. However, the rock was observed to be undercut to ~1.0m near the top of the outcrop (Photo 6). The undercut rock has a relatively thick cantilever arm in relation to its overhang length, displays no signs of cracking as viewed from above or below, and was observed to continue back up the slope a significant distance. As such, the outcropping rock is considered stable. A shallow fill has been placed on the N side of the outcrop for a level lawn area. The fill is supported by a stable concrete block retaining wall that was observed to be supported directly onto the rock (Photo 7).

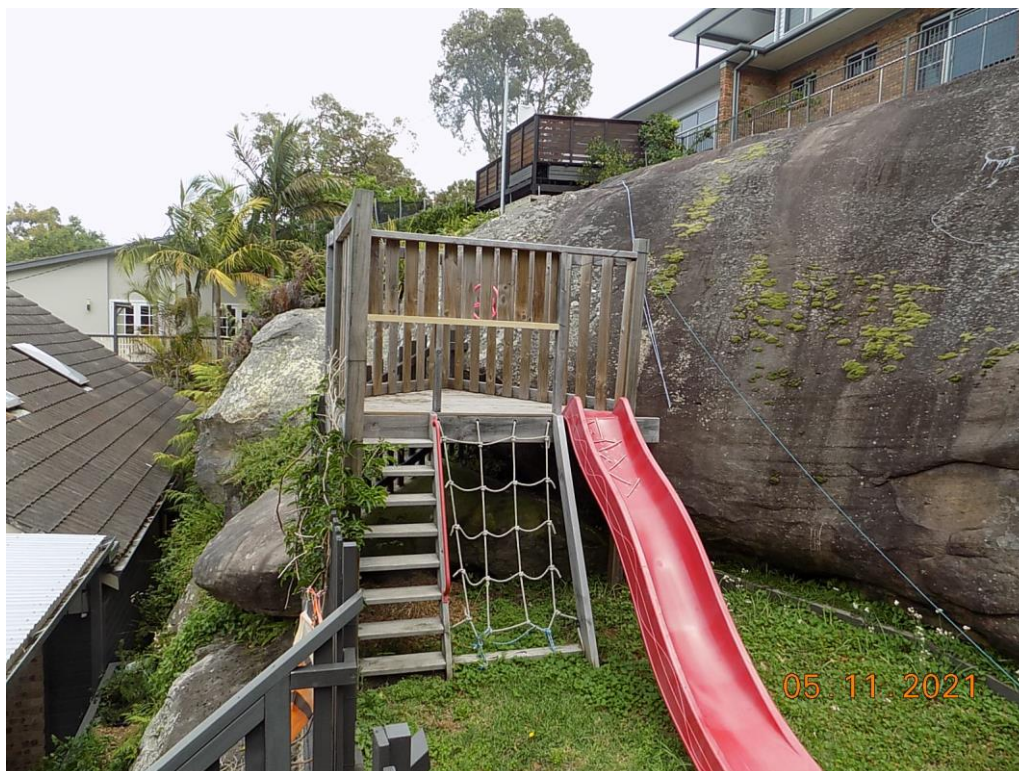
Photo 4

As Medium Strength Sandstone was observed to be outcropping across the location of the proposed works, no subsurface investigation was necessary (Photos 4 & 5). See the site plan attached showing locations where rock was observed to be outcropping.

| HAZARDS | Hazard One | Hazard Two |
|---|---|---|
| TYPE | The steep slope that falls across the property failing and impacting on the property. | The sandstone face that rises above the house failing and impacting on the proposed development (Photos 4 & 5). |

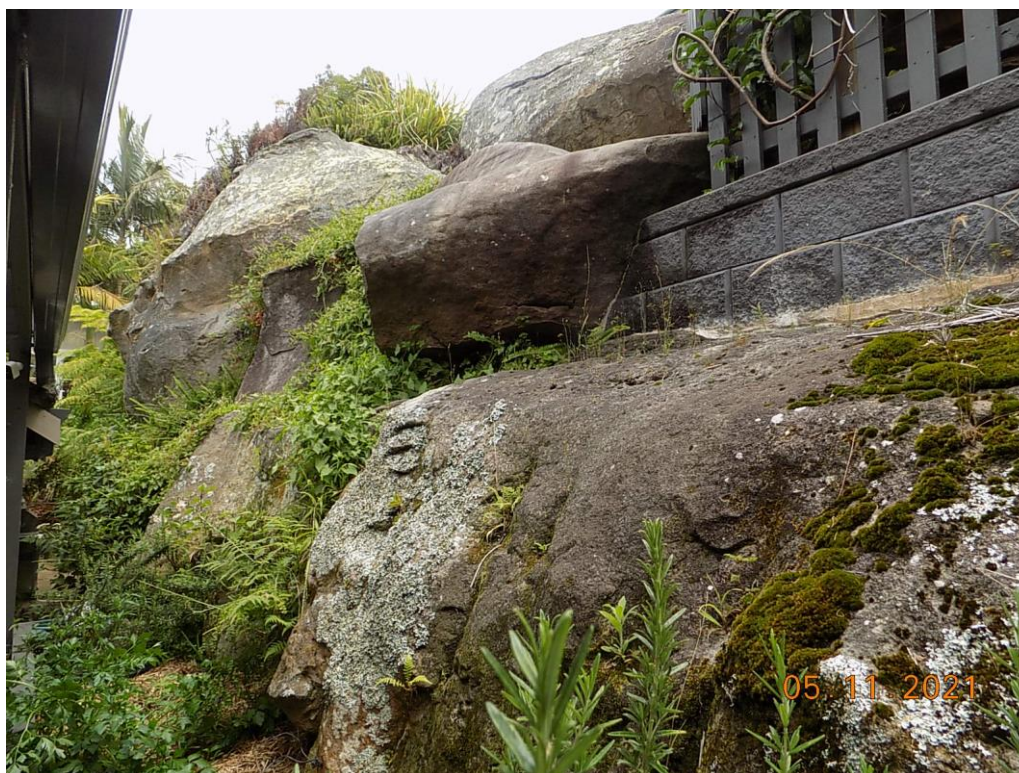
Photo 5

It is proposed to bring the excavation back to the existing low retaining wall (Photo 7). The rock is at least Medium Strength and no jointing was observed in the vicinity of the low wall. This is important because jointing immediately up slope can result in an excavation failure along the joint plane. At the S end of the proposed excavation, the downhill edge of an existing joint block will be trimmed to accommodate the excavation (Photo 5). The balance point of this rock is well upslope and removing the downhill edge will not cause instability. Another small block of rock is immediately beside this joint block to the S (Photo 5). This smaller rock can be broken down/removed from the face.

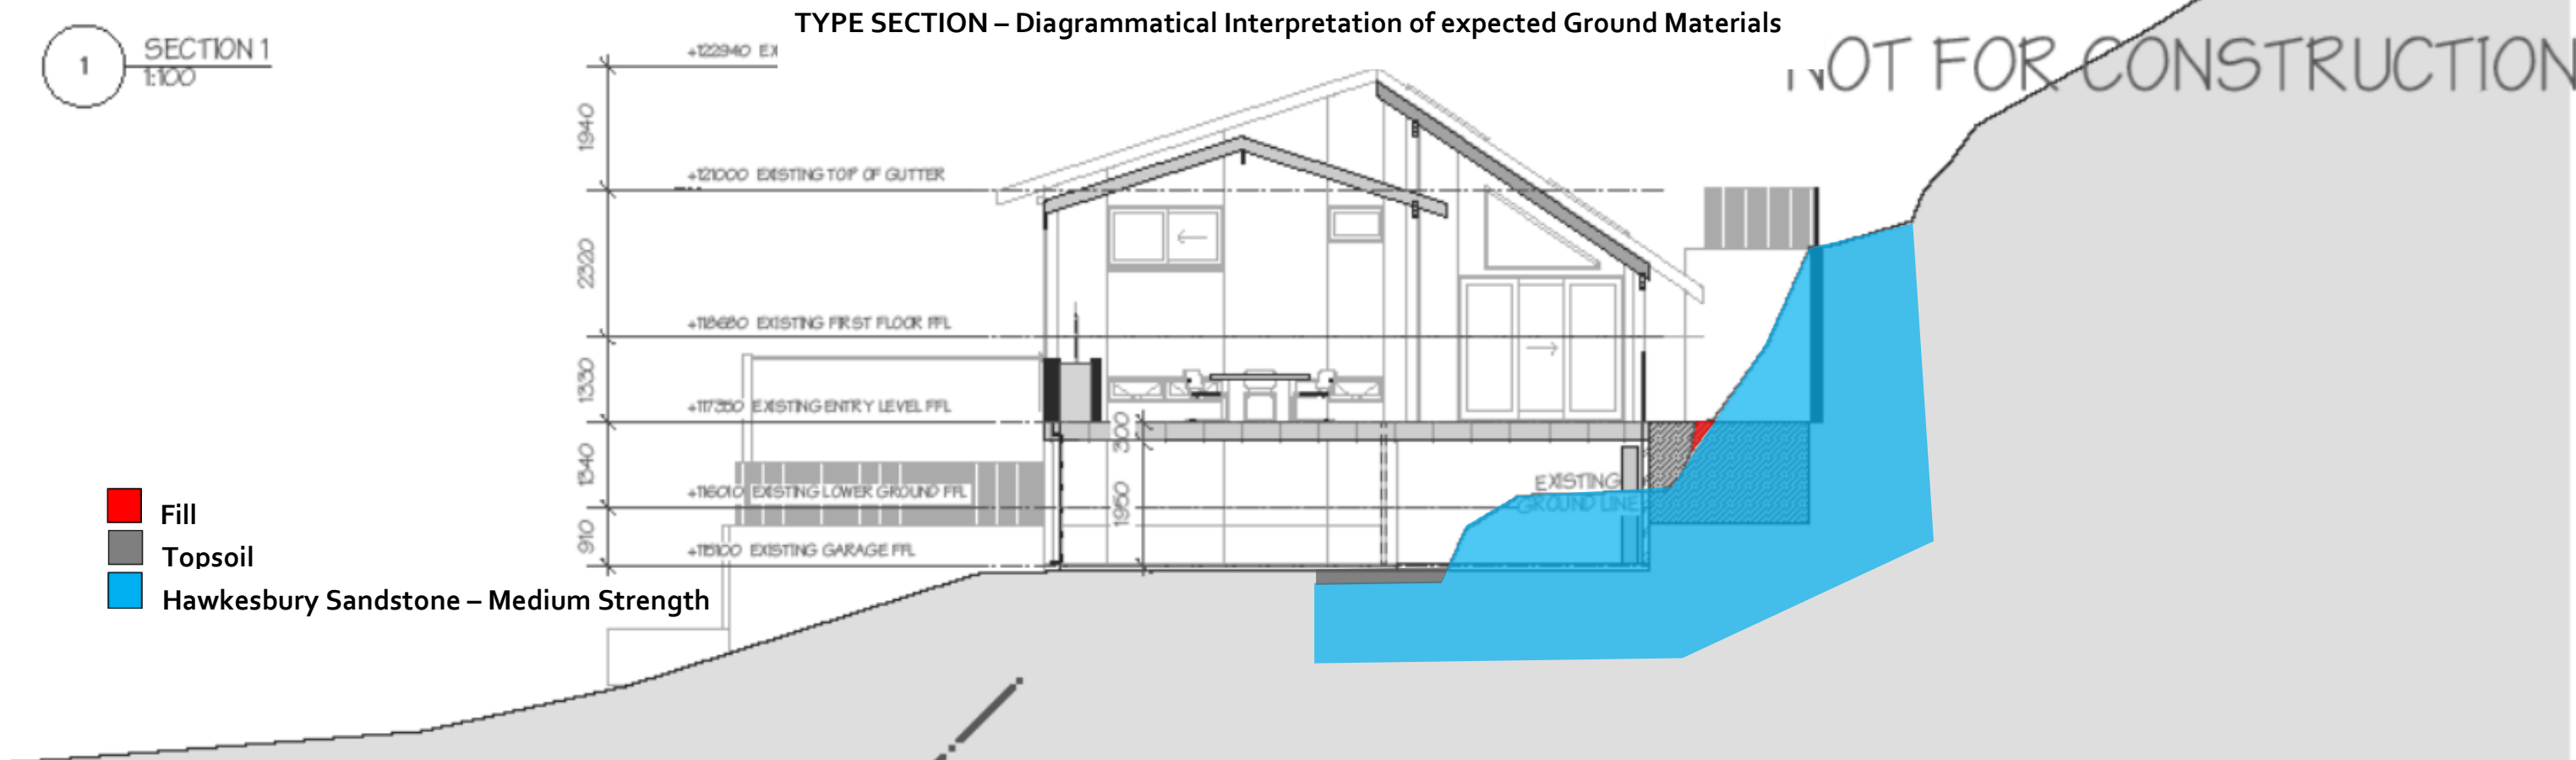
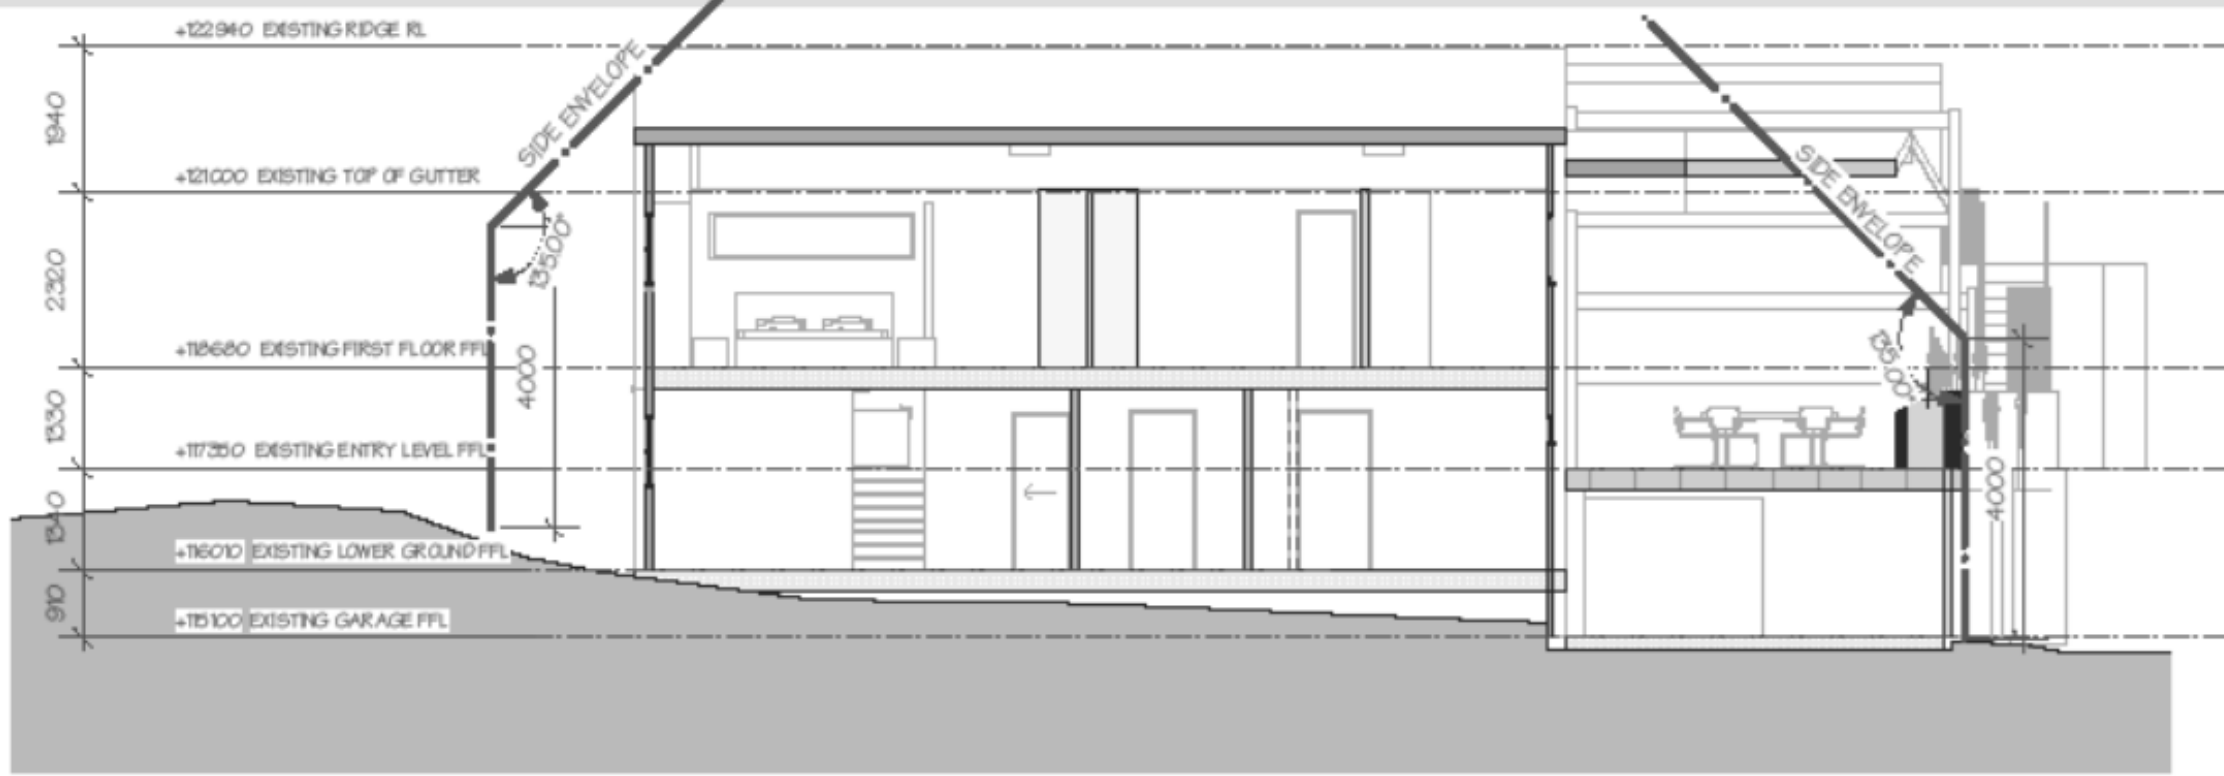
TYPE SECTION – Diagrammatical Interpretation of expected Ground Materials

and firm to very stiff sandy clays that fill the bench step formation. Rock of at least Medium Strength was observed to be outcropping across the location of the proposed works. A similar strength rock is expected to underly the entire site. See Type Section attached for a diagrammatical representation of the expected ground materials.
