J6002. 10<sup>th</sup> April, 2025. Page 1.

## **GEOTECHNICAL INVESTIGATION:**

Alterations and Additions at 316 Hudson Parade, Clareville

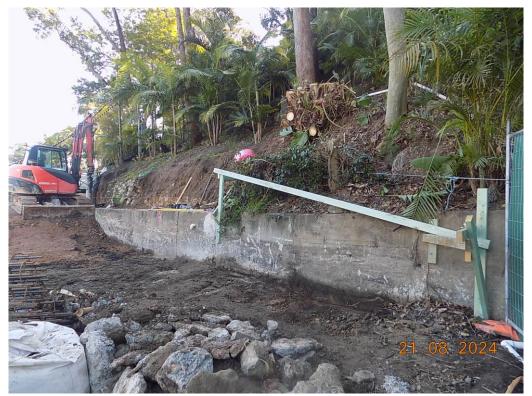
Photo 1

2.3 At the road frontage, a steeply graded slope falls to the uphill side of the subject house (Photos 1). Vehicular access to the property is provided by a shared driveway from the S that cuts across the slope and runs to the existing house and a detached brick garage/studio beside the house (Photos 2 & 3). The detached garage and uphill side of the property is currently undergoing demolition/construction works previously approved. Two rows of contiguous piles have been constructed uphill of the existing house for these works (Photo 9). Additional piling will be required for the proposed works.

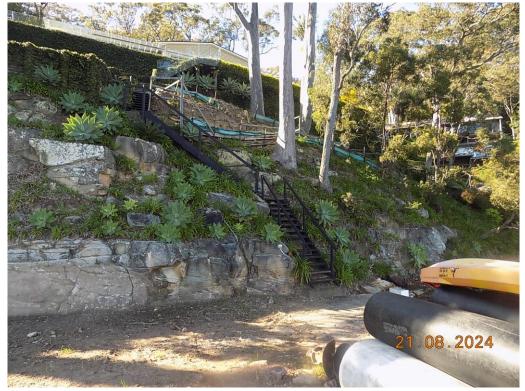
Photo 8

2.4 The area below the property has been partly terraced with treated pine retaining walls that appear well constructed. Below the walls, the slope falls steeply to the waterfront. Bands of Medium Strength Sandstone outcrop in this area

(Photo 8). The exposed sandstone is fractured and is relatively thinly bedded. The

exposed rock does not display any significant undercutting or geological defects that

could lead to a significant failure that could impact the retaining walls or house above.

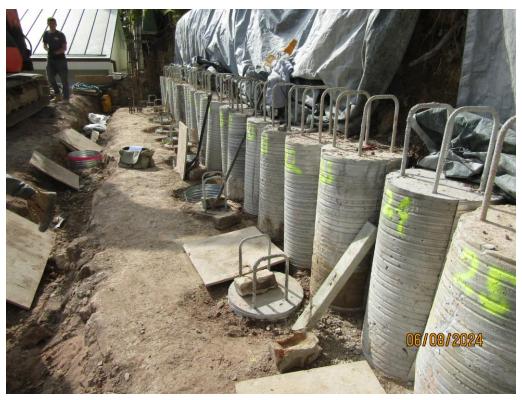
Photo 9

Two rows of contiguous piles have been constructed uphill of the existing house (Photo 9) for

the previously approved excavation works. Additional ground support will be required for the

proposed works downslope of these piles.

Contiguous piles can be utilised for the additional ground support. The drilling for the existing
