## **GEOTECHNICAL INVESTIGATION:**

Alterations & Additions at **37 Hilltop Road, Avalon**

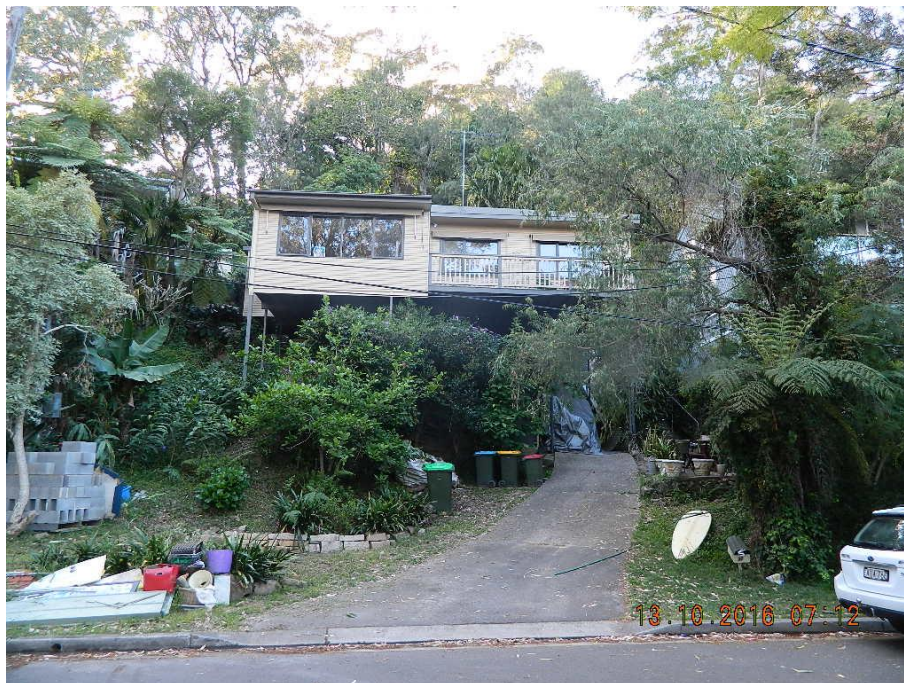
Photo 1

- 2.3** At the road frontage a concrete driveway runs up the slope to a parking area and shed under the house (Photo 1). This area has been cut into the slope. The upper S portion of the cut is supported by stepped brick, concrete crib and concrete block retaining walls (Photo 2 & 3). The upper concrete crib and concrete block walls display movement but will be demolished as part of the proposed works. The lower brick retaining wall is in good condition. A supporting brick wall of the house is located to the N of the stepped retaining walls (Photo 4). Below the wall a cut has been made into the slope to widen the existing parking area and to install a shed. The uphill side of the cut has undercut the supporting brick wall of the house (Photo 5). The excavation is either supported by the walls of the shed or a door with sandstone blocks holding it in place (Photo 5 & 6). The undercut footing and the unsupported cut below does not meet current engineering standards and our recommendations are outlined in **Section 17**. The shed will be demolished as part of the proposed works. Some loose soil has been scattered over the slope, under the N side of the house (Photo 7). We were informed by the owner that it will be removed

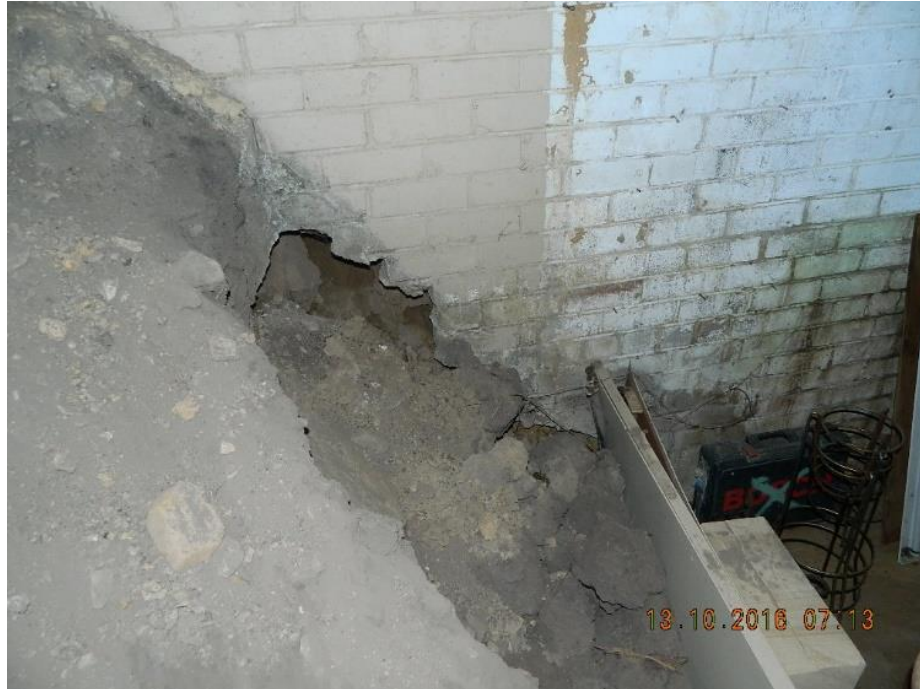
Photo 5

No geotechnical hazards were observed above, below or beside the property. The steep slope that rises across the property is considered a potential hazard (**Hazard One**). The existing supporting brick wall of the house that has been undercut is a potential hazard (**Hazard Two**). The proposed excavations are a potential hazard until retaining walls are in place (**Hazard Three**).

The house is to be adequately supported with propping or additional beams as required before any excavations commence. All existing footings that are to remain and that are within the zone of influence of the excavation are to be propped and underpinned to below the zone of influence or to medium strength rock, whichever is encountered first before any excavations commence. It should be noted that the N portion of the existing brick wall that has been undercut by a previous excavation will need to be underpinned as well (Photo 5).

The supporting brick wall of the house that has been undercut by an existing excavation (Photo 5 & 6) will require underpinning (See **Section 13** for general notes). The existing cut face that caused the undercutting of the wall will need to be supported by an engineering retaining wall, extending downhill from supporting

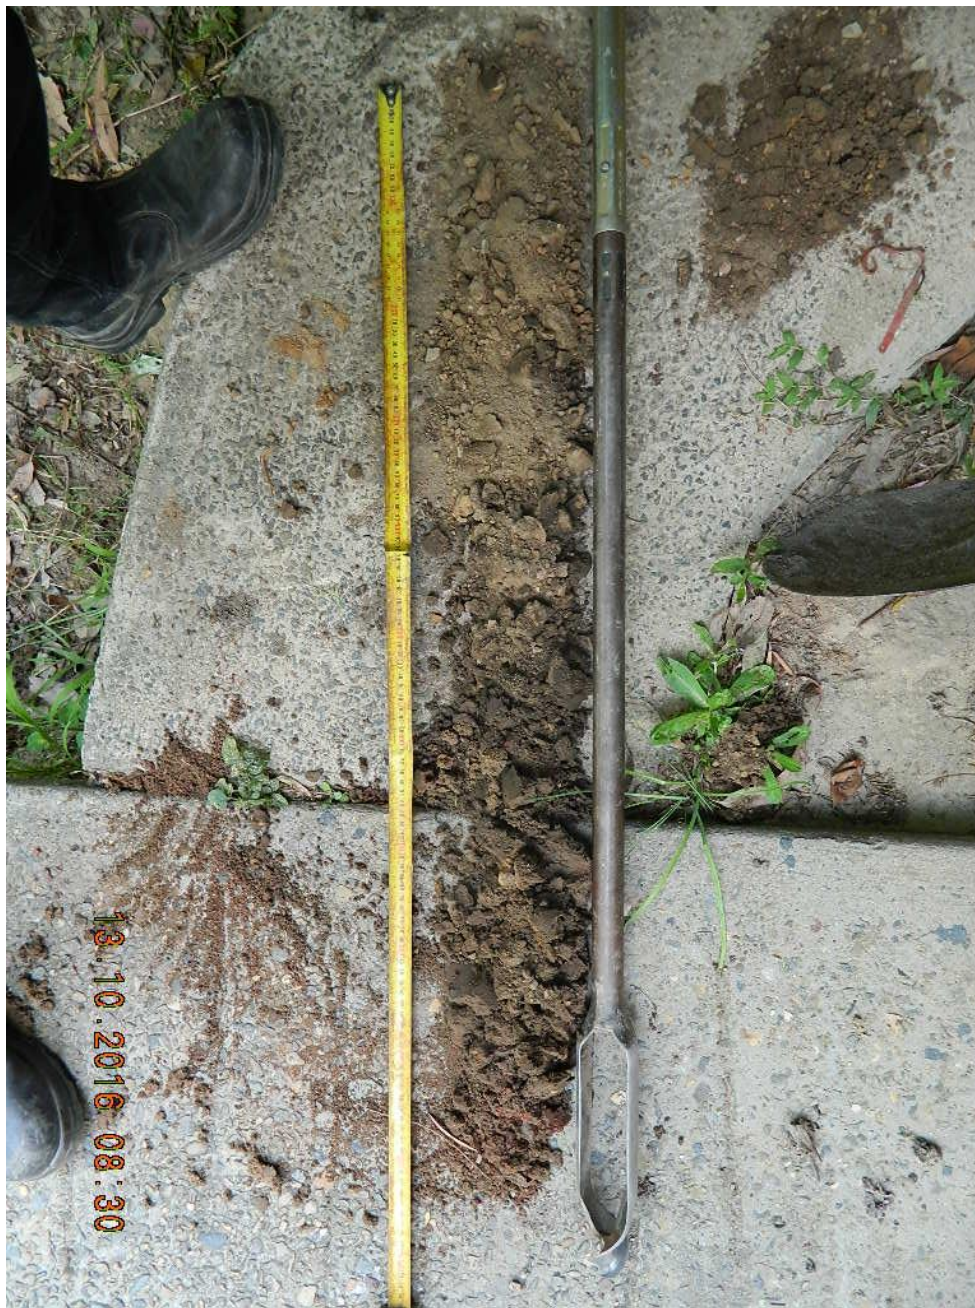
#### AUGER HOLE 1 ( $\sim$ RL 55.8) – AH1 (Photo 13)

| Depth | Material Encountered |
| 0.0 to 0.5 | <b>FILL &amp; COLLUVIUM</b> , mixture of brown sandy soil with small rock fragments, dry. |
| 0.5 to 1.0 | <b>SANDY CLAY</b> , brown with small rock fragments throughout, dry. |
| 1.0 to 1.2 | <b>WEATHERED ROCK</b> , red/purple, sugary texture, dry, brown sandy clay throughout (fallen from above). |

Refusal @ 1.2m, grinding on weathered rock. No watertable encountered.

*Photo 13 – Base of the auger is at the bottom of the picture*

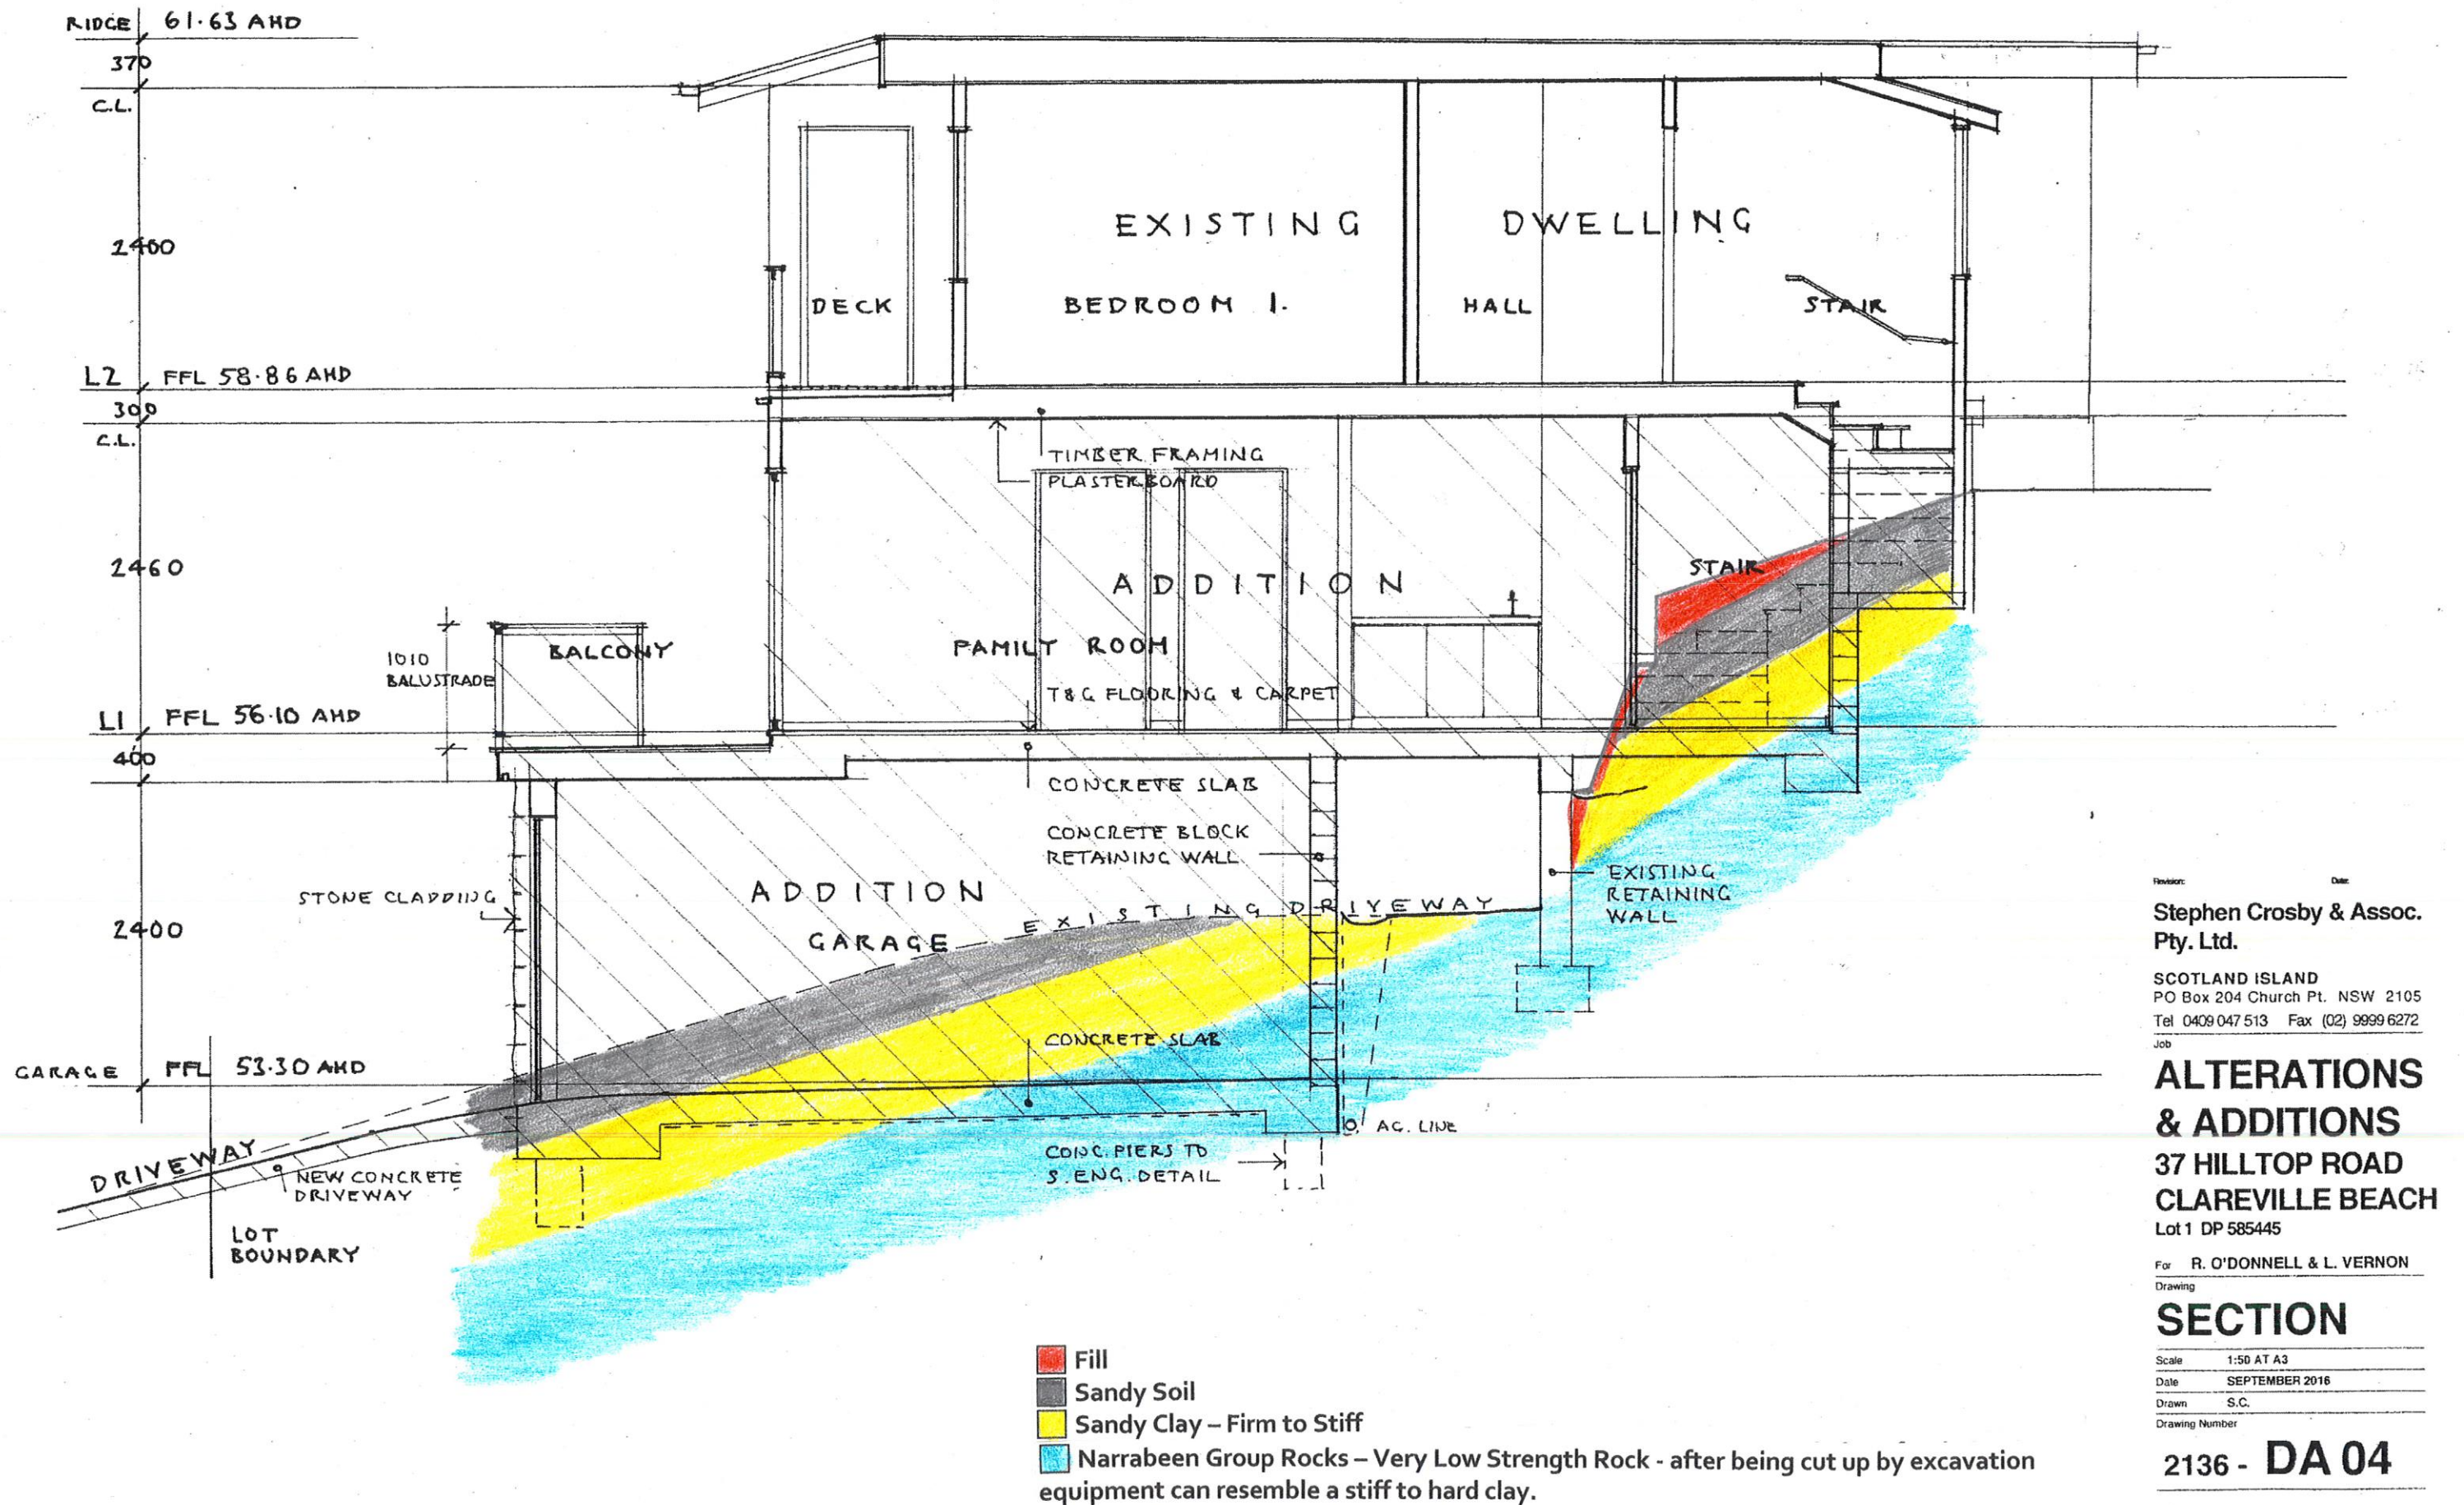
# TYPE SECTION – Diagrammatical Interpretation of expected Ground Materials

The slope materials are colluvial at the near surface and residual at depth. They consist of a thin sandy topsoil over sandy clays and clays with rock fragments throughout the profile. In the test locations the sandy clays and clays merge into the weathered zone of the under lying rocks at an average depth of ~1.1m below the current surface. The weathered zone is interpreted to be very low strength rock that becomes progressively stronger with depth. See the Type Section attached for a diagrammatical representation of the expected ground materials.
