Report Title: Geotechnical Report 54 McCarrs Creek Road, Church Point  
Report Date: 17/11/22

## **GEOTECHNICAL INVESTIGATION:**

Alterations and Additions at **54 McCarrs Creek Road, Church Point**

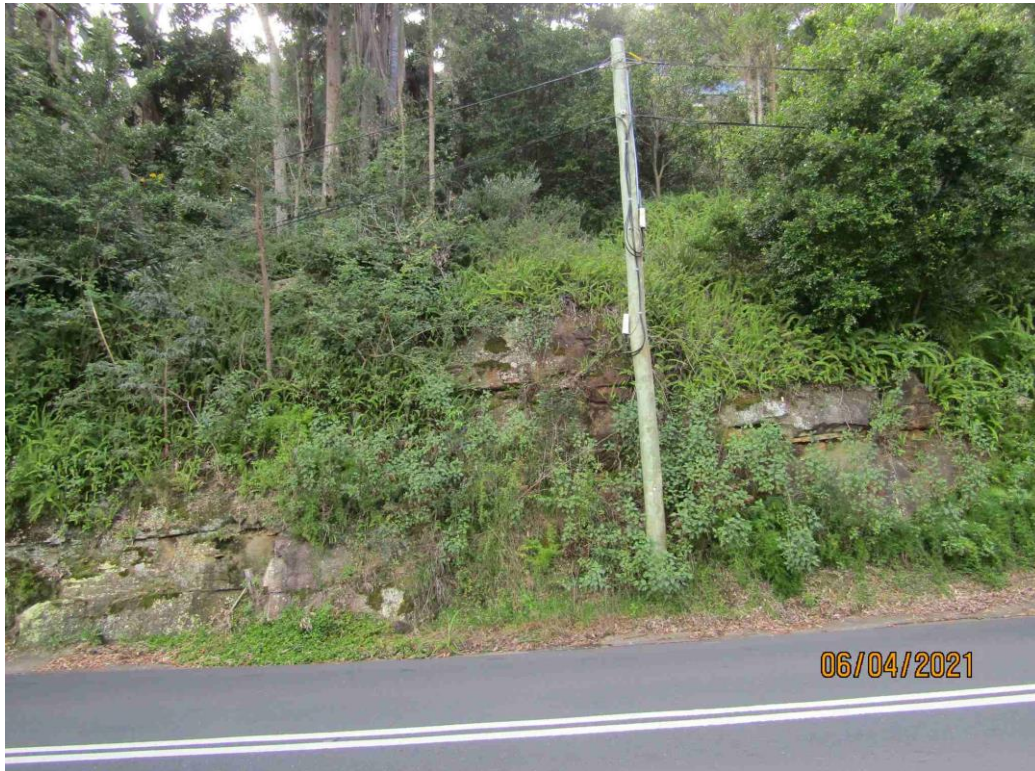
Photo 1

**2.3** Sandstone bedrock is outcropping on the uphill side of the road (Photo 1). At the road frontage, a concrete right of carriageway (ROW) runs to a garage attached to level 3 of the house (Photo 2). The three storey rendered masonry house is supported by rendered masonry walls and a concrete slab (Photos 3 & 4). The external supporting walls show no significant signs of movement. Levels 1 and 2 of the house are cut into the slope. A stable sandstone block retaining wall up to ~2.4m high supports a cut and fill on the downhill side of the ROW (Photo 5). A paved area is located downhill of the wall (Photos 5 & 6).

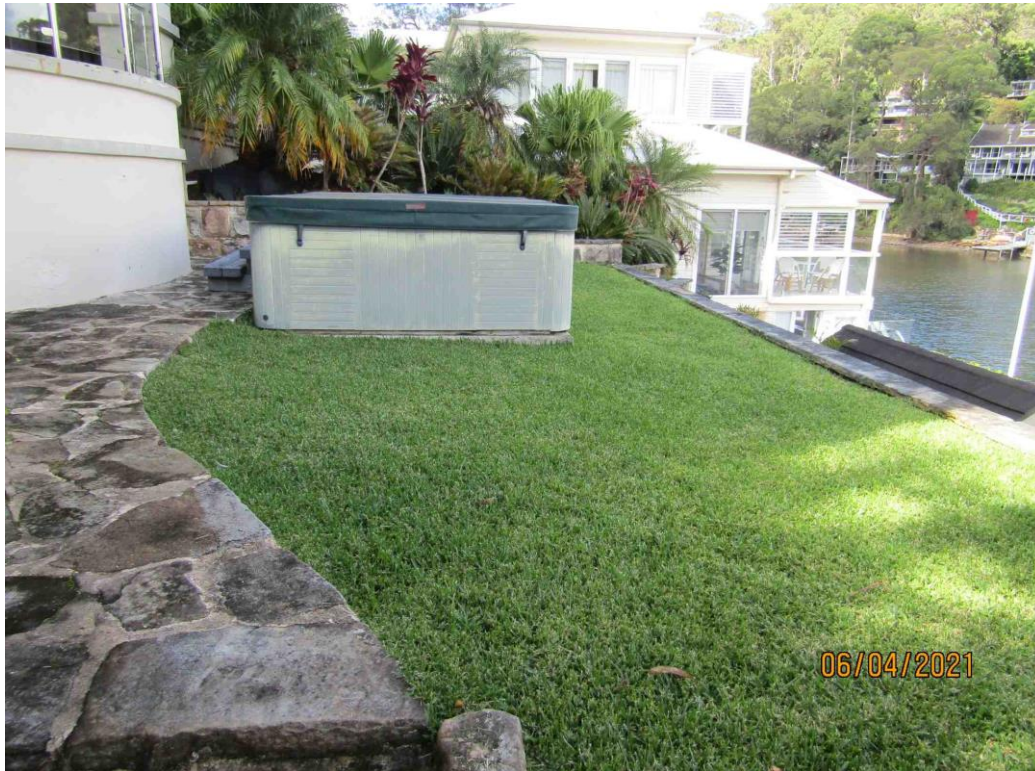
Photo 7

Fill provides level platforms for lawn and garden areas on the downhill side of the house (Photos 7 & 8). The fills are supported by sandstone block and concrete retaining walls up to ~1.9m high (Photos 8, 9 & 10). The sandstone block retaining walls are in good condition. The concrete retaining wall (Photo 10) displays fine cracking but no deflection and is considered to be stable. A rendered masonry outbuilding is located beside the concrete retaining wall. A rendered masonry boathouse, timber ramp and pontoon are located at the waterfront (Photo 11). A stable concrete retaining wall up to ~2.2m high supports a cut and fill on the SE side of the boathouse (Photo 12). No signs of slope instability were observed on the property. The adjoining neighbouring properties were observed to be in good order as seen from the street and subject property.

(**Hazard Two**). The additional surcharge loads from the proposed pool structure is a potential hazard to the existing sandstone block retaining wall (Photo 7) (**Hazard Three**).

| HAZARDS | Hazard One | Hazard Two | Hazard Three |
|---|---|---|---|
| TYPE | The steeply graded slope that falls across the property and continues above failing and impacting on the property. | The proposed excavation for the lift and storage area collapsing onto the worksite, undercutting the subject house and impacting the neighbouring properties before retaining walls are in place. | The additional surcharge loads from the pool structure transferring onto the existing retaining wall that leads to damage and instability (Photo 7). |
| RISK TO PROPERTY | 'Low' ( $2 \times 10^{-5}$ ) | 'Moderate' ( $2 \times 10^{-4}$ ) | 'Moderate' ( $2 \times 10^{-4}$ ) |

| HAZARDS | Hazard One | Hazard Two | Hazard Three |
|---|---|---|---|
| COMMENTS | This level of risk is 'ACCEPTABLE', provided the recommendations in <b>Section 16</b> are carried out. | This level of risk to life and property is 'UNACCEPTABLE'. To move the risk to 'ACCEPTABLE' levels, the recommendations in <b>Section 13</b> are to be followed. | This level of risk to life and property is 'UNACCEPTABLE'. To move the risk to 'ACCEPTABLE' levels the recommendations in <b>Section 15</b> are to be followed. |

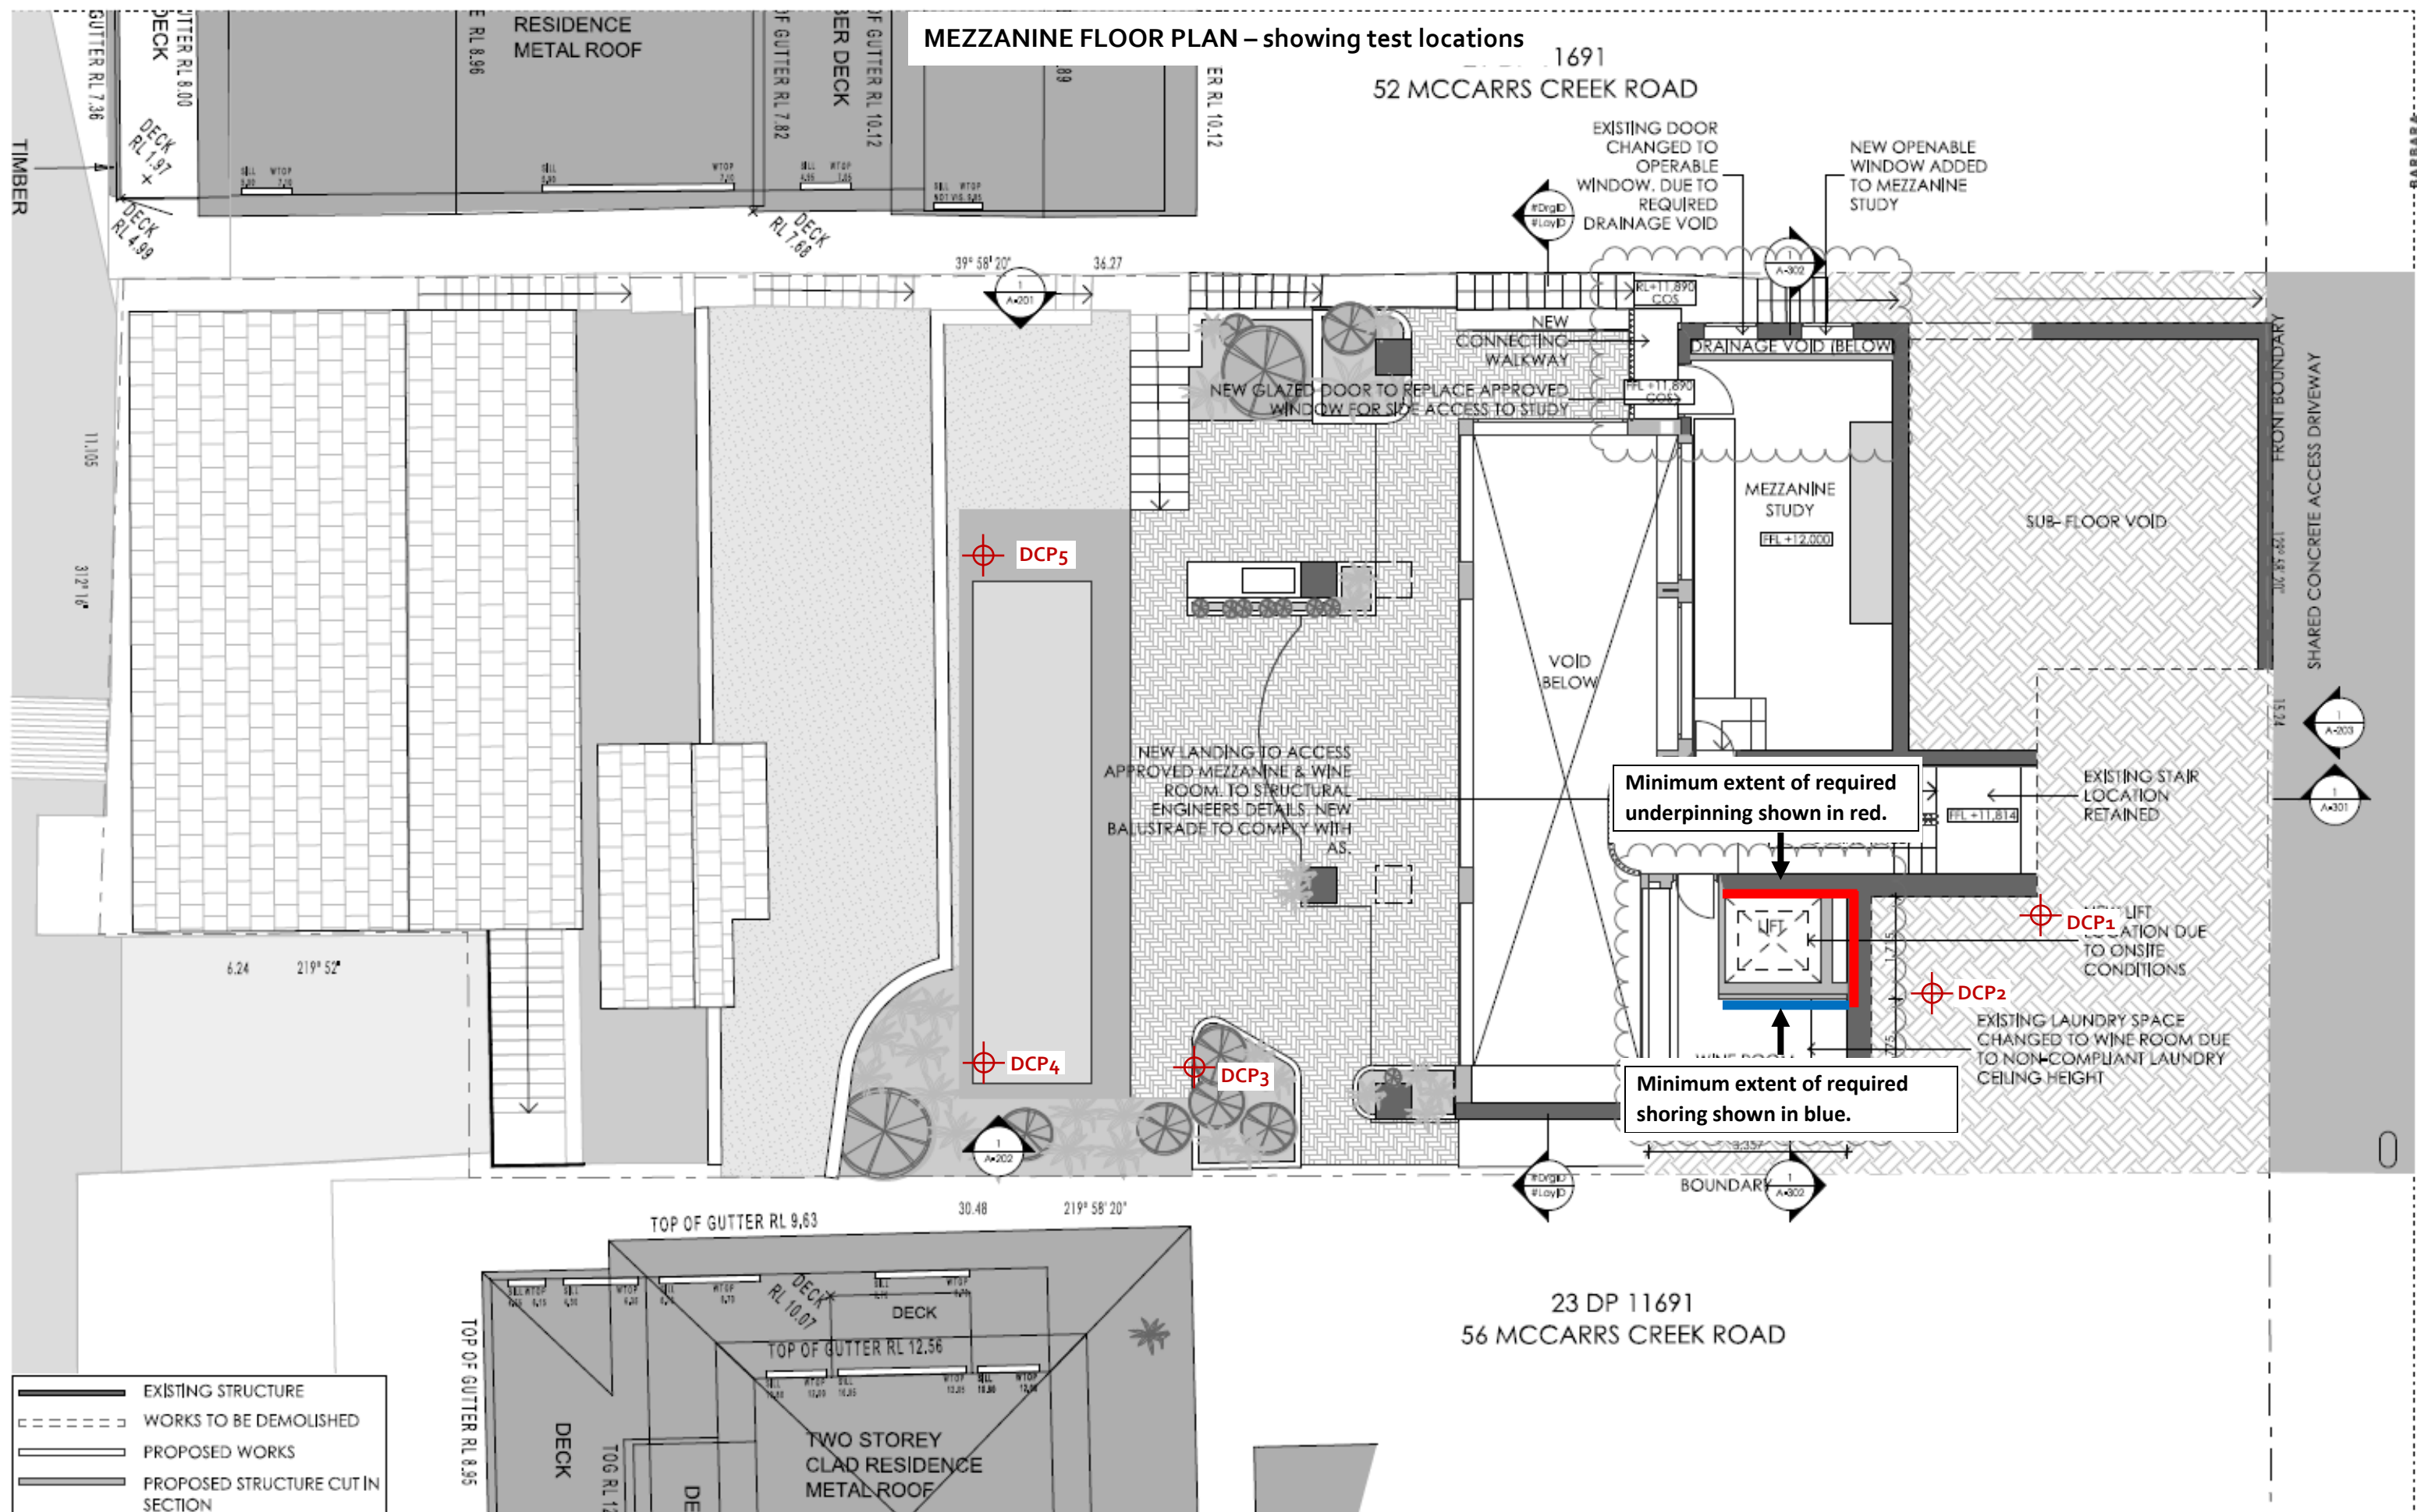
| REVISION<br><b>01</b> | DWG NO.<br><b>A-122</b> |

**Structures that require confirmation via exploration pits shown in red.**

An excavation to maximum depth of ~2.8m will be required to construct the proposed new lift. The excavation comes flush with the existing house walls. The existing NE house wall that is flush with the excavation can be demolished and propped as the excavation is lowered to provide access from the side. Hand tools can be used to excavate from the inside of the house. The other house walls that come flush with the excavation (that are to remain) are to be underpinned to the base of the excavation. As there are vertical limits on the extent of the depth of underpin foundations several stages of underpinning and then excavation lowering will be required to reach the base of the proposed lift. See the Mezzanine Floor Plan attached for the minimum extent of the required underpinning shown in red.

Due to the depth of the excavation, the SE cut through soil, clay and rock up to Low Strength is to be supported by a sprayed concrete retaining wall or a similar suitable support installed in stages as the excavation progresses. The shoring is to be designed/approved by the structural engineer so that not more than a depth of 1.2m of excavation face is left unsupported before shoring is installed. See the site plan attached for the minimum required extent of the shoring shown in blue.

If the foundations are confirmed to be at least 0.3m below the base of the proposed excavation (1.0m below the current surface), the excavation may commence. If they are not, they will need to be underpinned prior to the excavation commencing. The extent of the area of the required exploration pits/underpinning are shown in red on the site plan attached.

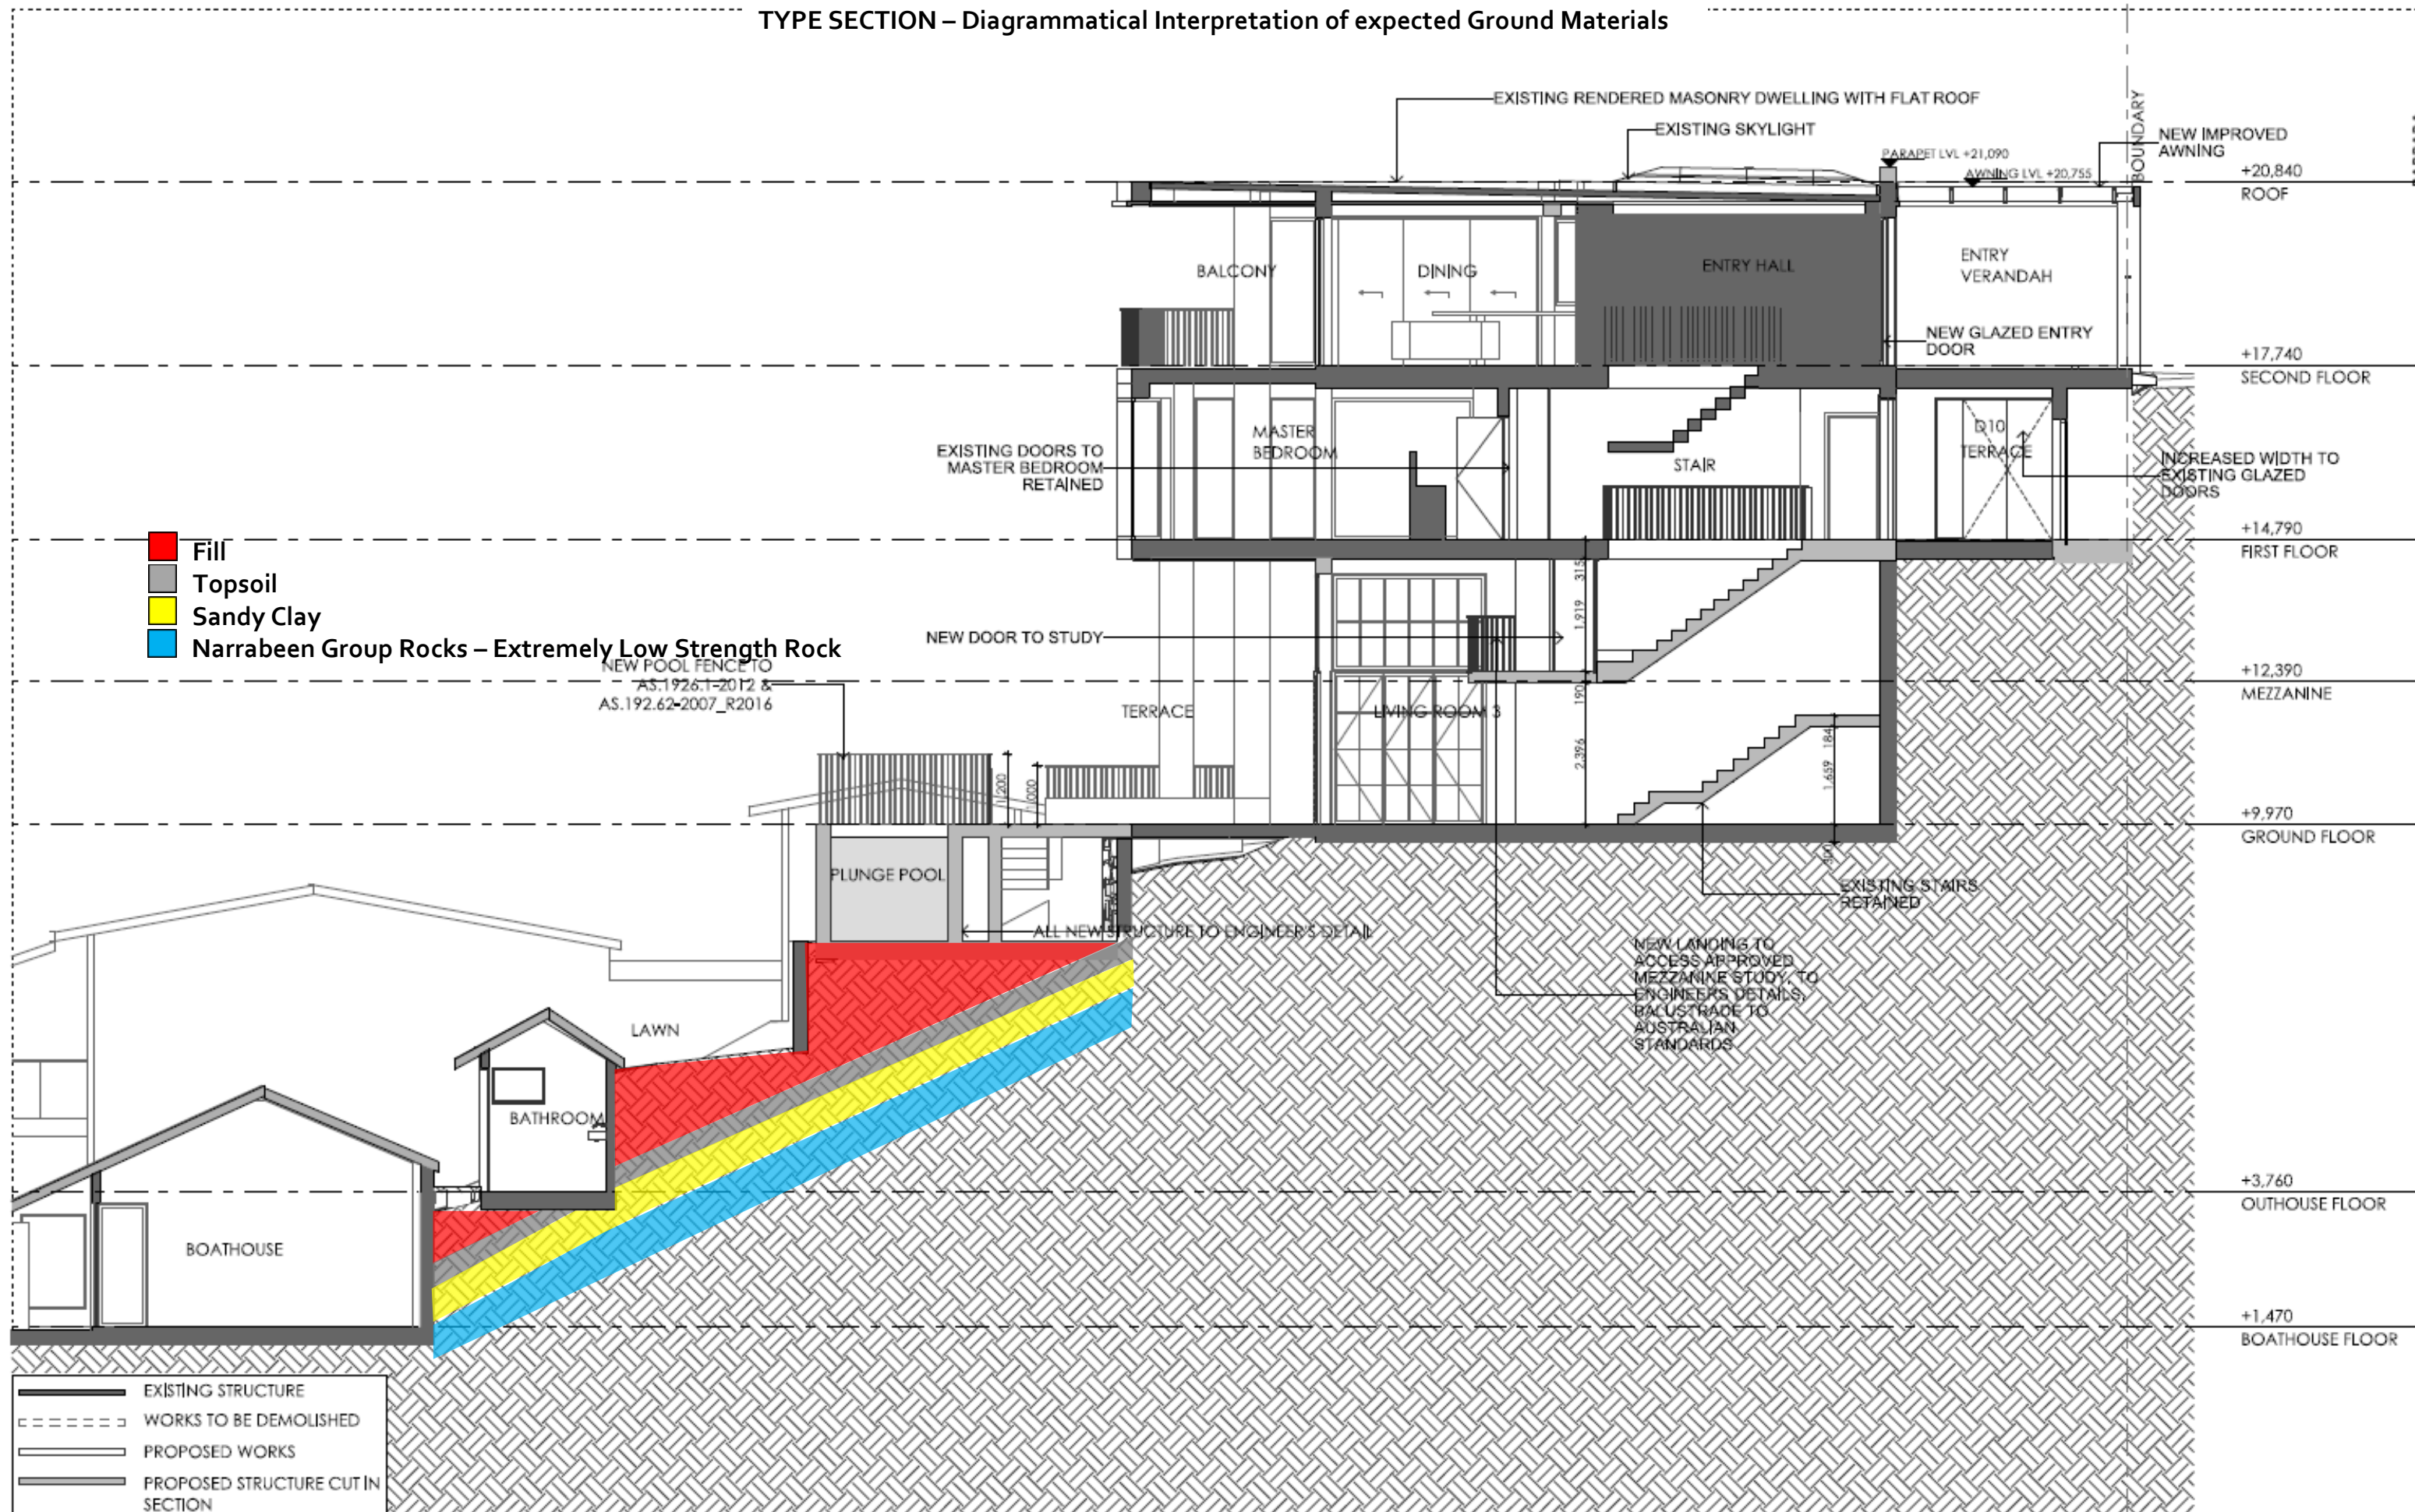
# TYPE SECTION – Diagrammatical Interpretation of expected Ground Materials

The slope materials are colluvial at the near surface and residual at depth. In the test locations, the ground materials consist of fill and a sandy topsoil over sandy clays. Fill to a maximum depth of ~1.9m provides level platforms for lawn and garden areas on the downhill side of the house. The clays merge into the weathered zone of the under lying rock at a depths from between ~1.1m to ~2.7m below the current surface, being deeper in the filled areas. The underlying rock is interpreted as Extremely Low to Low Strength Rock. It is to be noted that this material is a soft rock and can appear as a mottled stiff clay when it is cut up by excavation equipment. See Type Section attached for a diagrammatical representation of the expected ground materials.
