Report Title: Geotechnical Report 316 Hudson Parade, Clareville

Report Date: 28/8/24

## **GEOTECHNICAL INVESTIGATION:**

New Pool at **316 Hudson Parade, Clareville**

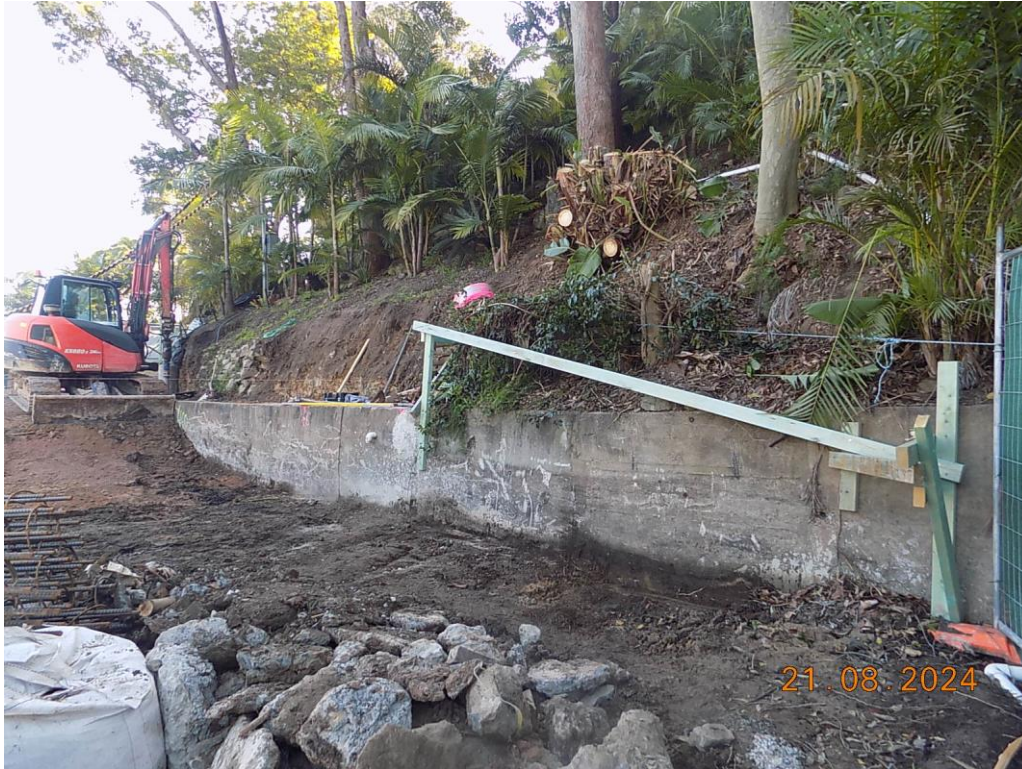
Photo 1

- 2.3** At the road frontage, a steeply graded slope falls to the uphill side of the subject house (Photos 1). Vehicular access to the property is provided by a shared driveway from the S that cuts across the slope and runs to the existing house and a detached brick garage/studio beside the house (Photos 2 & 3). The detached garage and uphill side of the property is currently undergoing demolition/construction works approved as part of a separate DA.

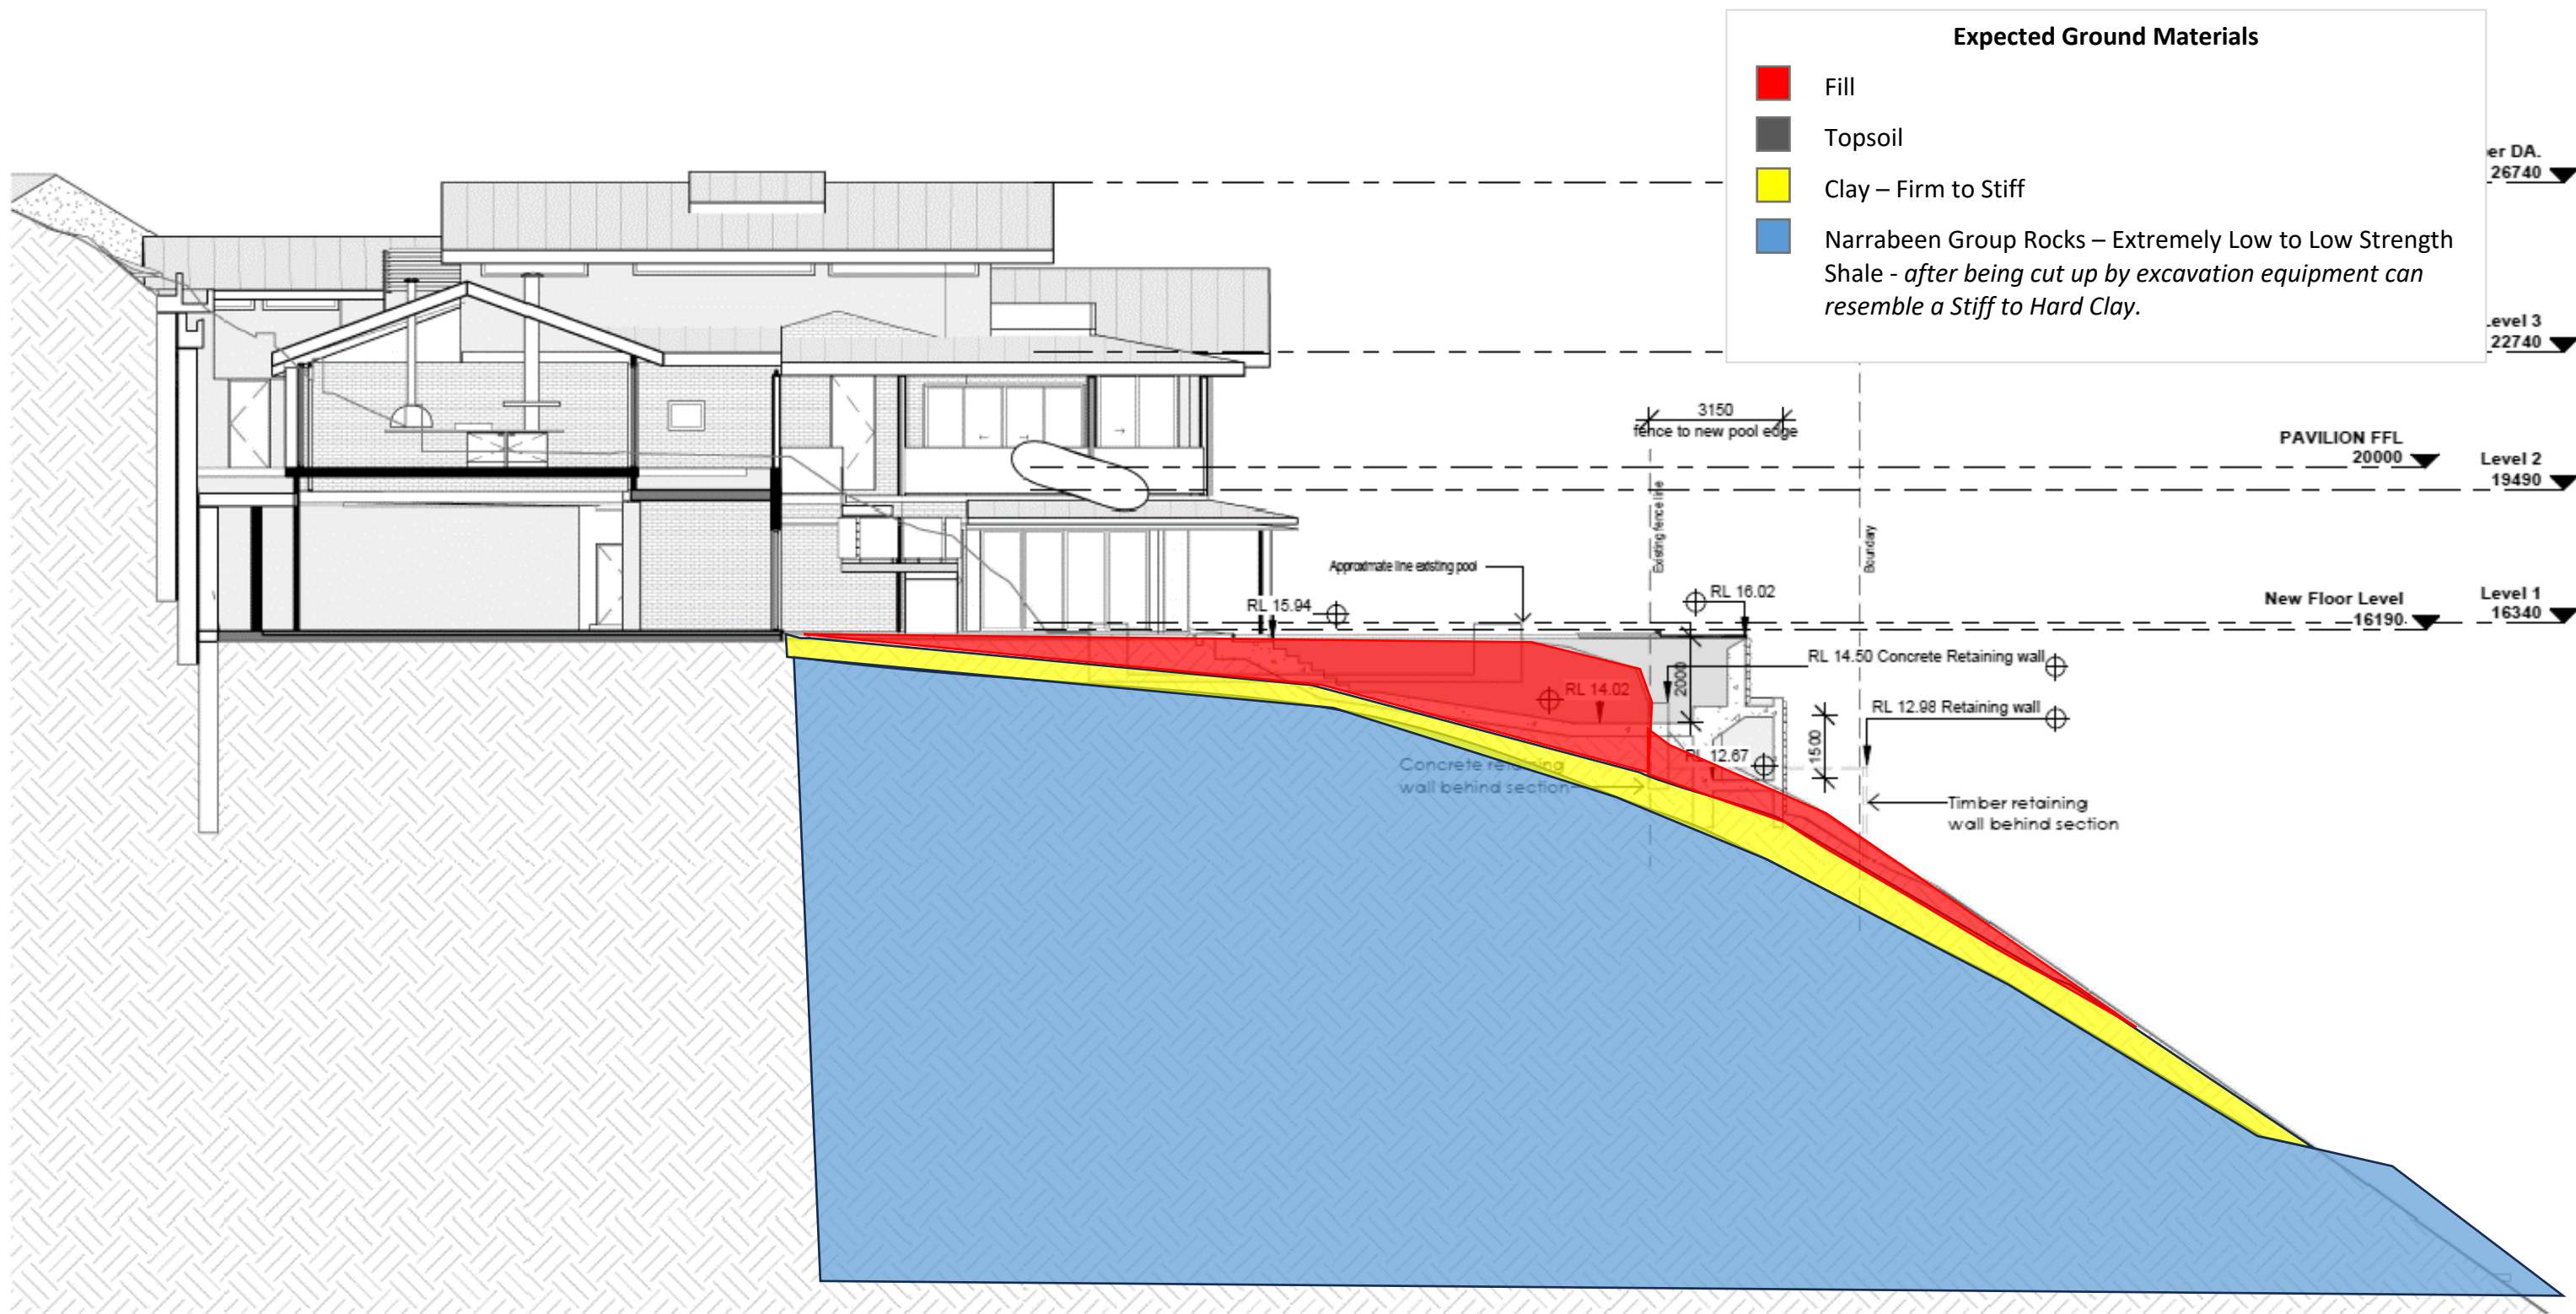
## TYPE SECTION – Diagrammatic Interpretation of expected Ground Materials

across the property. In the test locations, the clays merge into the weathered zone of the under lying rocks at depths of between ~1.2m to ~2.1m below the current surface, being deeper in the filled area. The weathered zone of the underlying rock is interpreted as Extremely Low to Low Strength Rock. It is to be noted that this material is a soft rock and can appear as a mottled stiff clay when it is cut up by excavation equipment. See Type Section attached for a diagrammatical representation of the expected ground materials.
