arboricultural impact assessment - proposed sewer pumping station - glenaeon, 207 forest way, belrose

18th November 2022 - prepared by Melanie Howden - Ass. Dip. Hort. (Haw. Ag. C.), SoA. Arb. MAIH, MIACA

Executive Summary

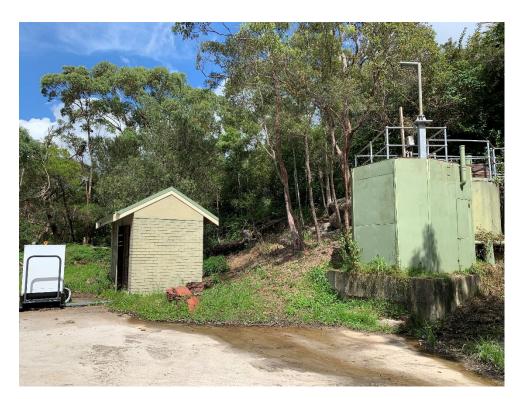
Figure 4.1 - The existing sewer pumping station looking south from the access road.

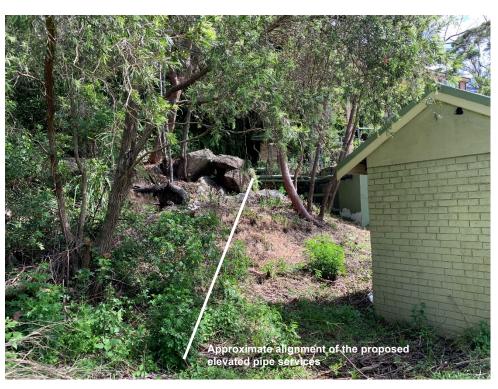
Figure 4.2 - View of the rocky terrain and the alignment of the proposed pipes which are to be elevated above ground and supported on piers.

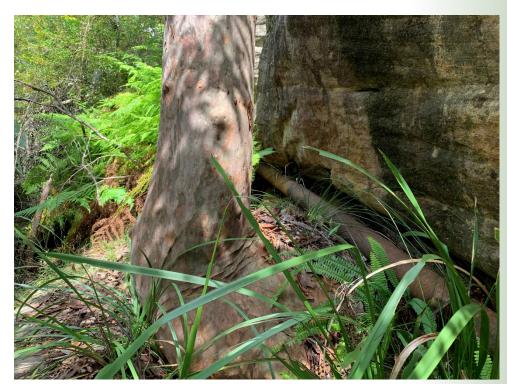
96.1	Angophora costata	Sydney Red Gum	12	12	340		Mature single trunk tree with an upright forest form; an upright trunk/s and balanced canopy and branch development. No evidence of significant branch pruning.	High L/scape Sig.	The tree appears stable and its branch attachment appears sound. The tree is considered to be in moderate health and displays good vigour.	Fair	15%	The tree is growing on a rock shelf with some epicormic growth evident	2	On site	4.10	52.8

Figure 4.3 - The base of Tree No. 96.1 showing the existing cast iron rising sewer main (right).

96.1	Angophora costata	560	590	2	High L/scape Sig.	6.70	141.00	2.7	The proposed electrical conduit is within 3.0m (west) of the tree and is proposed to be installed between existing boulders adjacent the cast iron rising sewer main	No significant impact	Retained with Tree Protection Measures	On site
