GEOTECHNICAL INVESTIGATION:

Subdivision and New house at **45 Oxford Falls Road, Beacon Hill**

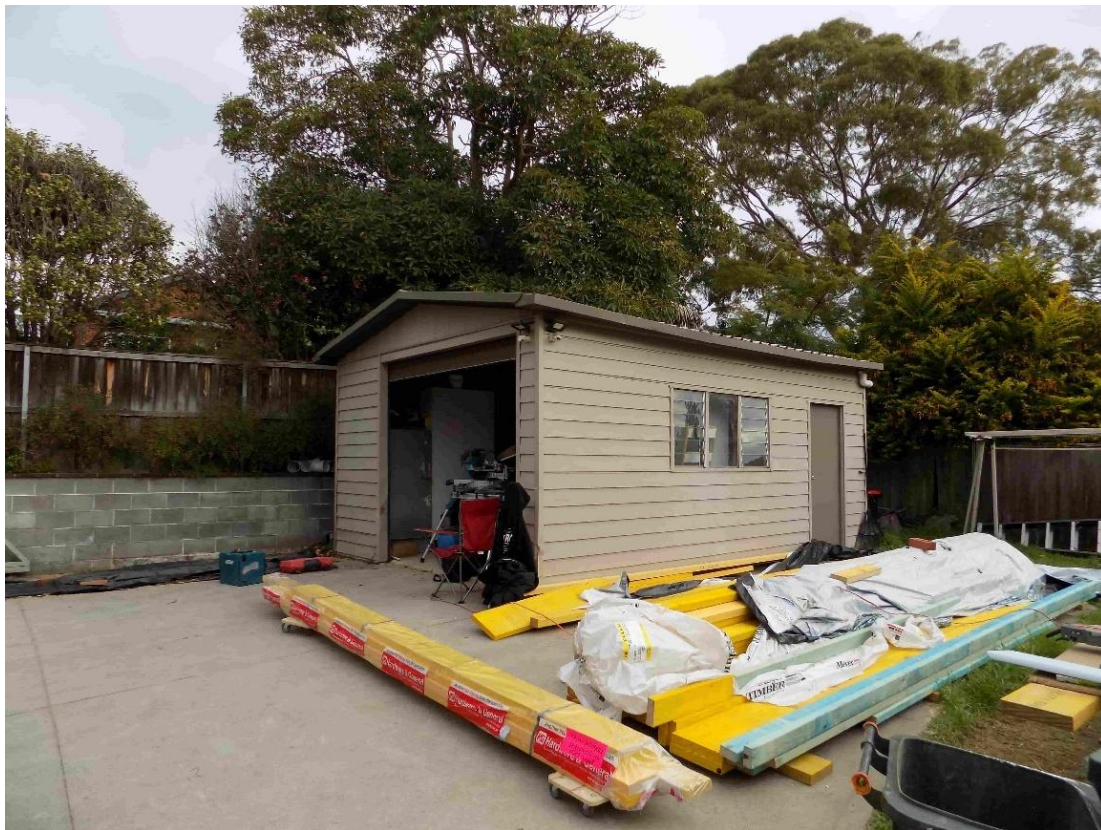
Photo 1

2.3 At the Dareen Street frontage, a concrete ROW runs to a timber framed garage on the uphill side of the property (Photo 1). Fill for the uphill neighbouring property is supported by a stable concrete block retaining wall reaching ~1.2m high (Photo 2). Between the garage and the house is a gently graded lawn. The two-story brick house which was being renovated at the time of inspection is supported on brick walls. No significant signs of movement were observed in the visible supporting walls. Between the downhill side of the house and the top of the cliff is a gently graded slope. Low to Medium Strength Sandstone is exposed at the base of a trench which has been dug along the W common boundary in this location (Photo 3). The rock face which steps down the property in this location reaches a maximum height of ~4.5m (Photo 4). No significant geological defects were observed in the rock face and it is considered stable. The remainder of the property between the base of the cliff and the downhill boundary is a steep, densely vegetated slope (Photo 5).

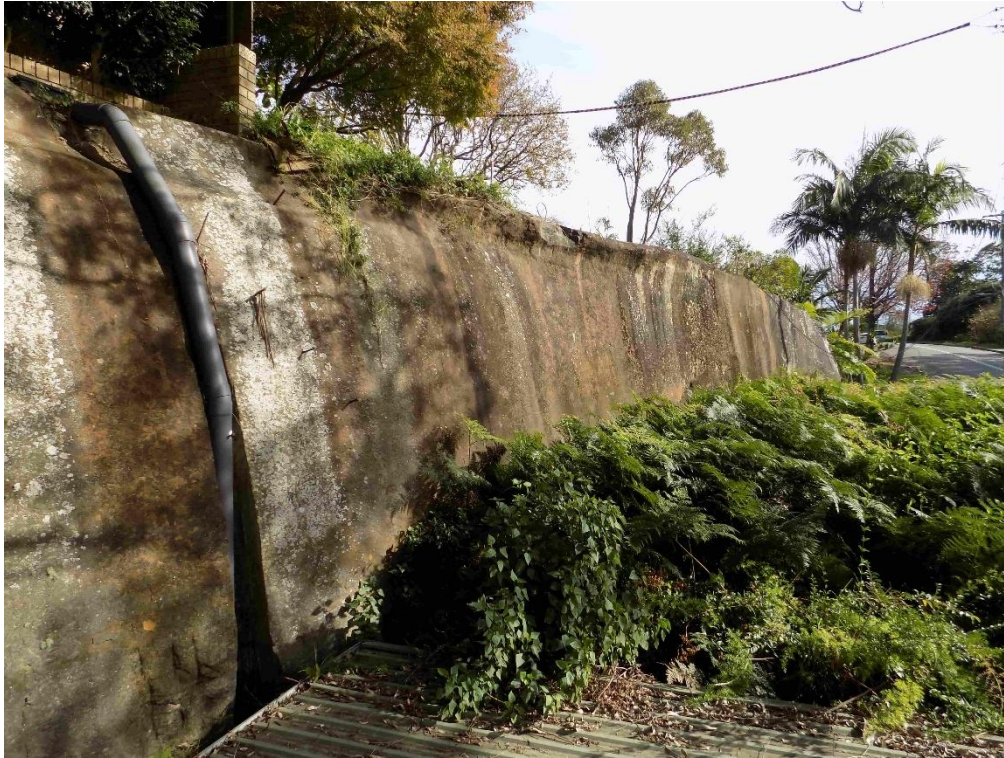
Photo 4

No geotechnical hazards were observed above or beside the property. The steeply graded slope that falls across the downhill side of the property and continues below is a potential hazard (**Hazard One**). The vibrations from the proposed excavations are a potential hazard (**Hazard Two**). A loose boulder, wedge, or similar geological defect toppling onto the work site during the excavation process is a potential hazard (**Hazard Three**). The large sandstone face that steps ~4.5m down the slope is a potential hazard (**Hazard Four**).

HAZARDS	Hazard Three	Hazard Four
TYPE	A loose boulder, wedge, or similar geological defect toppling onto the work site during the excavation process.	The sandstone face that steps ~4.5m down the slope failing and impacting on the proposed works (Photo 4).
LIKELIHOOD	'Possible' (10^{-3})	'Unlikely' (10^{-4})
CONSEQUENCES TO PROPERTY	'Medium' (20%)	'Medium' (25%)
RISK TO PROPERTY	'Moderate' (2×10^{-4})	'Low' (2×10^{-5})
RISK TO LIFE	6.6×10^{-5} /annum	2.9×10^{-7} /annum
COMMENTS	This level of risk to life and property is 'UNACCEPTABLE'. To move risk to 'ACCEPTABLE' levels, the recommendations in Section 13 and 14 are to be followed.	This level of risk is 'ACCEPTABLE'.

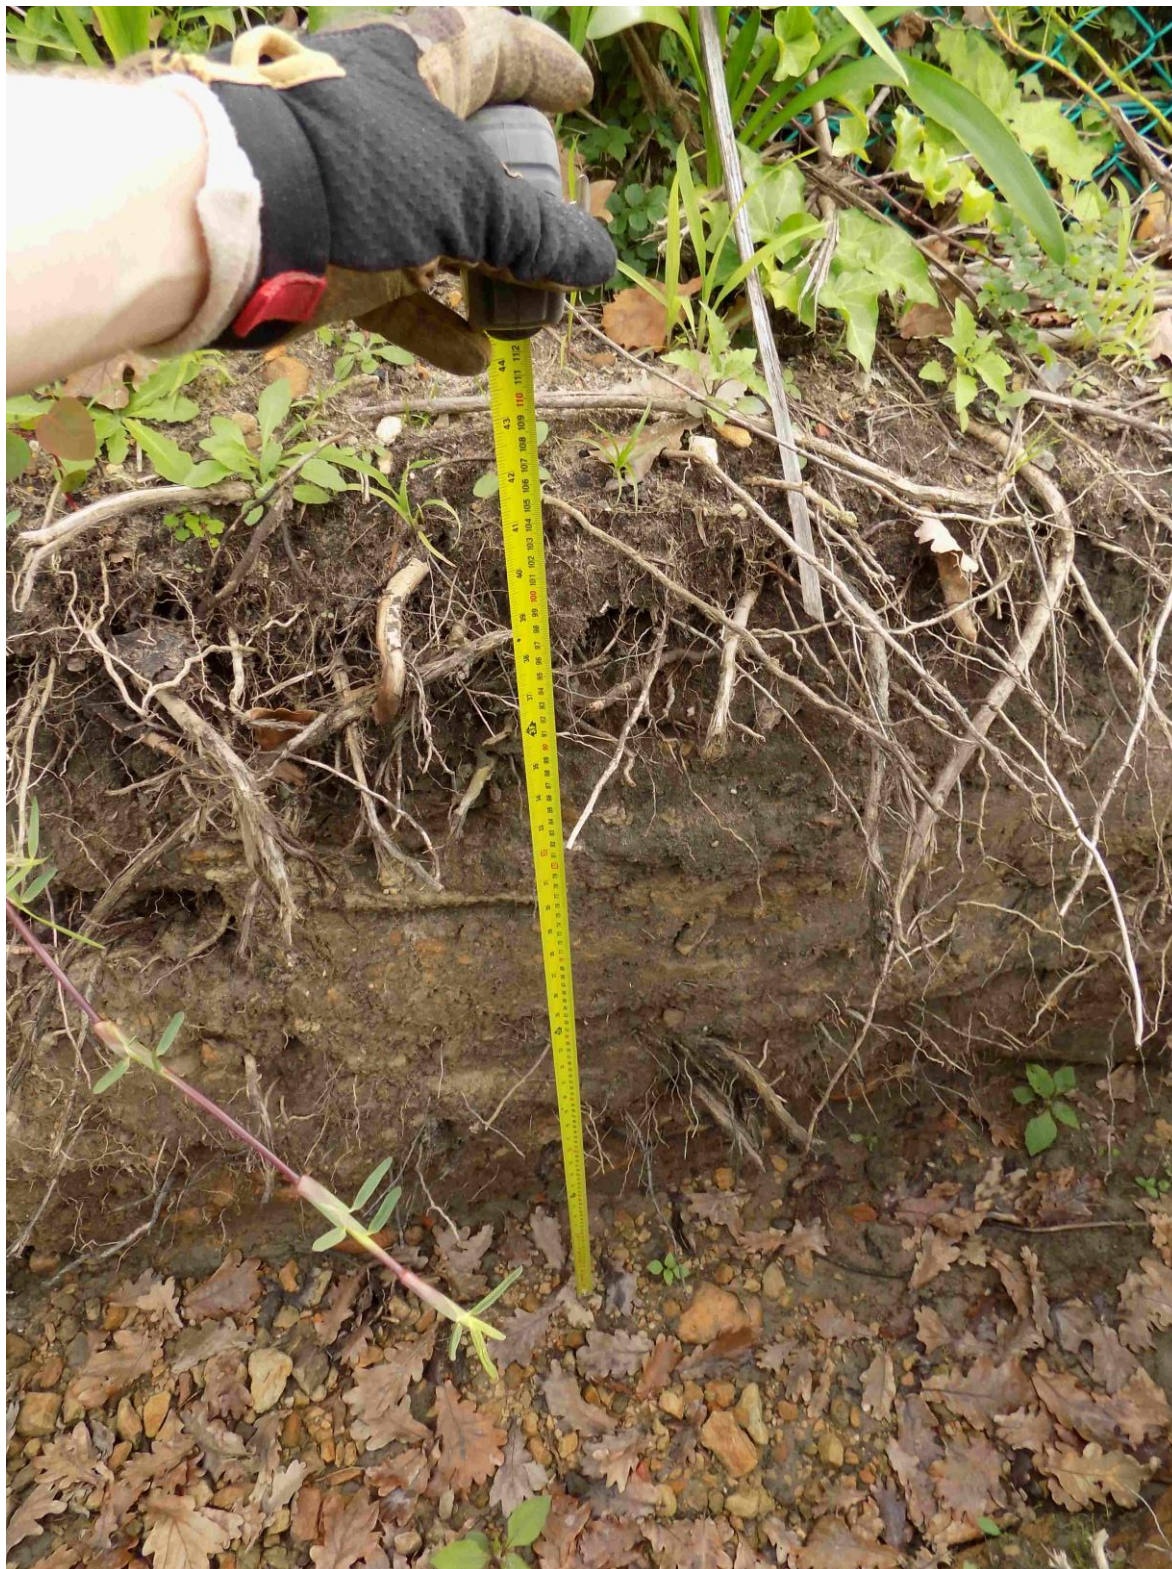
Photo 6 – LOG1

LOG 1 (~RL135.3) – (Photo 6)

Depth (m)	Material Encountered
0.0 to 0.2	TOPSOIL , dark brown, Medium Dense, dry, fine to coarse grained, rock fragments included.
0.2 to 0.7	SANDY CLAY , brown, Soft, dry, fine to medium grained.
0.7 to 1.0	LOW TO MEDIUM STRENGTH SANDSTONE , orange, yellow and grey, sugary texture in places.

Base of Trench at ~1.0m in Low to Medium Strength Sandstone. No water table encountered.
