# Geotechnical Assessment

**Project:** Alterations & Additions  
16 Worcester Street, Collaroy NSW

## Geotechnical Assessment

**16 Worcester Street, Collaroy NSW**

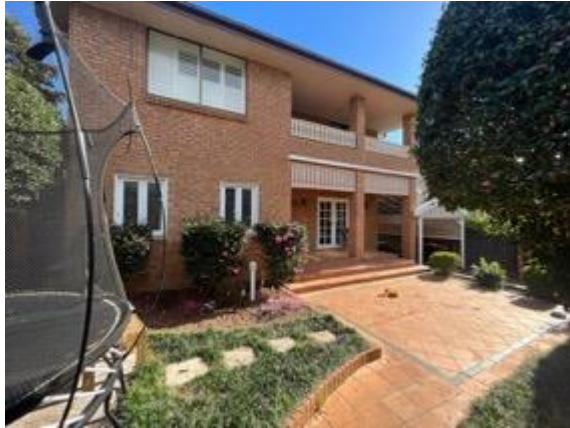
Photo 1

The four photos presented in Appendix D show the general conditions of the site on the day of the site visit conducted by AscentGeo.
