**Destructive Hazardous  
Building Materials Assessment  
Ivanhoe Park Childcare Centre  
Raglan Street, Manly NSW 2065**

**Northern Beaches Council  
July 2021**

**Job No: 96631S**

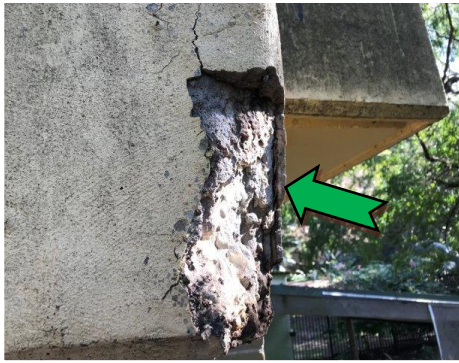
1. Exterior, north-east corner of building – non asbestos-containing render finish to roof slab.

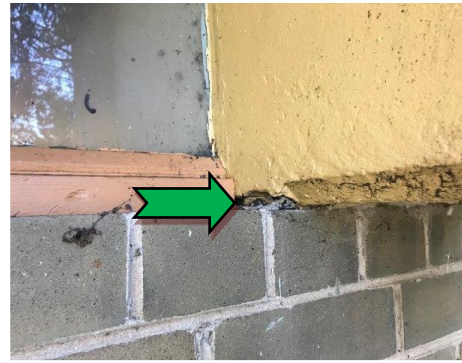
2. Exterior, north-east corner of building – non asbestos-containing bituminous expansion joint between roof slab and brick wall.

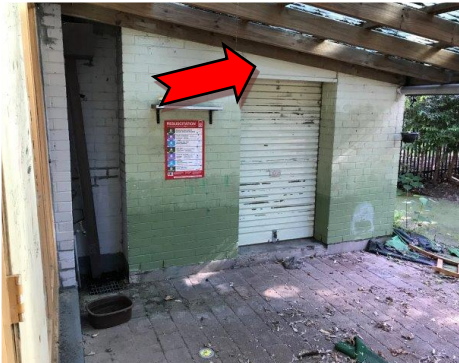
| Client: Northern Beaches Council | | | | Site Name: Ivanhoe Park Childcare Centre | | | | Site Address: Raglan Street, Manly NSW 2095 | | | | Client No: N0103 Job No: 96631S | | | | |
|---|---|---|---|---|---|---|---|---|---|---|---|---|---|---|---|---|
| Exterior | Adjacent north entrance, above roller door | Infill panel | Fibre cement sheeting | Asbestos | 96631S-001-009 | Positive | Non-friable | Low | Good | Low | Low | 1 m <sup>2</sup> | Remove under controlled non-friable asbestos removal conditions prior to refurbishment or demolition works by a Class B (non-friable) licensed asbestos removal contractor. | P4 | Jul-26 | 3 |

3. Exterior, adjacent north entrance, above roller door – asbestos-containing fibre cement sheet infill panel.

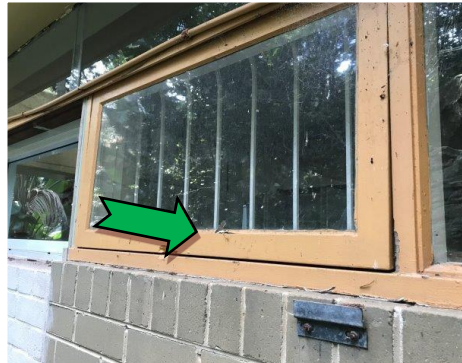
4. Exterior, south-west corner of building, window frame – non asbestos-containing window mastic.

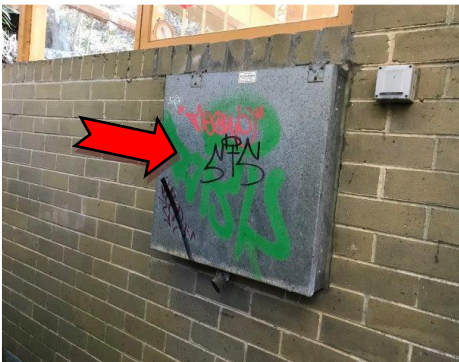
| Client: Northern Beaches Council | | | | Site Name: Ivanhoe Park Childcare Centre | | | | Site Address: Raglan Street, Manly NSW 2095 | | | | Client No: N0103 Job No: 96631S | | | | |
|---|---|---|---|---|---|---|---|---|---|---|---|---|---|---|---|---|
| Exterior | South-west corner of building | Electrical box | Bituminous backing board | Asbestos | Not sampled: locked | Assumed Positive | Non-friable | Low | Unknown | Low | Low | 1 unit | Unable to access at the time of the assessment due to lack of keys. Confirm presence, remove under controlled non-friable asbestos removal conditions prior to refurbishment or demolition works by a Class B (non-friable) licensed asbestos removal contractor. | P4 | Jul-26 | 5 |

5. Exterior, south-west corner of building, inaccessible electrical box – asbestos-containing bituminous backing board assumed to be present within.

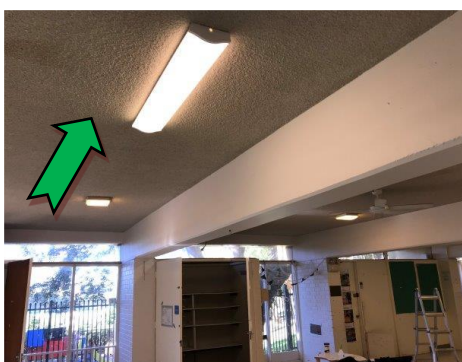
6. Interior, north section of playroom, ceiling – non asbestos-containing sprayed vermiculite.

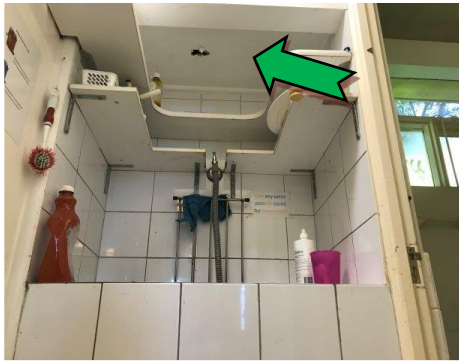
7. Interior, wash basin located adjacent adult bathroom, above sink – non asbestos-containing fibre cement sheet ceiling.

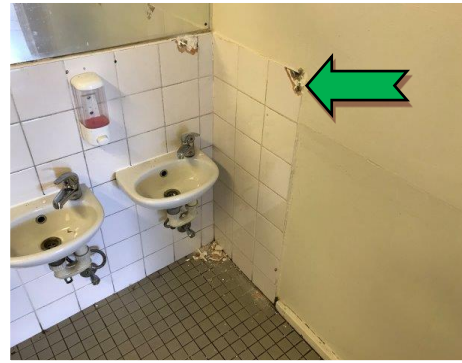
8. Interior, children's bathroom, wash basin area, behind ceramic tiles – non asbestos-containing fibre cement sheet wall linings.

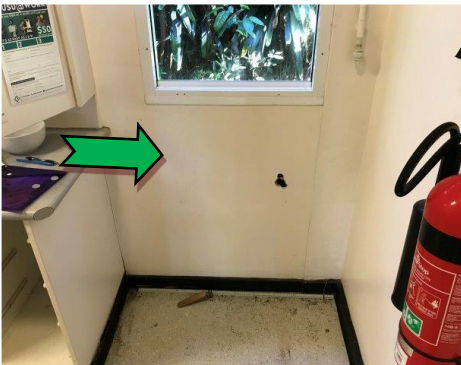
9. Interior, kitchen, north-west corner– non asbestos-containing fibre cement sheet wall linings.

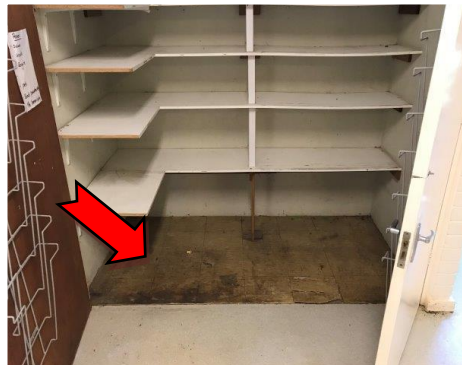
| Client: Northern Beaches Council | | | | Site Name: Ivanhoe Park Childcare Centre | | | | Site Address: Raglan Street, Manly NSW 2095 | | | | Client No: N0103 Job No: 96631S | | | | |
|---|---|---|---|---|---|---|---|---|---|---|---|---|---|---|---|---|
| Interior | Playroom, adjacent south exit, within cupboard | Floor coverings - beige | Vinyl floor tiles | Asbestos | 96631S-001-001A | Positive | Non-friable | Low | Good | Low | Low | 3 m <sup>2</sup> | Remove under controlled non-friable asbestos removal conditions prior to refurbishment or demolition works by a Class B (non-friable) licensed asbestos removal contractor. | P4 | Jul-26 | 10 |

10. Interior, playroom, adjacent south exit, within cupboard, floor coverings (beige) – asbestos-containing vinyl floor tiles.

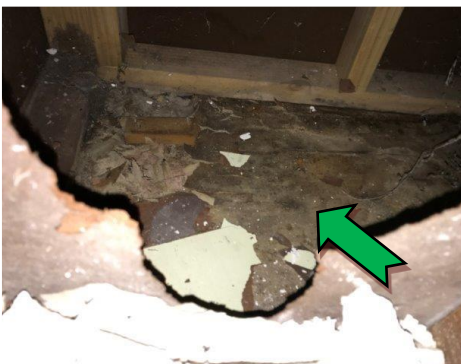
11. Interior, wash basin located adjacent adult bathroom, within void beneath sink, floor coverings (brown) – non asbestos-containing sheet vinyl.

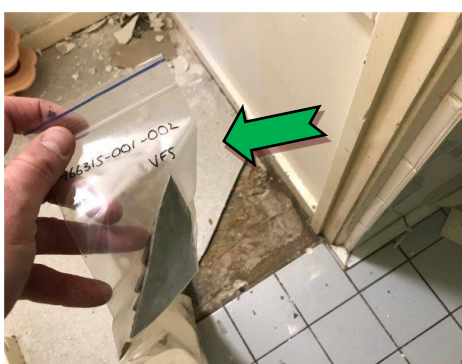
12. Interior, wash basin located adjacent adult bathroom, floor coverings (grey) – non asbestos-containing sheet vinyl.
