J0877. 24th June, 2016. Page 1.

GEOTECHNICAL INVESTIGATION:

Secondary Dwelling at 6 Bushrangers Hill, Newport.

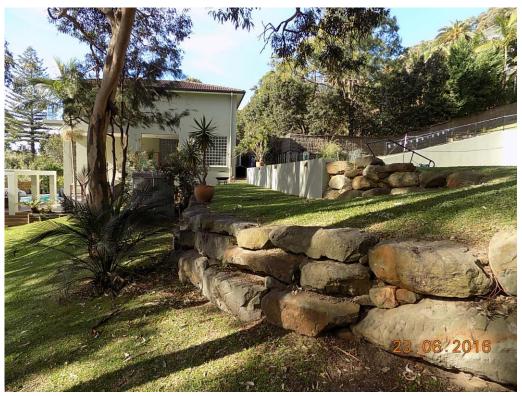
Photo 1

- 2.3 At the Bushrangers Hill road frontage two concrete driveways runs up the slope to a concrete parking area and rendered brick garage. A large sloping lawn that has been terraced encompasses the entire W half of the site (Photo 1). The fills are supported by stable rendered concrete block and stacked boulder retaining walls. A large cut has been made into the slope for a level lawn and concrete-paved area which is supported by a ~2.7m high concrete block retaining wall (Photo 2). The wall displays minor hairline cracking but no signs of movement. The lawn beside to the E and above the cut extends to a chain-link fence lining the upper third of the site.

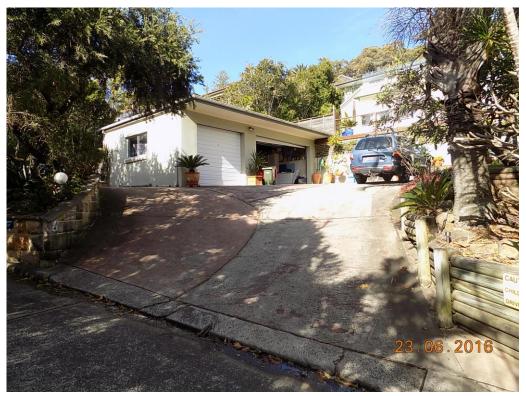
Photo 3

The E driveway is flanked on both sides by low terraces supported by low retaining walls (Photo 3). The W flank terraces are supported by two low timber retaining walls. The lower wall is ~0.7m high and tilting at angles of ~7°. The wall will eventually need replacing but is not considered a threat to life or property. The upper wall is up to ~1.0m high and considered stable (Photo 4). The E flank terraces are supported by 2 mortared sandstone block walls ~0.6m high. The walls display cracking through the blocks and the upper wall has settled away from the concrete of the

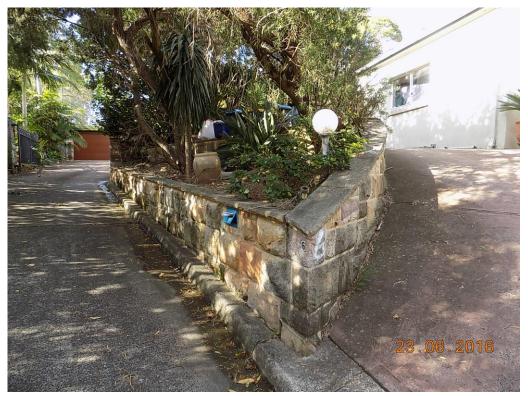
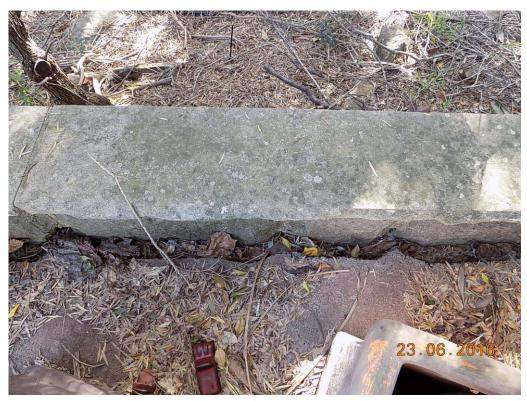
driveway by ~40mm (Photos 5 & 6). This settlement most likely occurred soon after the construction of the walls and is currently considered stable. The cut for the garage and driveway is supported by a ~1.8m high concrete retaining wall that displays a minor crack from the top of the wall to the base but no signs of deflection were observed (Photo 7). A pool area extending off the downhill side of the house displayed no signs of movement (Photo 8). A cut has been made in the slope to provide a level platform for the house. The part three storey rendered brick house is in good condition (Photo 9). The external supporting brick walls show no signs of movement that could be related to slope instability. The supporting brick piers and steel posts stand vertical (Photo 10). A concrete and lawn area extends off the uphill side of the house. A soldier pile timber retaining wall ~1.2m high lines the boundary on the uphill side of the house (Photo 11). The wall

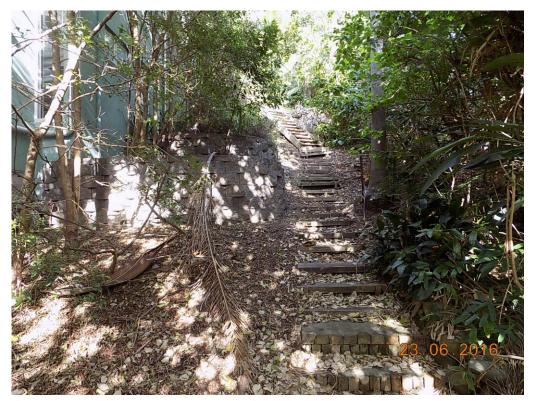
Photo 12

The upper third of the property is steeply graded and covered in native and exotic vegetation. The slope is terraced with five stable keystone retaining walls reaching a maximum height of ~1.2m and three low rough stack rock walls (Photo 12). The two lower rough stack rock walls are considered stable. The upper wall is crumbling but will be demolished as part of the proposed works. The fill batter for Bungan Head Road merges into the natural slope and is considered stable.
