Our ref: 11087.Addendum.4

8 November 2017

Report: Additional Tree Removals and Tree Protection RSL Anzac Village: Labuan (Old and New Darby and Joan) 90 Veterans Parade, Narrabeen NSW (the site)

URBAN TREE MANAGEMENT © 2017, Our reference 11087. Addendum. 4 Section 96 Application - Removal of additional trees and protection of additional trees. RSL Anzac Village: Labuan (formerly Old Darby and Joan), 90 Veterans Parade, Narrabeen NSW ©.

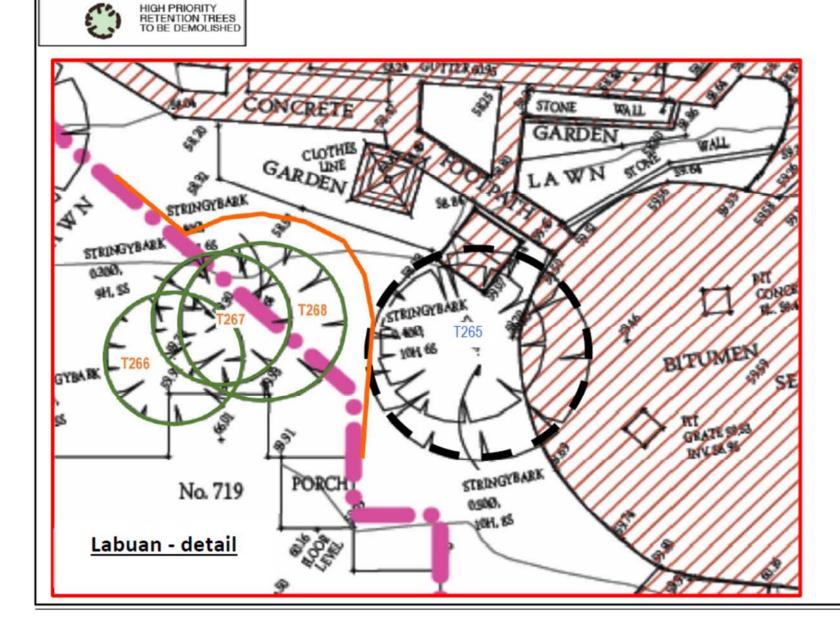
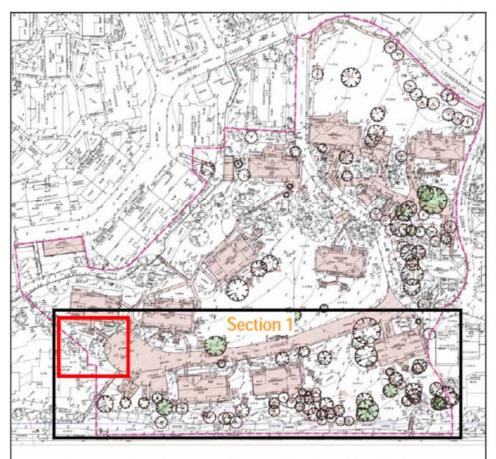
Appendix B Tree Protection Plan (3 of 3) Trees 266, 267 and 268.

Stand of trees to be retained and encroached on north side be excavation and retaining wall for courtyard to new dwellings to north.

Trees 263-269 are additional to the initial report and of these Trees 263-265 and 269 are to be removed and Trees 266-268 are to be retained and protected. Tree 263 is a Narrow-leaved Black Peppermint, senescent and a non-locally indigenous tree species with a limited life expectancy in cultivation within the Sydney region. Tree 264 is a Scribbly Gum that is structurally deteriorated due to a large trunk wound from borers. Tree 265 is a locally indigenous Bangalay, located at the end of a cul de sac and required to be removed for road works. Trees 266-268 are a stand of locally indigenous Bangalay to be retained in an area adjacent to excavation for a court yard requiring a retaining wall to be constructed at the edge of the Tree Protection Zone and each expected to remain viable and stable. Tree 269 is a young a self-sown Blackbutt of small dimensions that has recently arisen from the mulch in the shrub garden adjacent Lantana Avenue. Trees 174, 175, 178, 179, 180 263 and 264 are to be removed to facilitate the widening of the internal road for ambulance access. This will require excavation and reconstruction of retaining walls where the trees are growing, which cannot be retained for reasons of safety due to root loss and expected resultant instability. Tree 269 is to be removed to facilitate the construction of a driveway. Tree 170 is a Eucalyptus haematoma – Scribbly Gum and will likely be adversely impacted by encroachment of the building envelope of Unit 39 and is expected to decline and become unstable and is to be removed.

Root Protection From Soil Profile Desiccation – all trees. After excavation at the edge of the Tree Protection Zone for the soil level changes for the courtyard and construction of the retaining wall (Appendix B, Plan 3 of 3), roots are to be protected from exposed soil profiles drying out. Immediately root after excavation the exposed soil profile is to be protected with a double layer of hessian of Geotextile fabric is to overlap the top of the profile by 300 mm and be pegged into place. The soil profile protection is to remain in place and be maintained until the commencement of backfilling behind the new retaining wall, when it is to be removed.
