Report Title: Geotechnical Report 51 Alleyne Avenue, North Narrabeen

Report Date: 24/7/25

GEOTECHNICAL INVESTIGATION:

New Granny Flat at **51 Alleyne Avenue, North Narrabeen**

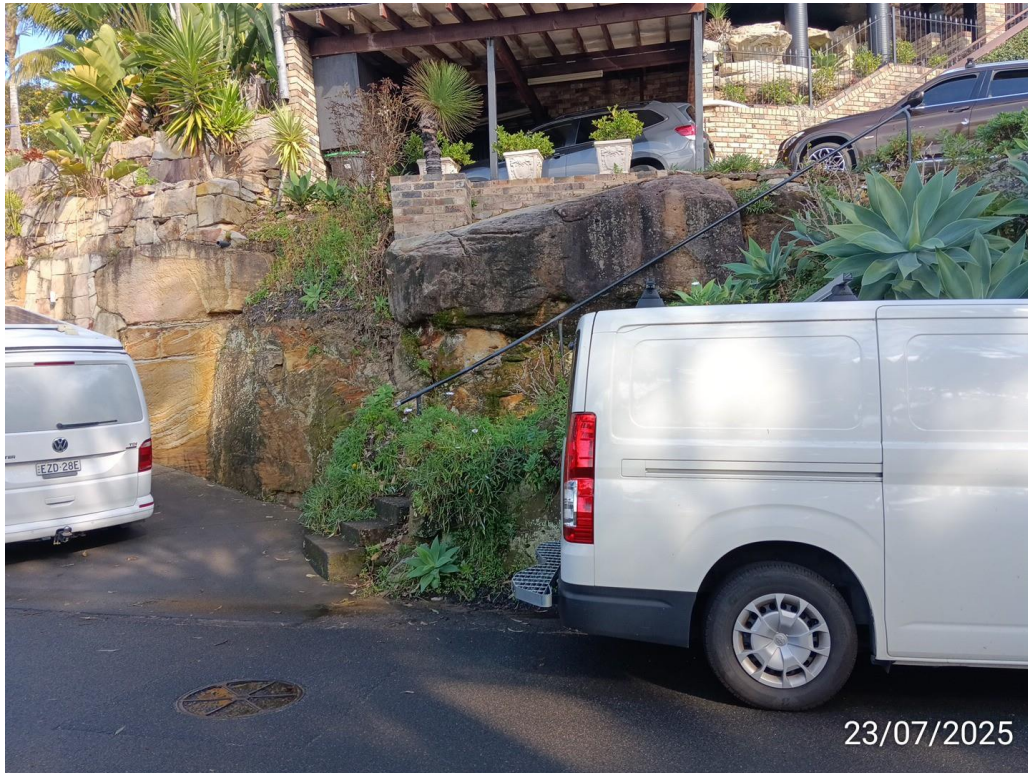
Photo 1

- 2.3** Low to Medium Strength Sandstone bedrock outcrops at the uphill side of the road (Photo 1). A suspended timber parking platform is located at the road frontage. The timber posts that support the parking platform stand vertical (Photo 2). Beneath the parking platform, a large boulder is partially embedded in the slope (Photo 2). It is considered stable provided the drainage regime on the slope is not altered (i.e. so water flows are not directed to the uphill side of the boulder). Cuts and fills provide level platforms for lawn, garden and paved areas between the parking platform and

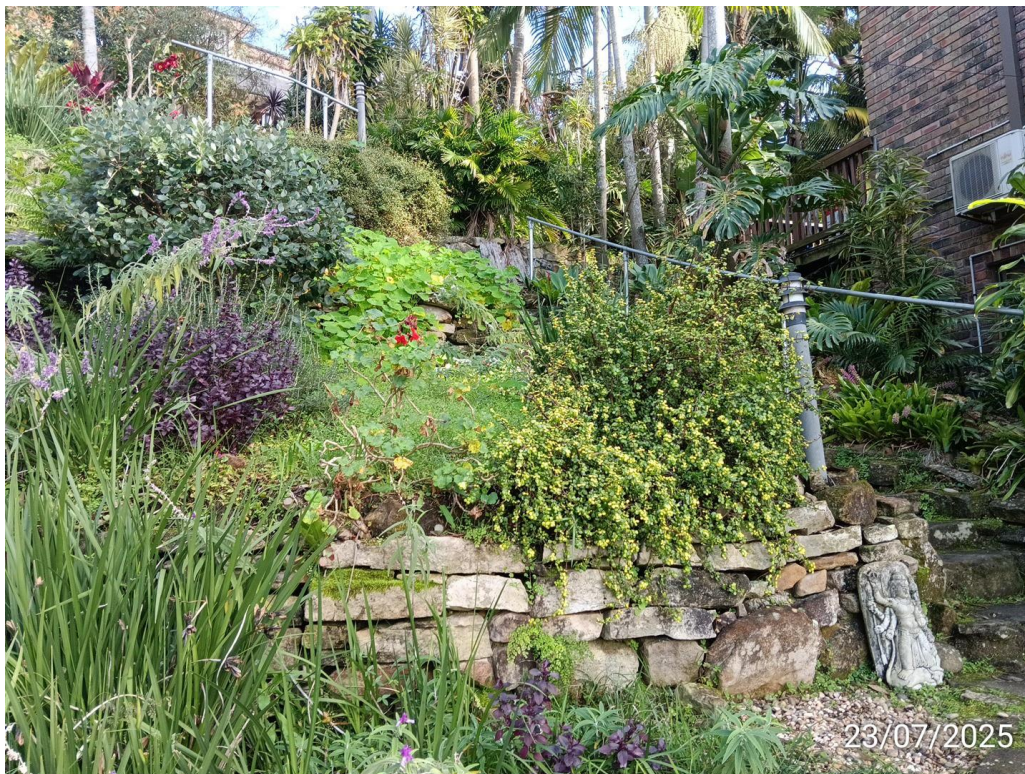
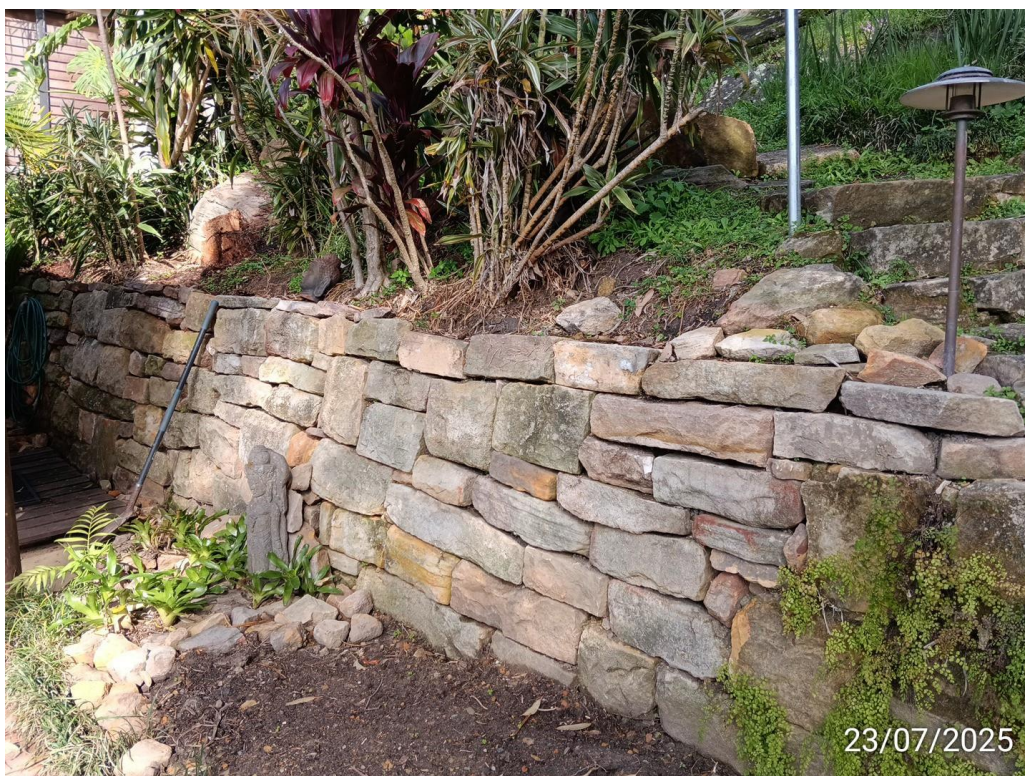
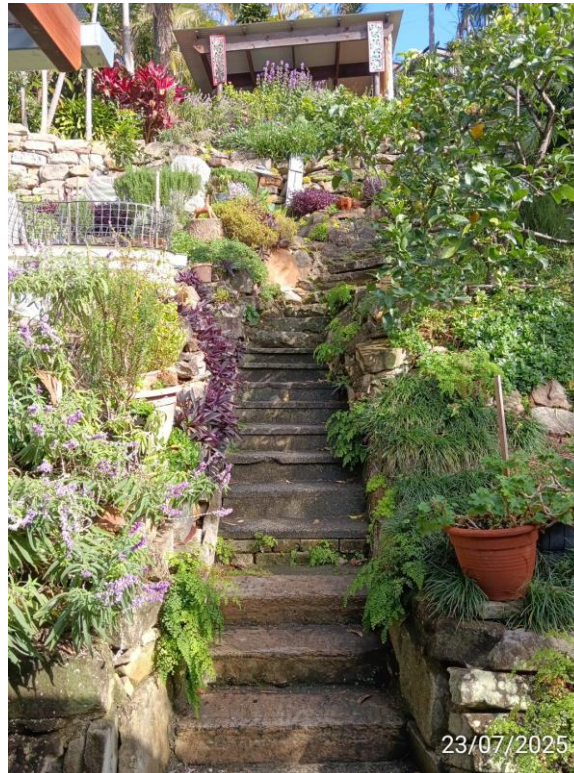
the house. The cuts and fills are lined by stable stacked rocks up to ~1.4m high (Photos 3 to 5). In this area, there is also a scattering of detached sandstone joint blocks that appear to be stable (Photo 6).

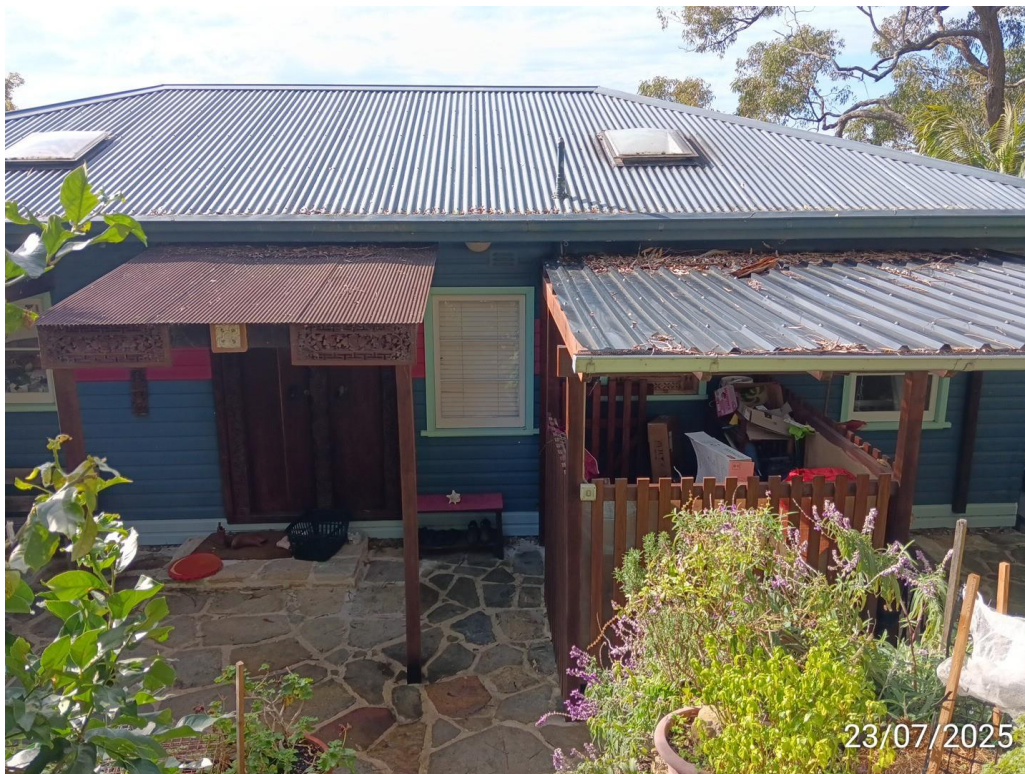
Photo 7

The two storey split level timber framed house is supported on brick piers and timber posts (Photos 7 to 9). The supporting piers and posts stand vertical (Photos 8 & 9). The downhill side of the property has been terraced with two timber retaining walls up to ~1.3m high. The lower wall is currently bulging and some of the central supporting posts are tilting downslope significantly (Photo 10). However, due to its low height and location, it is not considered a significant threat to life or property. The owner has informed us this area will be re-landscaped and the retaining wall will be replaced as part of a separate development.

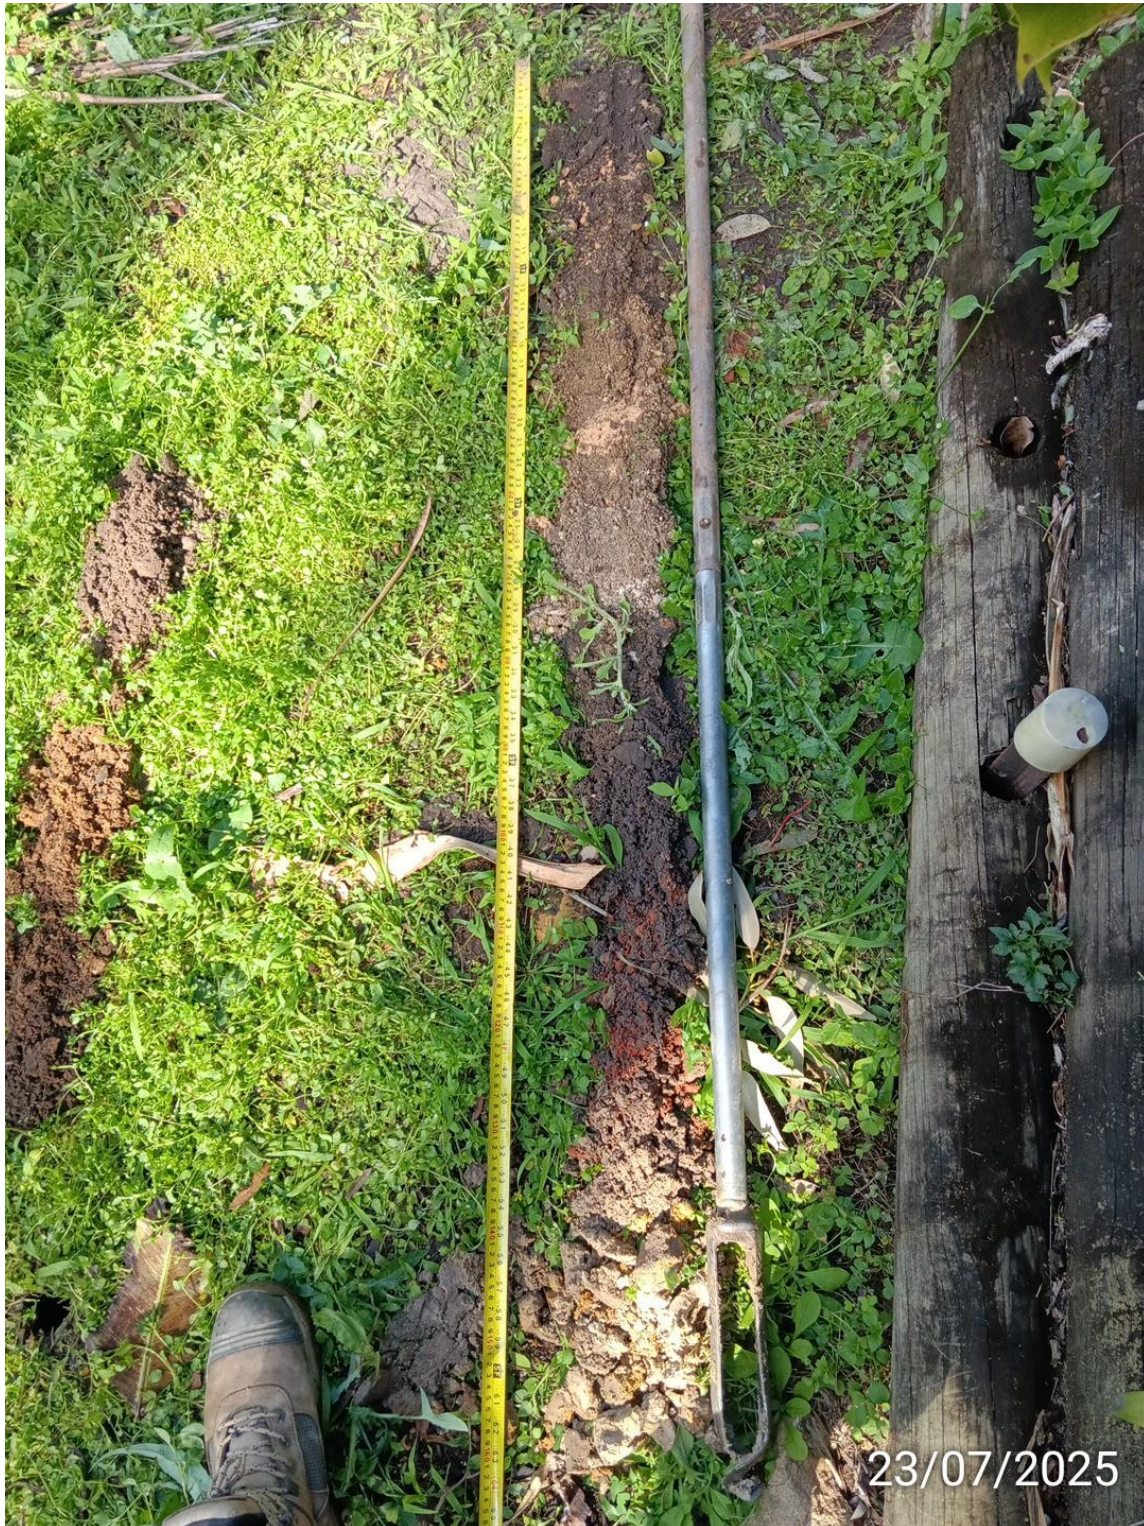
AUGER HOLE 1 (~RL42.0) – AH1 (Photo 11)

Depth (m)	Material Encountered
0.0 to 0.8	FILL , sandy soil and sand, with some rock fragments, dark brown, brown, orange, grey, moist, fine to coarse grained.
0.8 to 1.4	COLLUVIUM , sandy soil and sand, with some rock fragments, dark brown, grey, orange, moist to damp, fine to coarse grained.
1.4 to 1.6	SANDY CLAY , light brown/orange and light grey/white, firm to very stiff, moist.

End of hole @ 1.6m in firm to very stiff clay. No water table encountered.

Photo 11: AH1 – Downhole is from top to bottom.

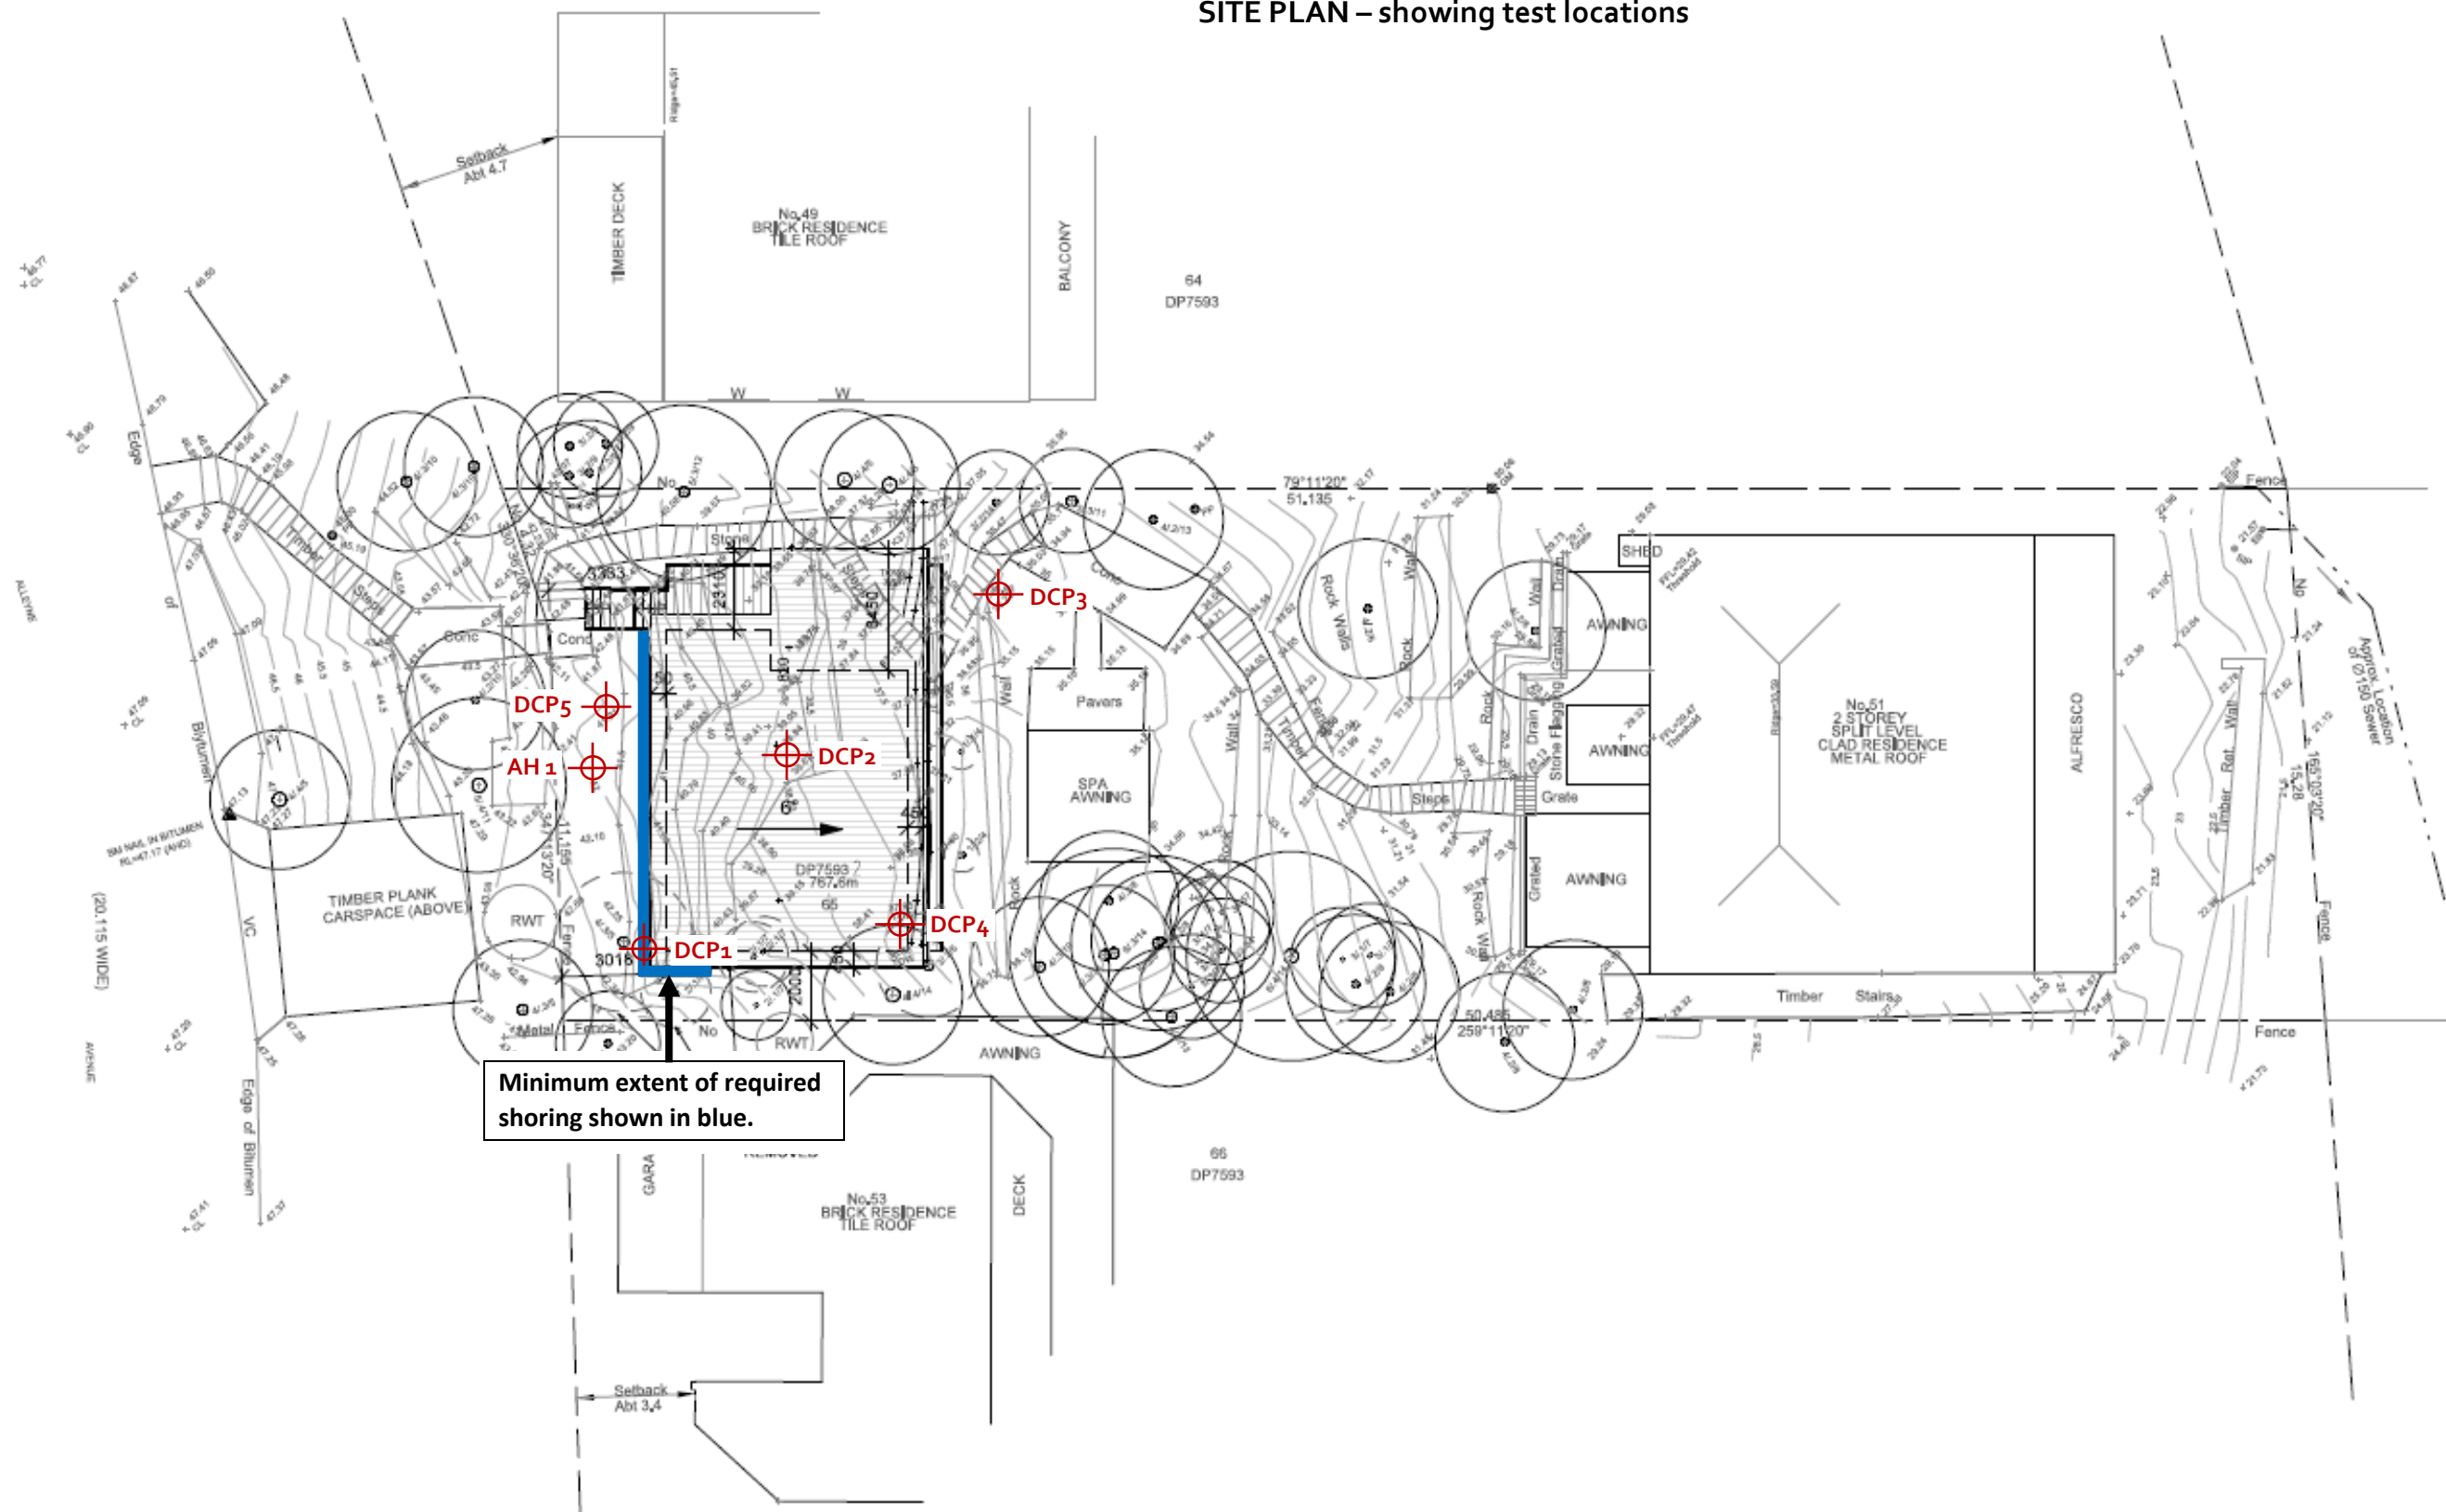
SITE PLAN – showing test locations

One hand Auger Hole (AH) was put down to identify the soil materials. Five Dynamic Cone Penetrometer (DCP) tests were put down to determine the relative density of the overlying soil and the depth to weathered rock. The locations of the tests are shown on the site plan attached. It should be noted that a level of caution should be applied when interpreting DCP test results. The test will not pass through hard buried objects so in some instances it can be difficult to determine whether refusal has occurred on an obstruction in the profile or on the natural rock surface. This is expected to have occurred for DCP1 and may have occurred for DCP2. Due to the possibility that the actual ground conditions vary from our interpretation there should be allowances in the excavation and foundation budget to account for this. We

Due to the steep grade of the slope, the depth of the fill/colluvium and the proximity to the common boundaries, the excavation will need to be temporarily supported during the excavation process in a staged manner, so cut batters are not left unsupported. The support will need to be designed or approved by the structural engineer. See the site plan attached for the minimum extent of the required shoring shown in blue.

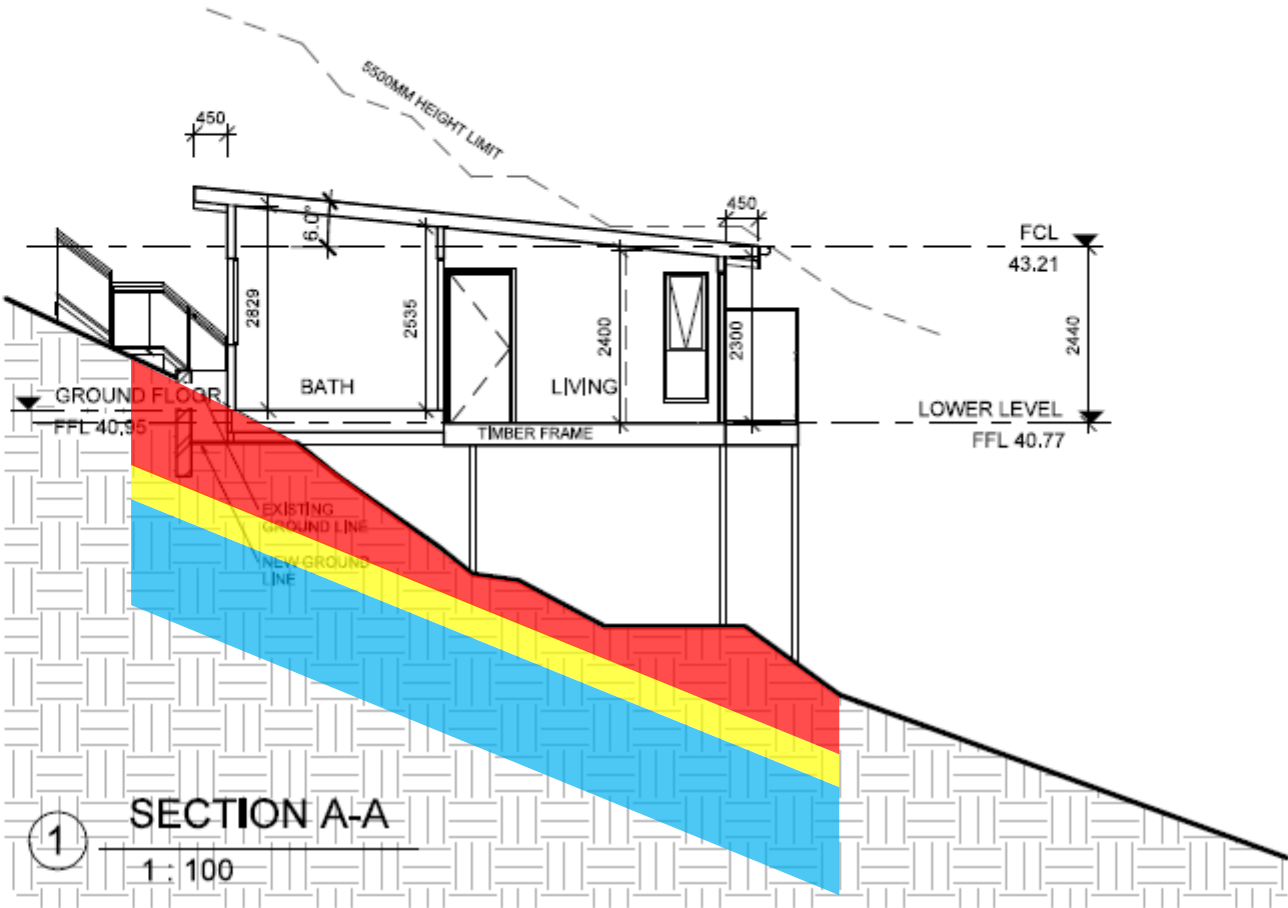
TYPE SECTION – Diagrammatical Interpretation of expected Ground Materials

The slope materials are colluvial at the near surface and residual at depth. In the test locations, the ground materials consist of fill and colluvium over Firm to Very Stiff Clays. Fill to a maximum depth of ~1.3m provides level platforms for landscaping and paved areas across the property. In the test locations, the clays merge into the weathered zone of the underlying rock at depths of between ~0.9m to ~1.8m below the current surface, being deeper where the fill and colluvium is deeper. DCP1 is expected to have encountered refusal on a sandstone boulder within the colluvium or another obstruction in the profile. This may have also occurred for DCP2. The weathered zone of the underlying rock is interpreted as Extremely Low to Low Strength Rock. It is to be noted that this material is a soft rock and can appear as a mottled stiff clay when it is cut up by excavation equipment. See Type Section attached for a diagrammatical representation of the expected ground materials.

- Fill and Colluvium
- Clay – Firm to Very Stiff
- Narrabeen Group Rocks – Extremely Low to Low Strength Rock - after being cut up by excavation equipment can resemble a stiff to hard clay.
