# Geotechnical Assessment

**Project:** Alterations & Additions  
5 Crawford Place, Beacon Hill NSW

**Ref:** AG 25309  
7 August 2025

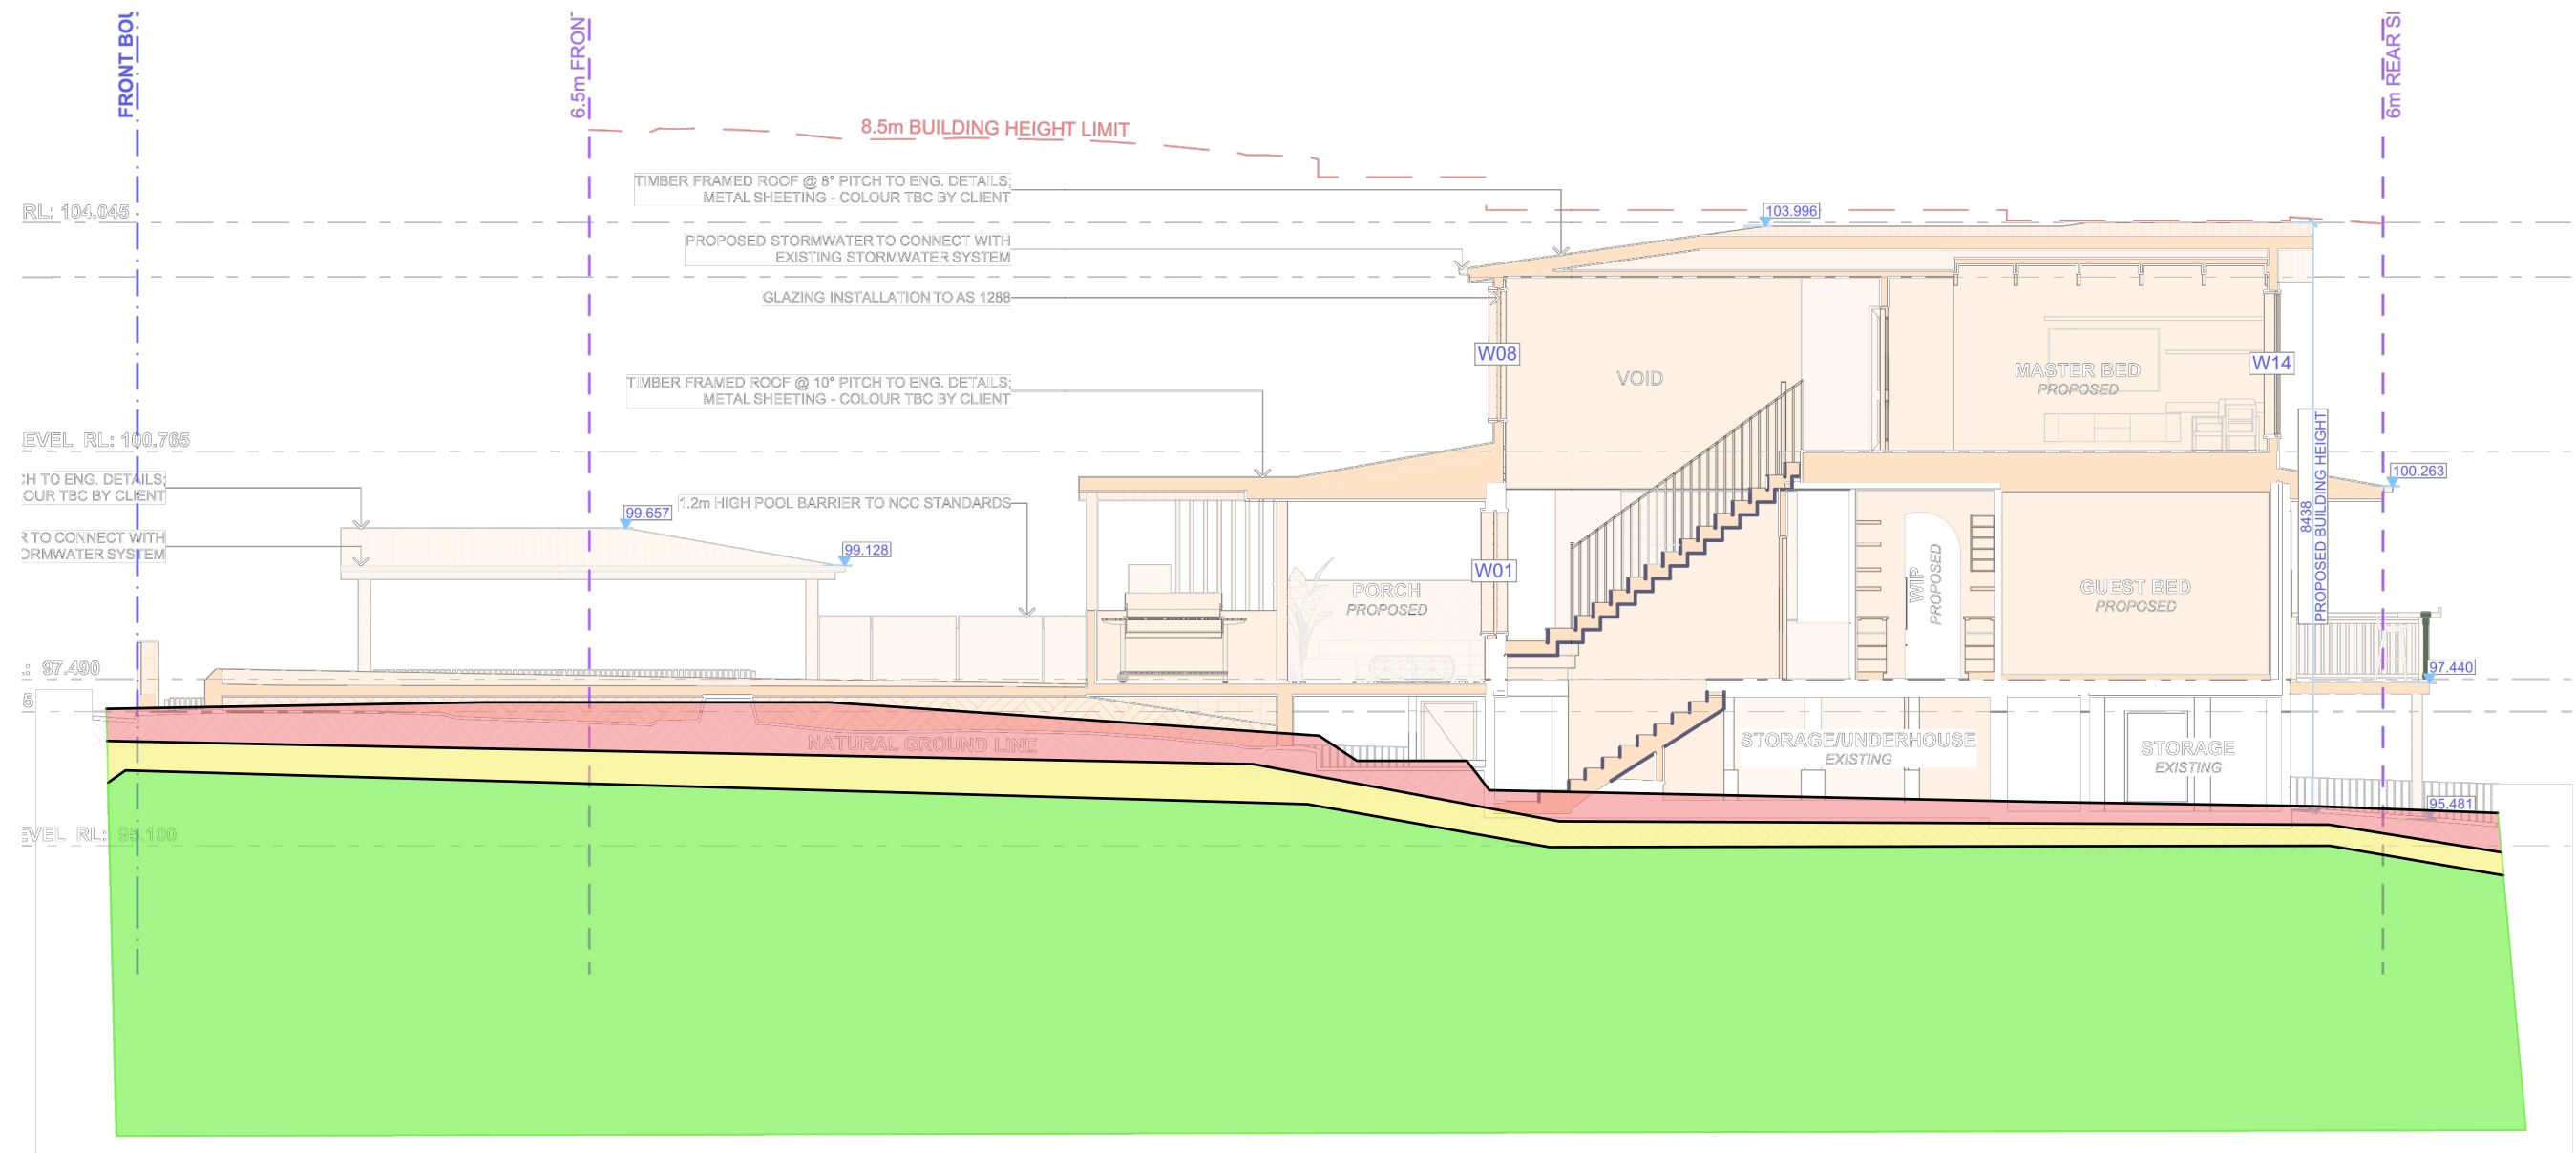
**INFERRED GEOLOGICAL SECTION**  
SCALE NTS

INTERPRETED SUBSURFACE SECTION ONLY.  
ACTUAL GROUND CONDITIONS MAY VARY.

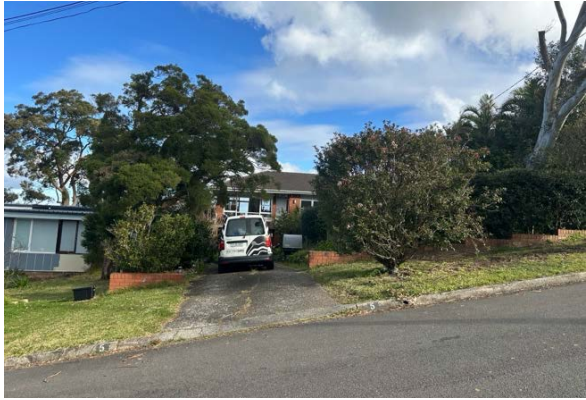
**Photo 1:** Site frontage, looking south.

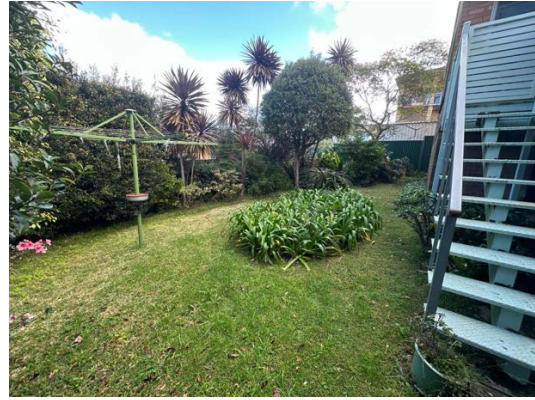
**Photo 2:** Photo of rear yard of site, looking west.

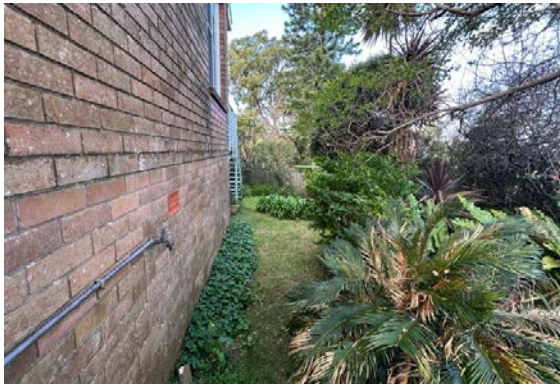
**Photo 3:** Photo of rear yard of site, looking east.

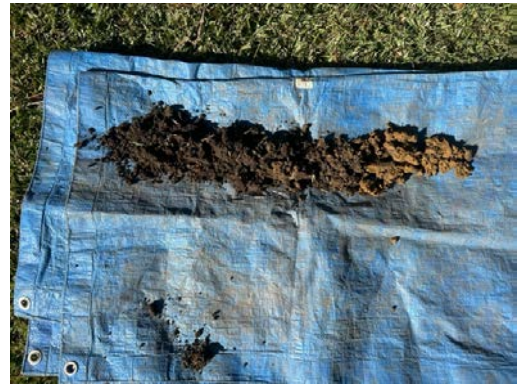
**Photo 4:** Subsurface soil profile of BH01.
