Development Application for D & J Suttie  
Name of Applicant

Address of site 67 Florence Terrace, Scotland Island

Report Title: RISK ANALYSIS & MANAGEMENT FOR PROPOSED BOAT SHED AND SKID RAMP AT 67 FLORENCE TERRACE, SCOTLAND ISLAND- PX 00007

**RISK ANALYSIS & MANAGEMENT  
FOR  
PROPOSED BOAT SHED AND SKID RAMP  
AT  
67 FLORENCE TERRACE, SCOTLAND ISLAND**

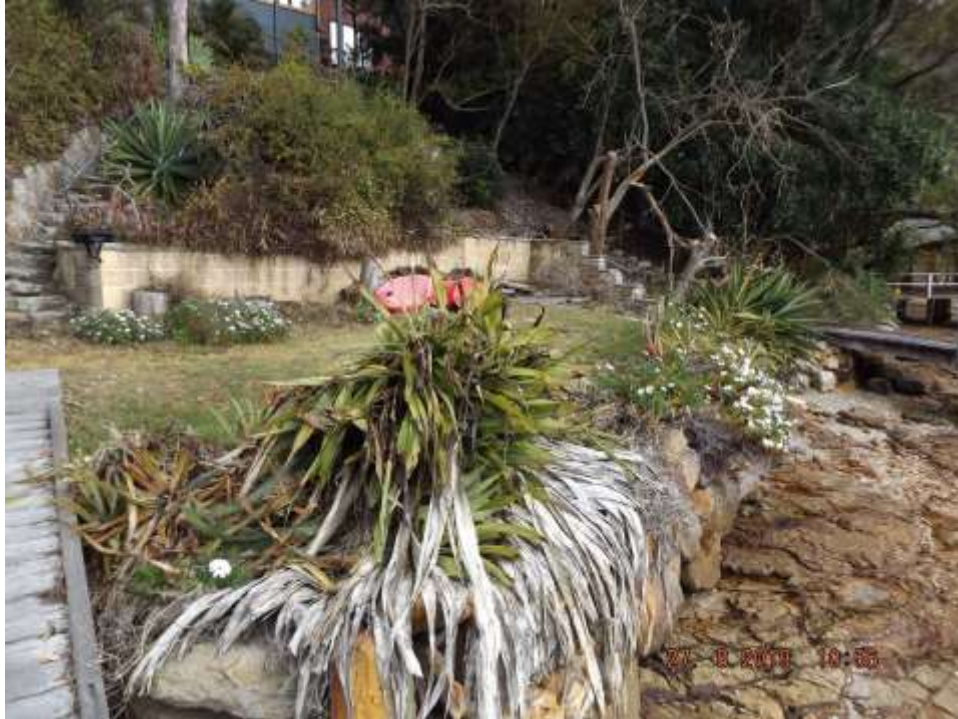
**Photo 1**

**3.3** The site is accessed from Florence Terrace or the water front. From the water front a stairway leads up to the residence, Photo 1. At the top of the sea wall there is a level lawn area. A block retaining wall is at the toe of the vegetated slope rises up to the residence from the level area. An 'S' shaped stone stairway leads up to the residence from the waterfront, Photo 2. At the top of the stairs a path with a railing runs across the eastern side of the house and around the corner to the main entrance to the existing residence. Along the south eastern side of the residence is a paved path with steps that leads to the rear of the property, Photo 3. The rear of the property is accessed up some wooden stairs that leads to garden area at the south western end of the block. The slope continues to rise up to and beyond Florence Terrace, Photo 4. Florence Terrace can be accessed via path with handrail. There are two tanks in the north western corner of the property, Photo 5.

**5.1** Based on visual observation the site is considered consistent with adjacent local sites previously inspected and reported and accordingly physical subsurface investigation has not been conducted at this stage on this proposed development. The rock shelf is visible some 1.5 metres below the level lawn area as seen in Photo 1.

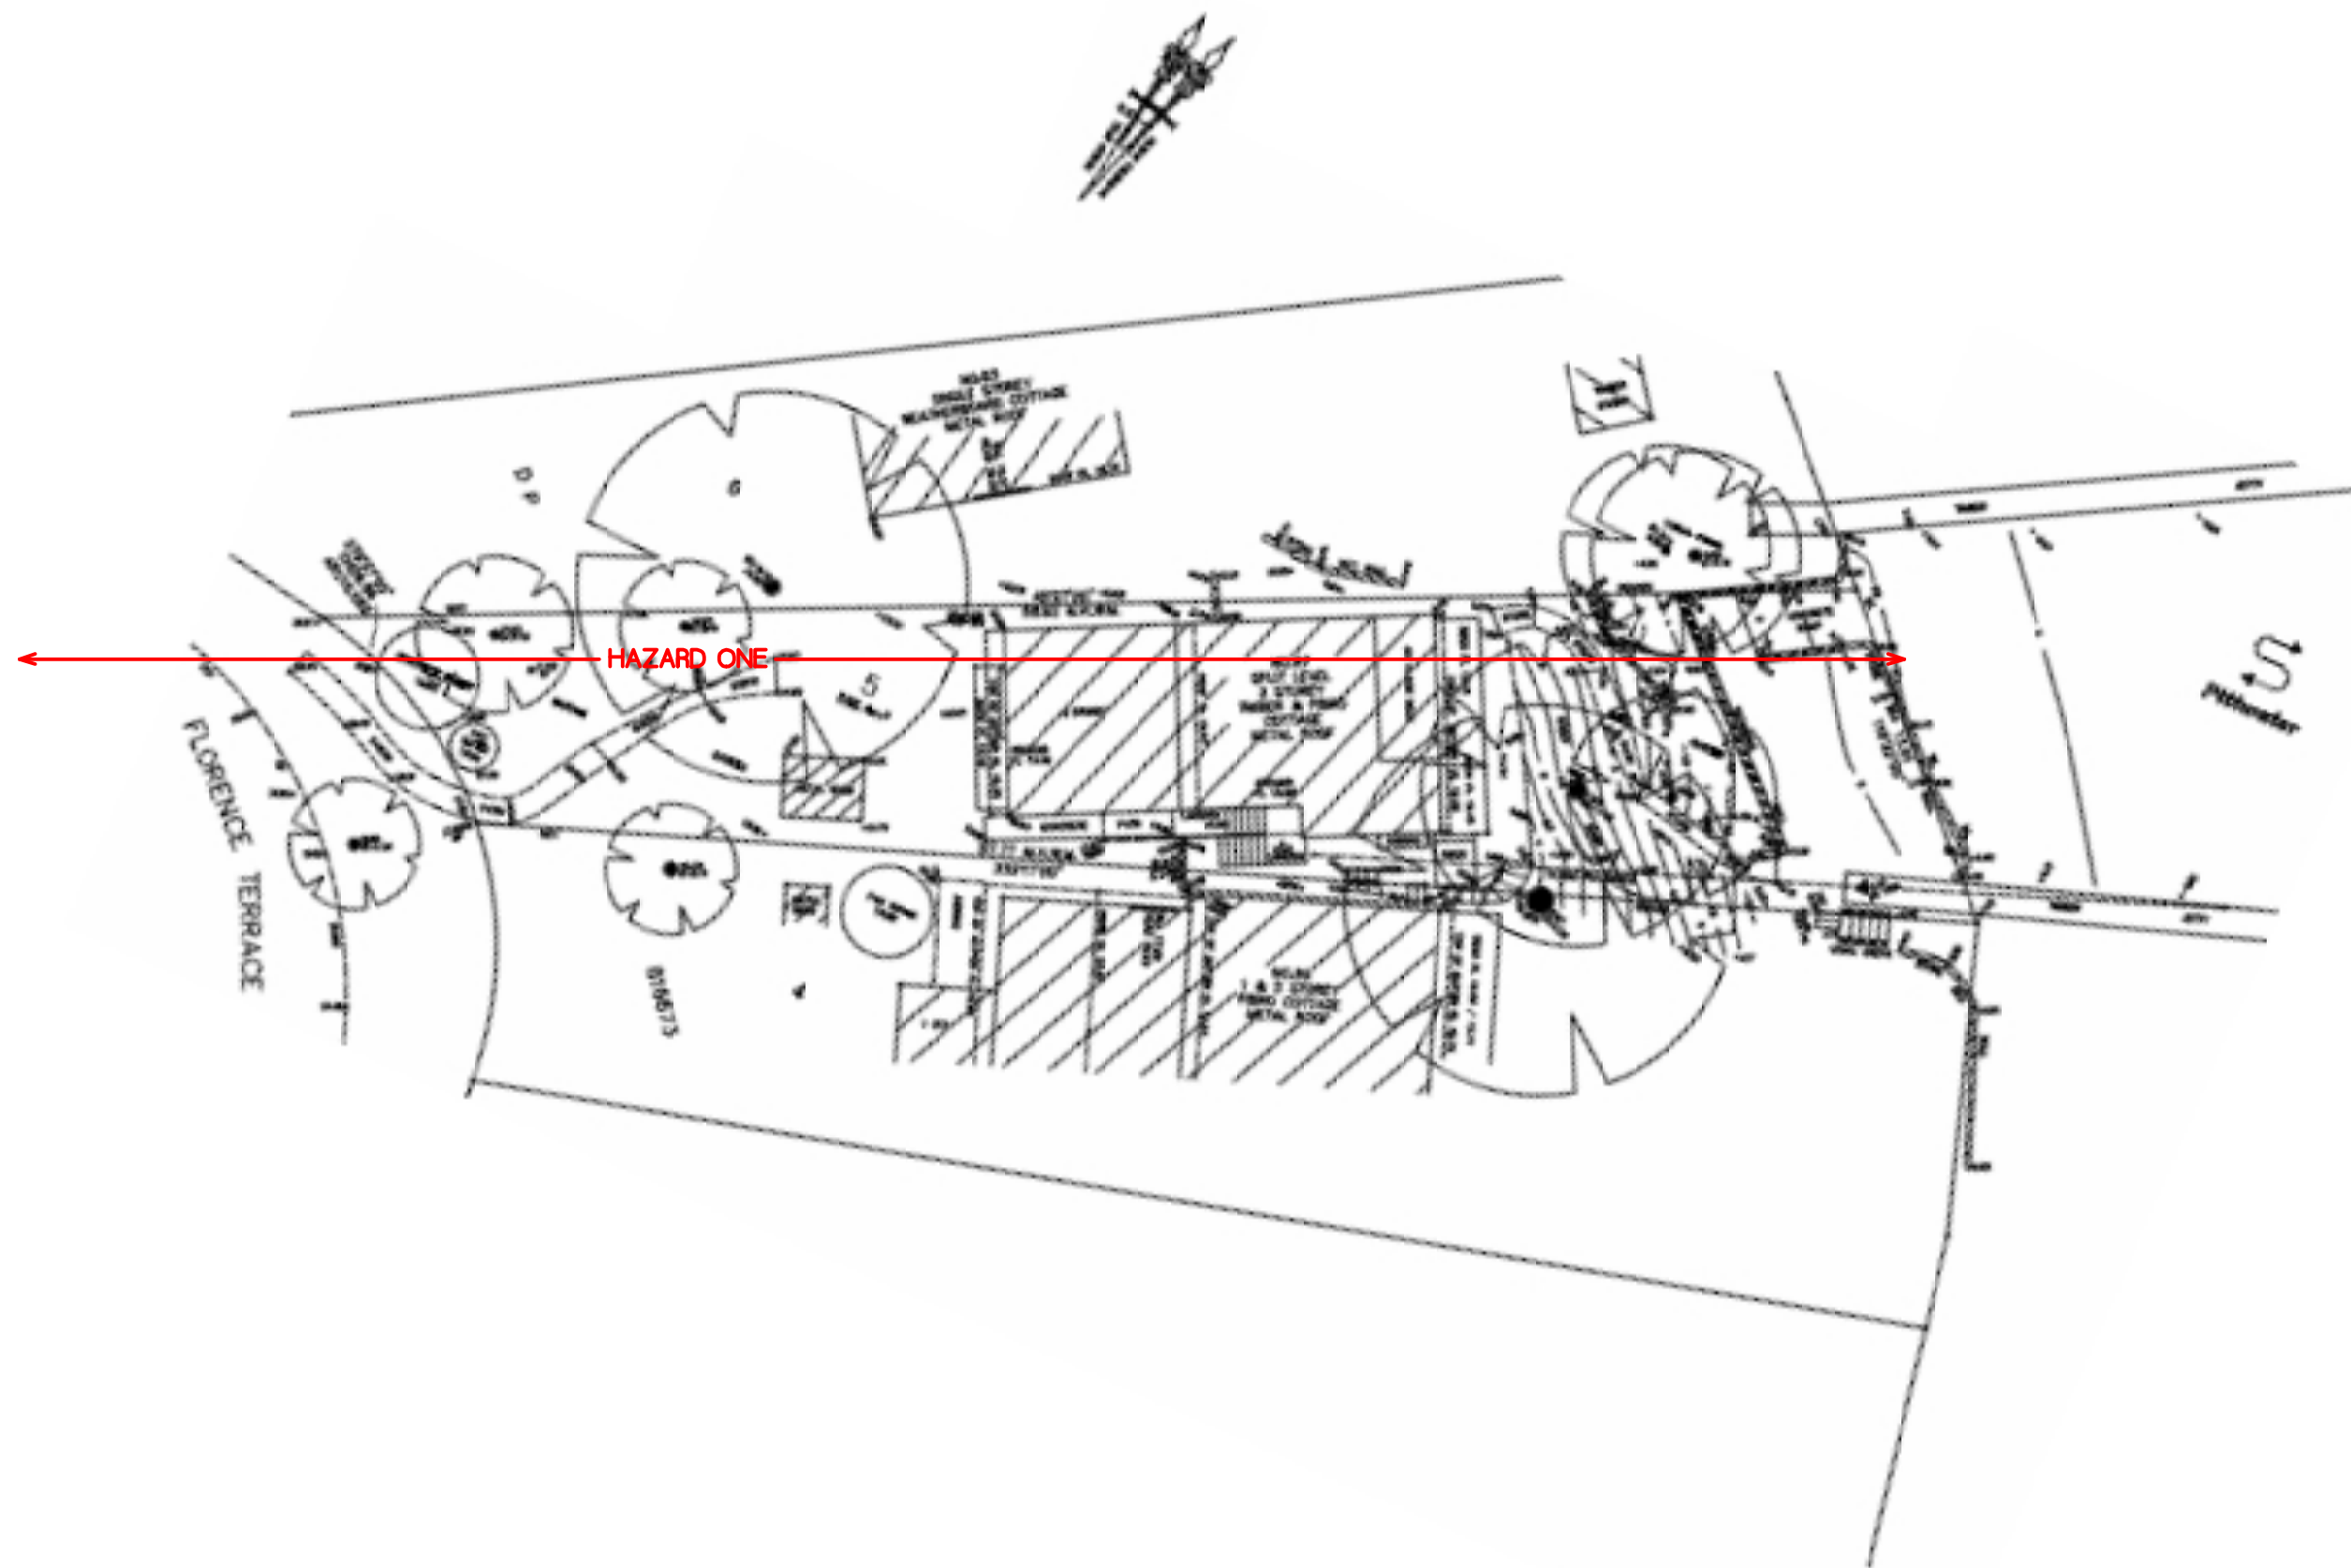
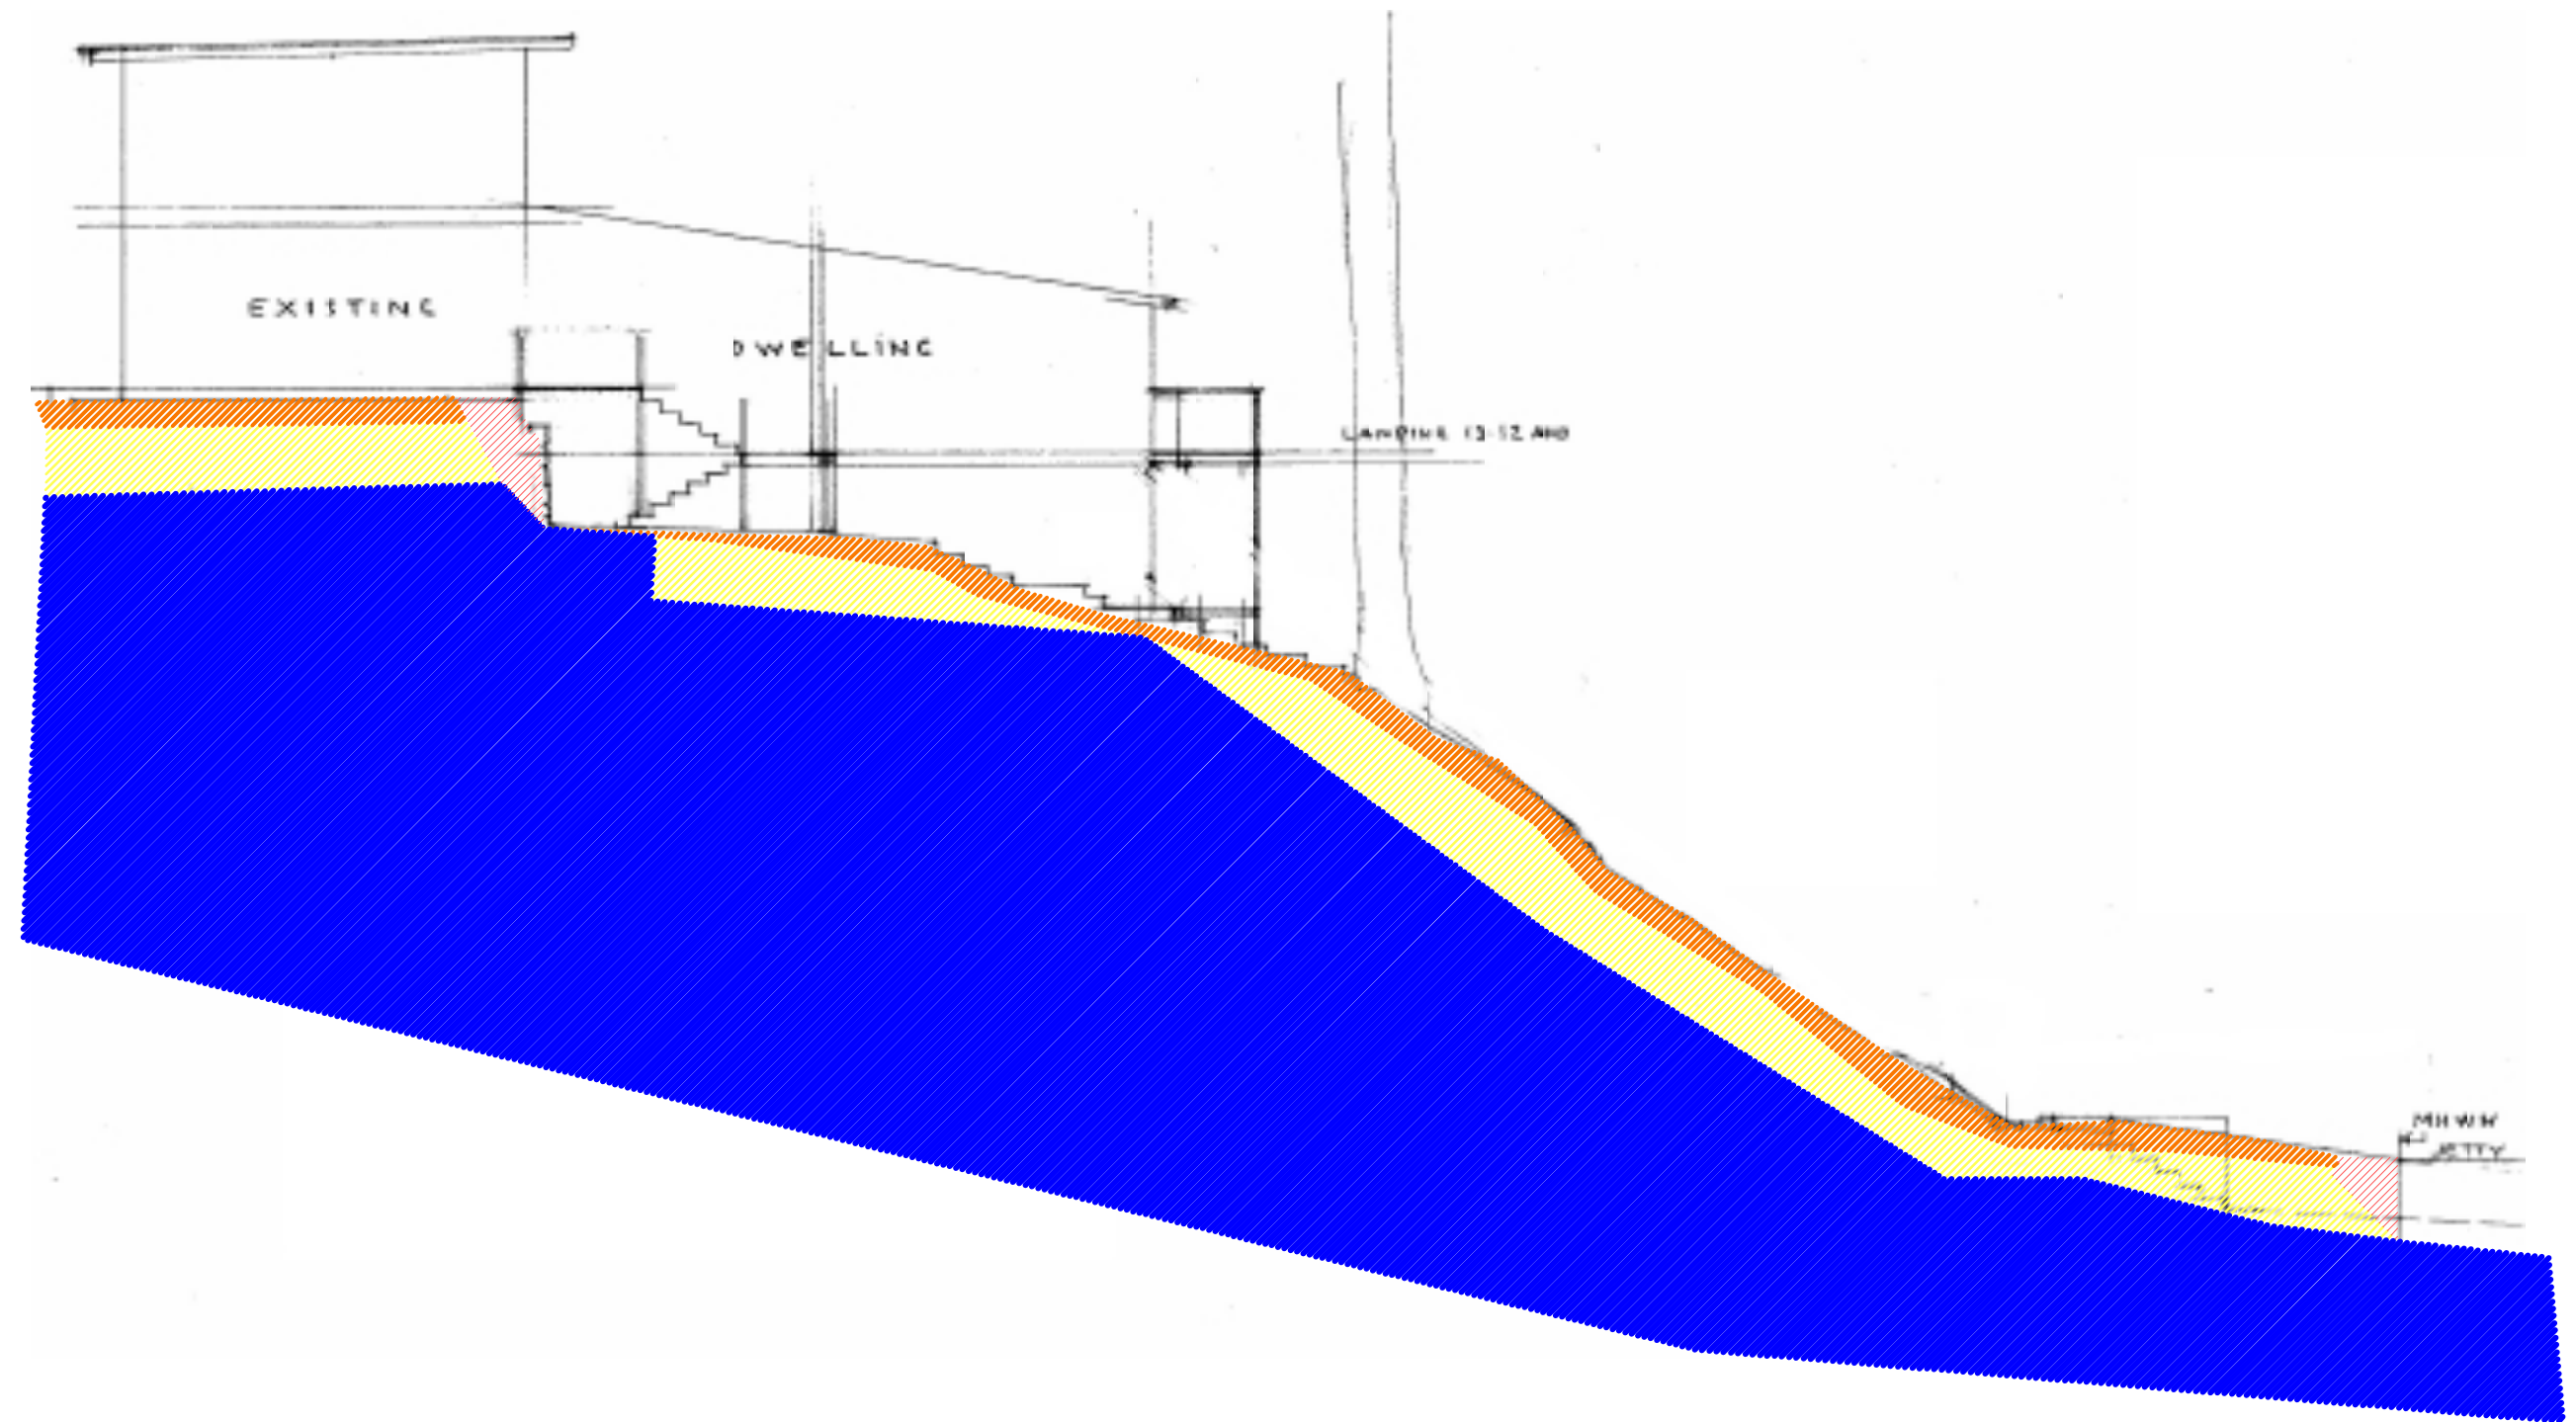
TYPE SECTION

**4.2** The slope materials are colluvial in origin at the surface and become residual with depth. They consist of topsoil over sandy clays and clays that merge into the weathered rock at depths varying from 0.5 to 1.5 metres or deeper where filling has been carried out.

**10.2.2** Excavations for the proposed foundations of the boat shed and skid ramp will require minimal excavation for the piered footings. These piered footings will encounter fill material and clays overlying the weathered rock of the Narrabeen Group to approximate depths of 1.5 metres or deeper where filling has been carried out.

It is recommended that all footings be supported on and socketed into the underlying bedrock, using piers as necessary. The design allowable bearing pressures are 400 kPa for spread footings or shallow piers. All footings are to be founded on material of similar consistency to minimise potential for differential settlement.
