"GROWING MY WAY"

Construction Impact & Management Statement December 2020

Site: Lot 1 in DP 1229229 145A Crescent Road NEWPORT, NSW Client: Jacob & Jessica Shanahan 145A Crescent Road NEWPORT, NSW 2106 Author: Kyle A Hill Registered (Arb Aus #1884) Practising & Consulting Arborist Post Graduate Certificate in Arboriculture, Uni of Melb Diploma of Horticulture-Arboriculture TAFE, Grow SA Certificate of Horticulture, TAFE Certificate Advanced Tree Care TAFE Founder - Growing My Way Tree Services (1977) Member of International Society of Arboriculture Member of Arboriculture Australia

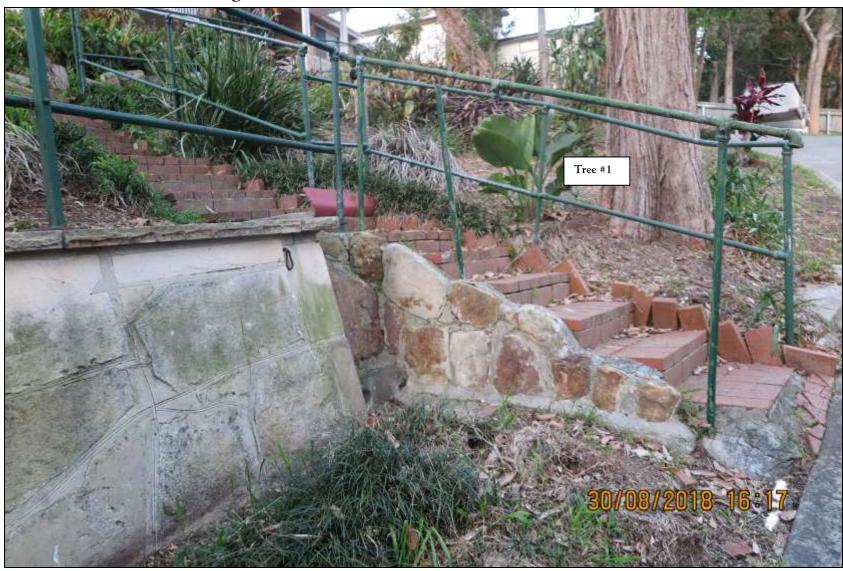
Tree #3 Tree#2 Tree not required to be discussed by virtue of distance between location & proposed works. 2020/11/26 11:30

Figure 6: Above & previous pages illustrates the location of the three (3) discussed trees.

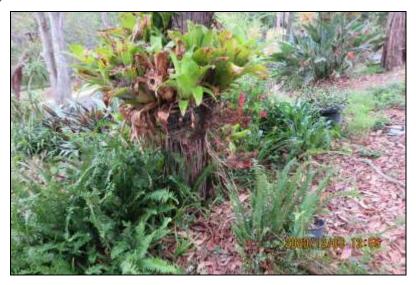
Tree #2 as can be seen on page 10 (Figure 4) is some 6.50m away from any proposed works. It is also noted as support for the new DA that this tree has been long term subjected to fairly significant change in soil levels. On this basis it is very unlikely the new DA as proposed will compromise its Useful Life Expectancy (believed to be at least medium term).

Figure 7: Illustrates very long term established change of natural ground levels around Tree #2.

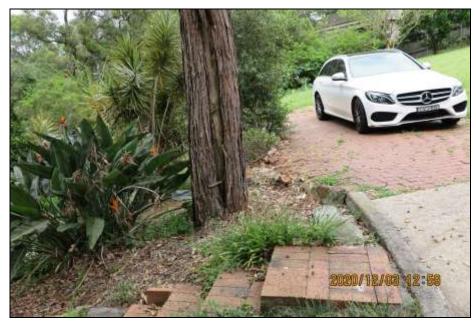
Tree #3 as can be seen on page 10 (Figure 4) is some 2.20m, taking into account the required additional excavation for new retaining wall & its drainage system. As such,

the DA as proposed will compromise its Useful Life Expectancy. Simply, on the basis ample room exists elsewhere (uphill) for new trees to be planted that can actually enhance the total canopy footprint for up to the very long term it is supported for this tree to be replaced.

Figure 8: Illustrates the vertical trunk wound plus very long term established change of natural ground levels around Tree #3.
