Geotechnical Assessment

Project: Alterations & Additions
37 Bushey Place, Dee Why NSW

Ref: AG 25137
7 April 2025

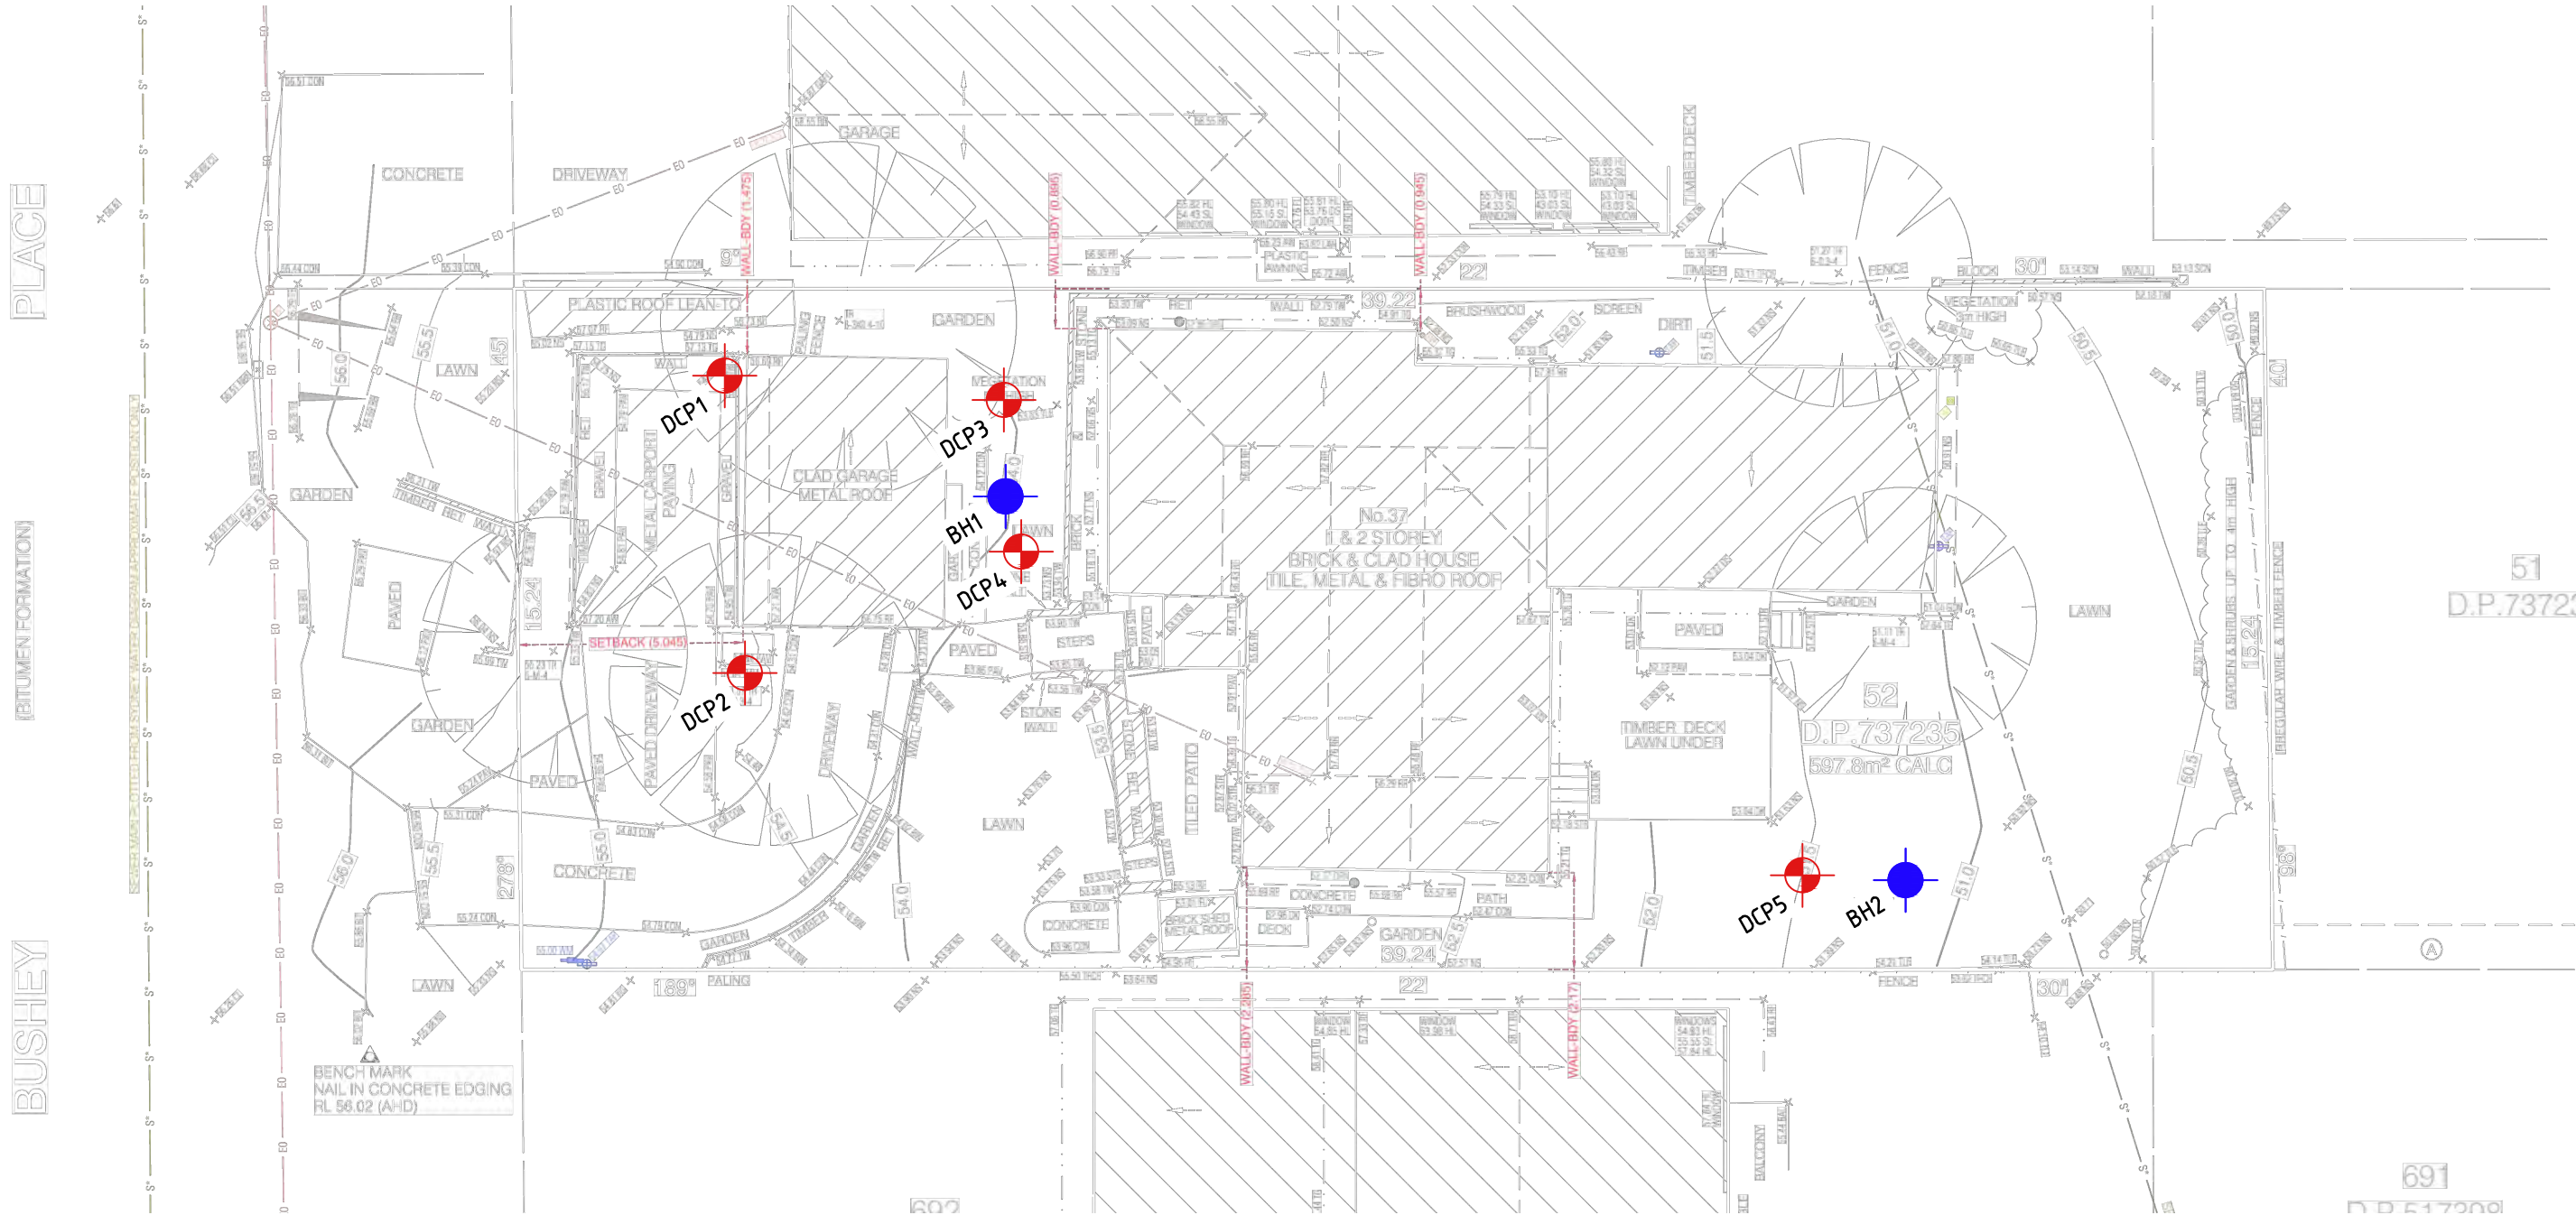
SITE PLAN/GROUND TEST LOCATIONS
SCALE NTS

Test	Summary
DCP 1	Refused at surface, likely buried slab under pebble material.
DCP 2	Refusal @ 1.6m Bouncing on inferred bedrock. Brown clay on moist tip.
DCP 3	Refusal @ 1.6m Bouncing on inferred bedrock. Brown clay on moist tip.
DCP 4	Refusal @ 1.6m Bouncing on inferred bedrock. Brown clay on moist tip.
DCP 5	Refusal @ 1.3m Bouncing on inferred bedrock. Brown clay on moist tip.

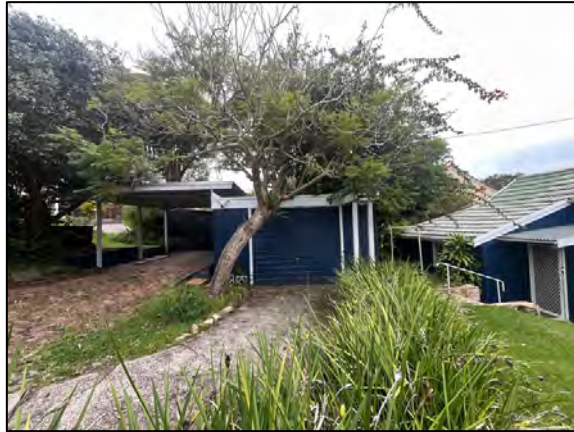
Photo 1: Carport, garage and residence frontage

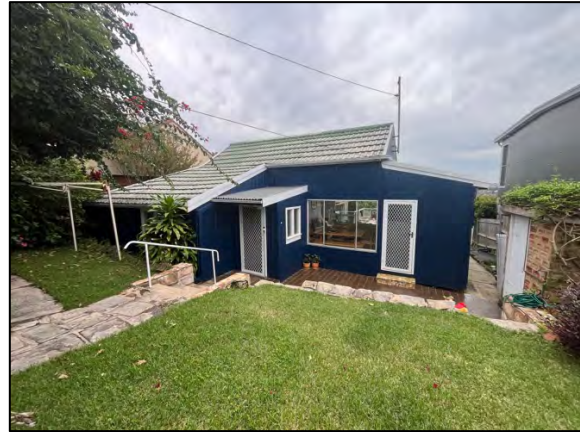
Photo 2: Residence frontage

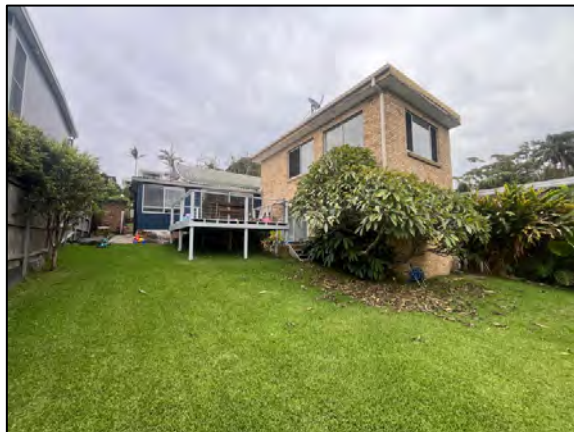
Photo 3: Residence rear

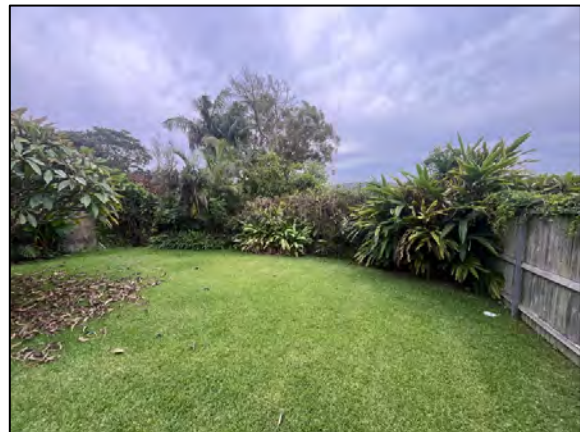
Photo 4: Rear yard
