# Geotechnical Assessment

**Project:** Alterations & Additions  
38 King Street, Manly Vale NSW

**Ref:** AG 24348  
3 September 2024

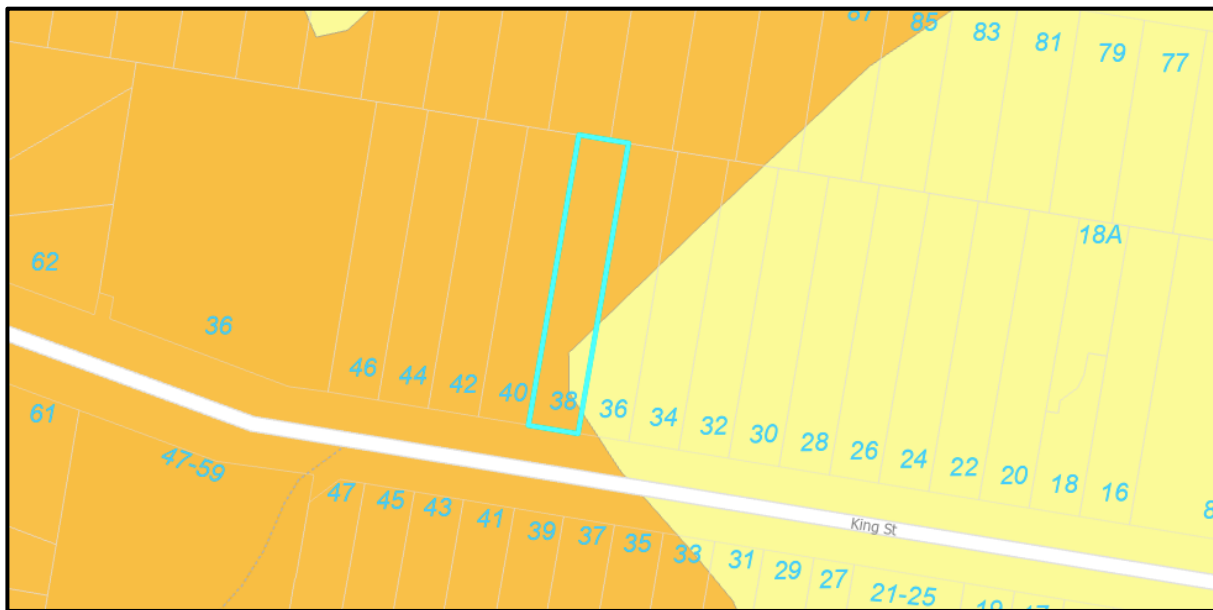
**Image 2.** Warringah Landslip Risk Map:  
38 King Street, Manly Vale NSW (© NBC Maps)

- The site is underlain by relatively shallow sandstone bedrock.
- The property is classified as **Area B** with reference to Northern Beaches Council WLEP – Warringah Landslip Risk Map (**Image 2**).

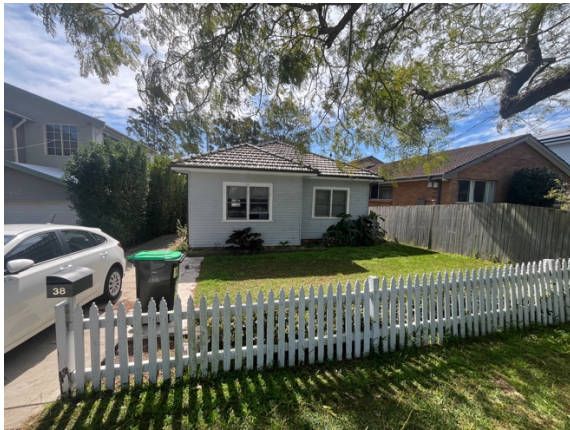
**Photo 1:** Site frontage.

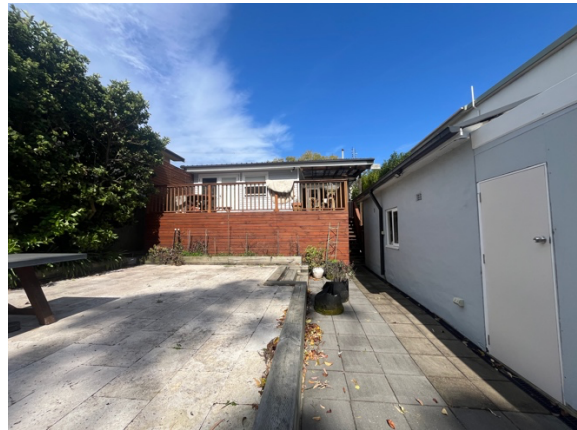
**Photo 2:** Dwelling rear.

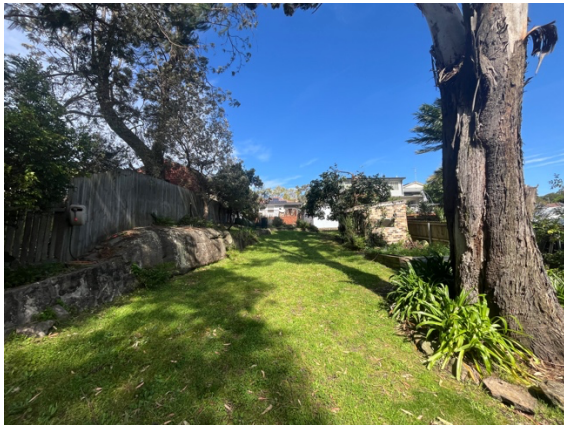
**Photo 3:** Rear yard looking towards dwelling rear.  
Sandstone bedrock outcrop on left side of the photo.

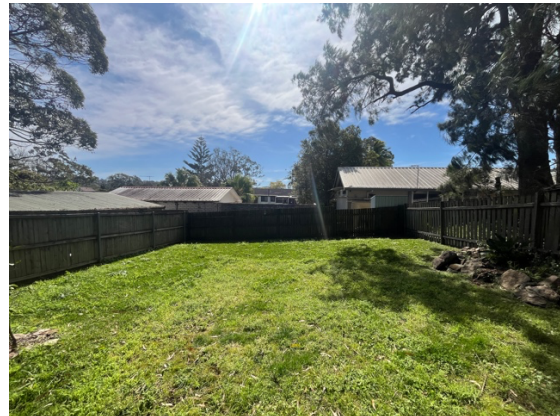
**Photo 4:** Looking towards the rear boundary.
