## Preliminary Geotechnical Assessment

For Alterations and Additions at  
5 Berrinda Place, Frenchs Forest NSW

This report presents the findings of a preliminary geotechnical assessment carried out at 5 Berrinda Place, Frenchs Forest NSW (the “Site”), by Ascent Geotechnical Consulting Pty Ltd (Ascent). This assessment has been prepared to meet Northern Beaches Council lodgement requirements for DA.

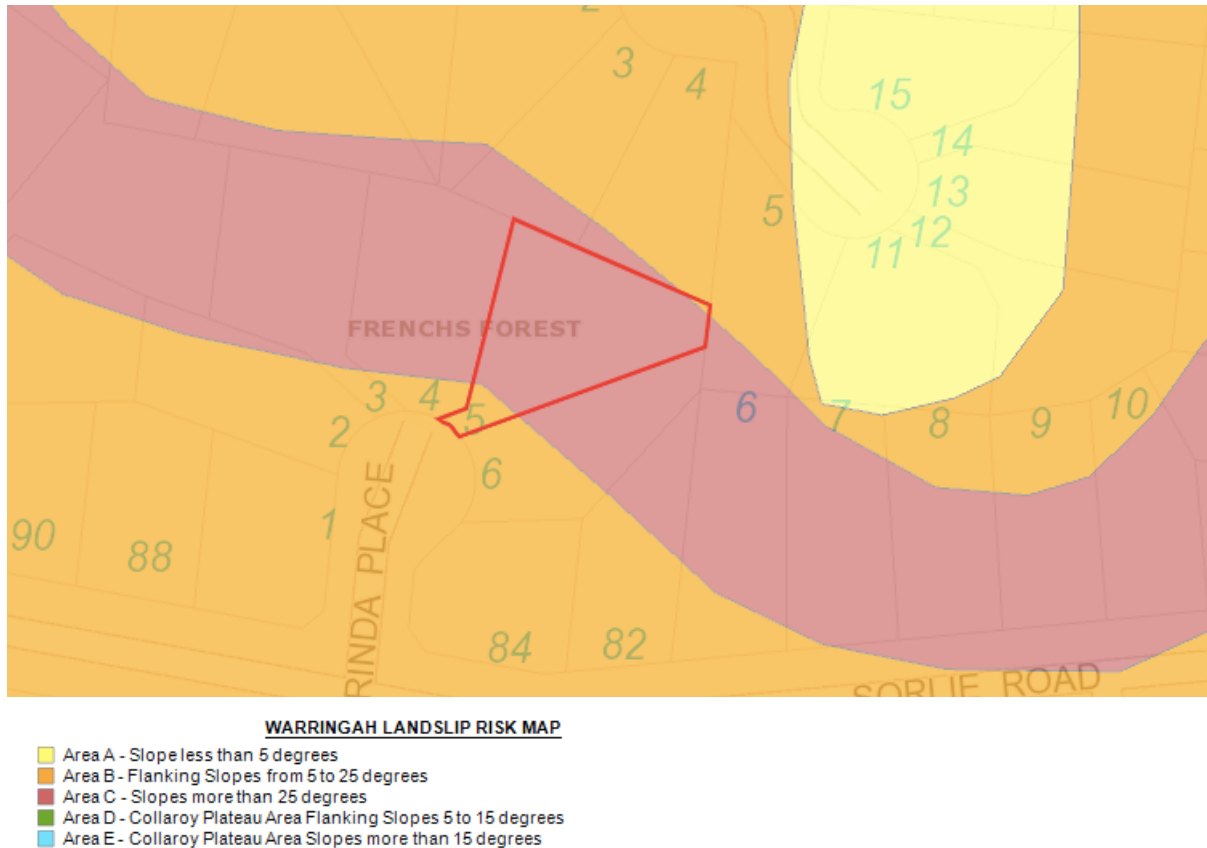
The site is mapped as **Area C** on the Landslip Risk Map WLEP 2011 (**Image 1**, below).
