# Geotechnical Site Investigation and Landslide Risk Assessment

**Lot 6 / DP 218250**

**13 Cheryl Crescent, Newport NSW 2106**

**Date**  
9/05/2022

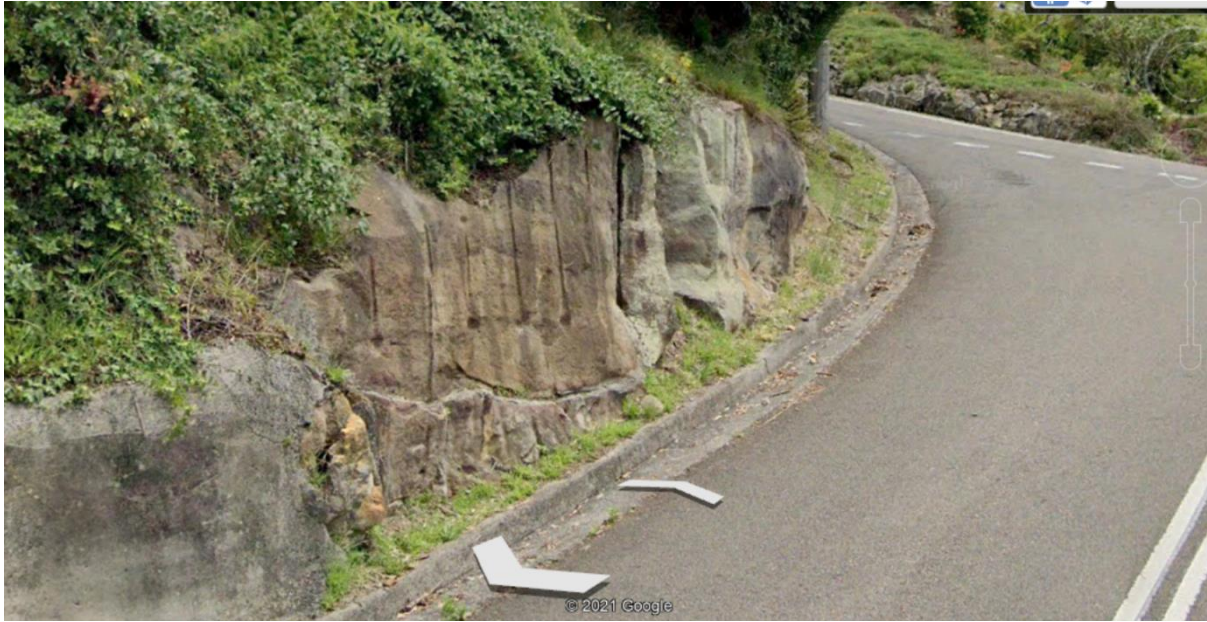
Screenshot from Google Street View near eastern site boundary
