Date: 8th April 2020

Project No.: 2015-199.1

Preliminary Landslip Risk Assessment for 36 Kirkstone Road, Wheeler Heights.

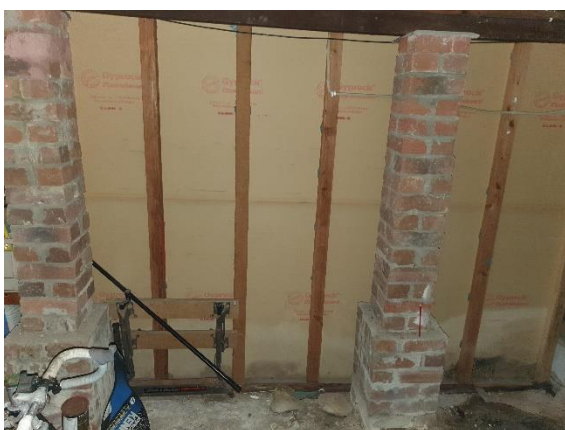
Observations made from within the garage identified that the western ground floor of the dwelling is supported by brick columns (Photograph-1) formed off footings bearing on sandstone bedrock of at least low strength and containing gently dipping bedding defects (Photograph-2). The brick columns appeared in good condition as well as the surrounding brick walls.

Photograph-1: Brick columns supporting western portion of the dwelling. View facing west towards the back of the timber rear laundry wall, that is proposed to be demolished.

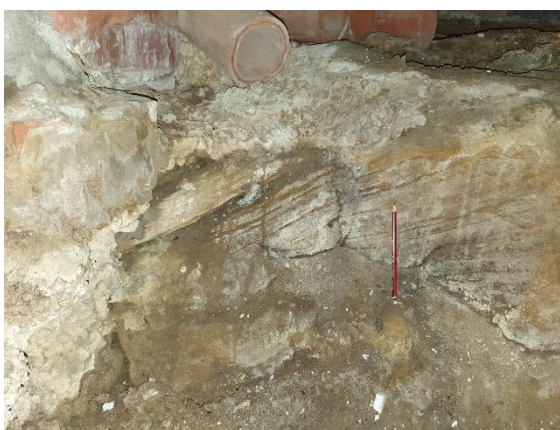
Photograph-2: Bedrock, comprising sandstone of at least low strength with exposed gently north dipping cross bedding defects. View looking east.
