## **REPORT ON GEOTECHNICAL SITE INVESTIGATION**

### **PROPOSED NEW RESIDENTIAL HOUSE**

**1168 BARRENJOEY ROAD, PALM BEACH, NSW**

**Project No.: 2022-210**

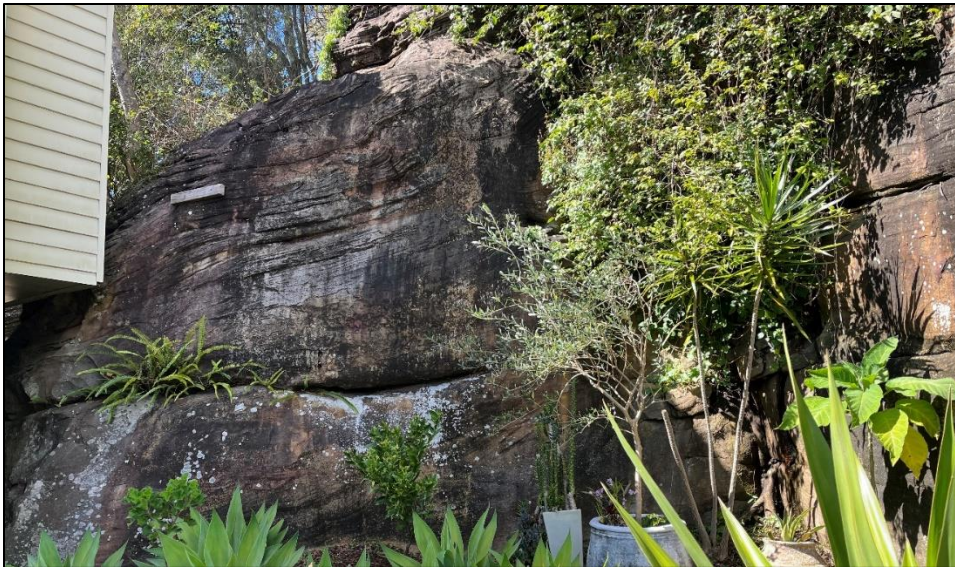
*Photograph 3: View of a section of the cliff within the site and No.1170 looking south from the rear of the site dwelling.*

The cliff appeared to be globally stable displaying widely spaced sub horizontal bedding defects with no significant seams or widespread adverse defects observed. One localised previous wedge failure was observed within the cliff and is shown in Photograph 4.

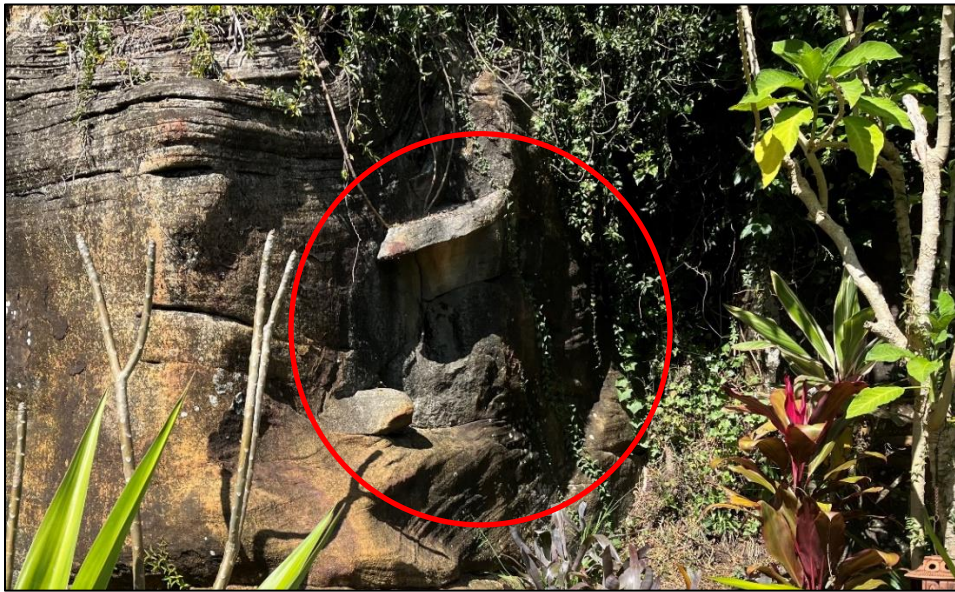
*Photograph 4: View of a previous wedge failure (circled red) within the cliff line to the rear of the site house.*

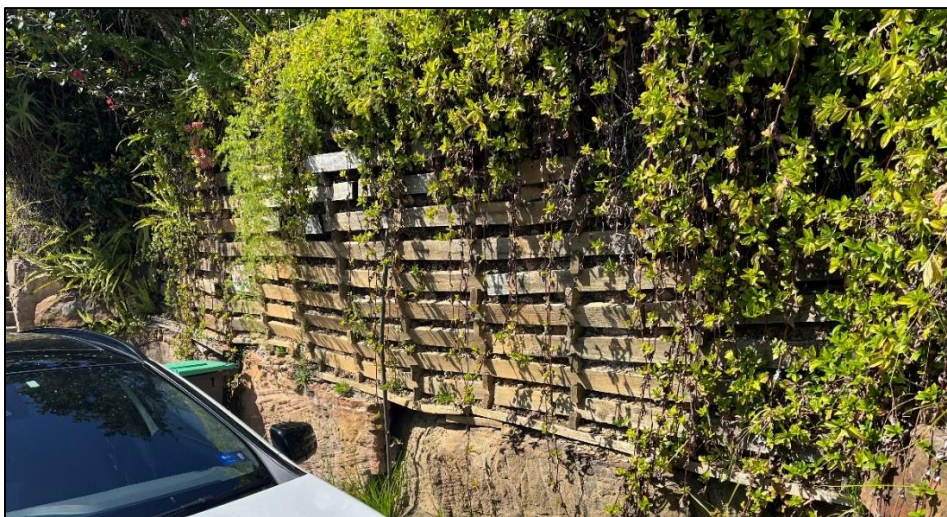
The timber retaining wall within Barrenjoey easement adjacent to the parking area displayed bulging which is likely due to insufficient original construction, and it is considered likely that the retaining wall is nearing the end of serviceability lifetime. (See Photograph 5)

The retaining wall was founded on a sandstone outcrop approximately 0.7m in height. The outcrop was approximately 0.7m in height and comprised low to medium strength sandstone.

*Photograph 5: View of deformation in retaining wall in Barrenjoey Road easement.*

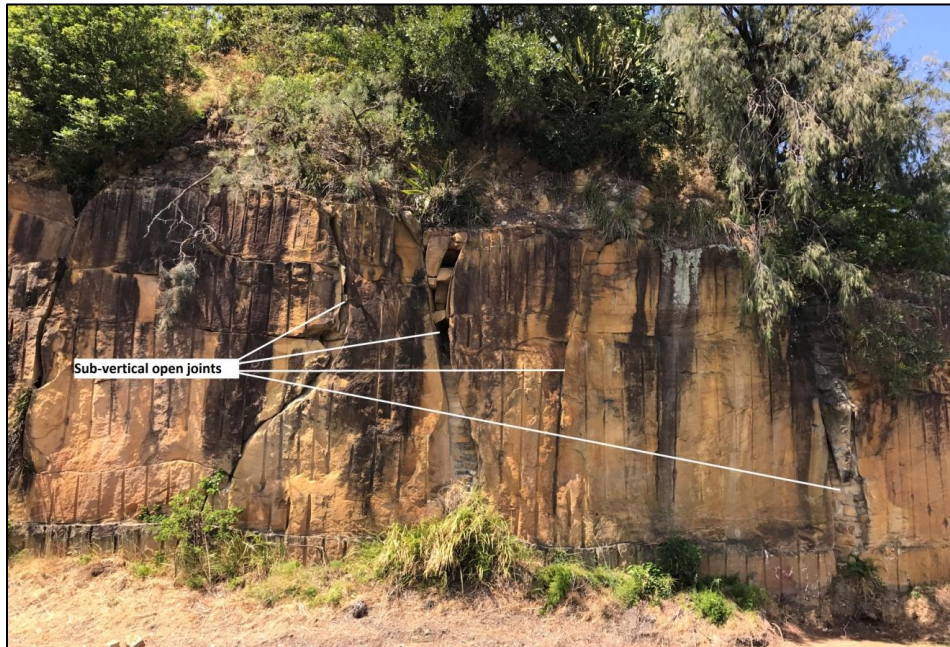
To the west of the site, a sandstone outcrop is present adjacent to Barrenjoey Road. Defects within this face appeared to vary from perpendicular (trending north-south to northwest-south east). A view of the defects is shown in Photograph 6.

*Photograph 6: View of defects within exposure to the west of the site*
