## **Geotechnical Assessment**

**Project:** Alterations & Additions  
65 Ferguson Street, Forestville NSW

**REF: AG 21003**  
21 January 2021

## Preliminary Geotechnical Assessment

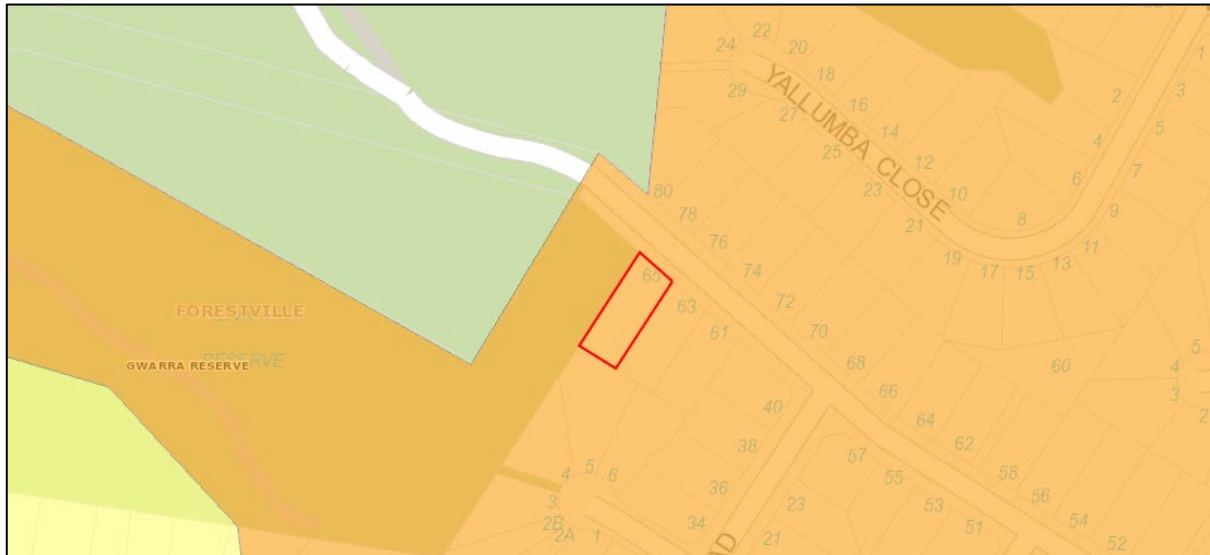
- The site is mapped as **Area B** subject to specific landslip risk/geotechnical hazard mapping with reference to the Warringah Landslip Risk Map (**Image 1**).

**Image 1.** WLEP Landslip Risk Map  
– 65 Ferguson Street, Forestville NSW
