## 150 Queenscliff Road, Queenscliff

### Geotechnical Comments for Section 4.55

## **GEOTECHNICAL INVESTIGATION:**

### **Alterations and Additions at 150 Queenscliff Road, Queenscliff**

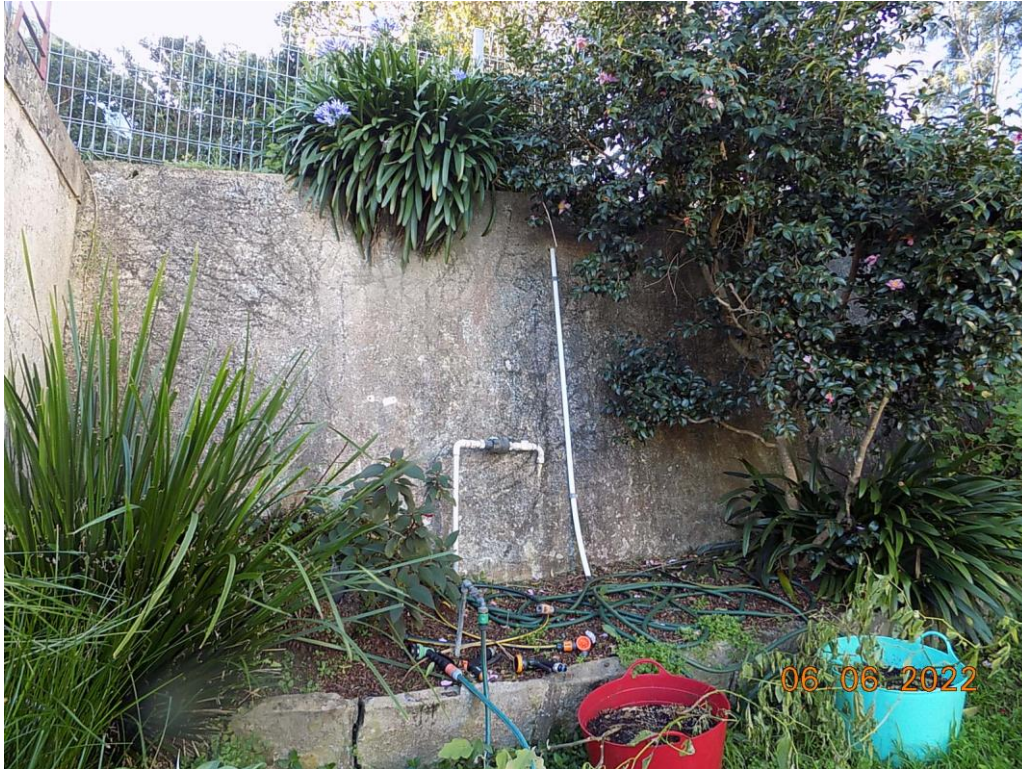
Photo 1

**2.3** The fill for Queenscliff Road is supported by a formed concrete retaining wall reaching ~2.0m high (Photo 1). The wall approximates the road frontage and displays some vertical cracking but no deflection and is currently considered stable. Between the road frontage and the house is a gentle to moderately sloping lawn and garden area (Photo 2). An excavation has been made in the slope for the lower ground floor of the house. The cut is supported by a stable ~1.8m high mortared sandstone block retaining wall (Photo 3). The W end of this wall was observed to be supported directly onto outcropping Medium Strength Sandstone (Photo 4). The part two-storey brick house is supported on brick walls and brick piers (Photo 5). The supporting walls display no significant signs of movement and the supporting piers stand vertical. The E side of the house was observed to be supported directly onto outcropping Medium Strength Sandstone (Photo 6). A steep garden slope falls from the downhill side of the house to the lower road frontage with Aitken Avenue (Photo 7). Medium Strength Sandstone outcrops through this slope in places (Photo 8). A fill at the lower portion of this slope is supported by a stable mortared stack rock retaining wall ~1.8m high (Photo 9). A garage has been cut into the slope at the road frontage to Aitken Avenue (Photo 10). The garage will be demolished as part of the proposed works.

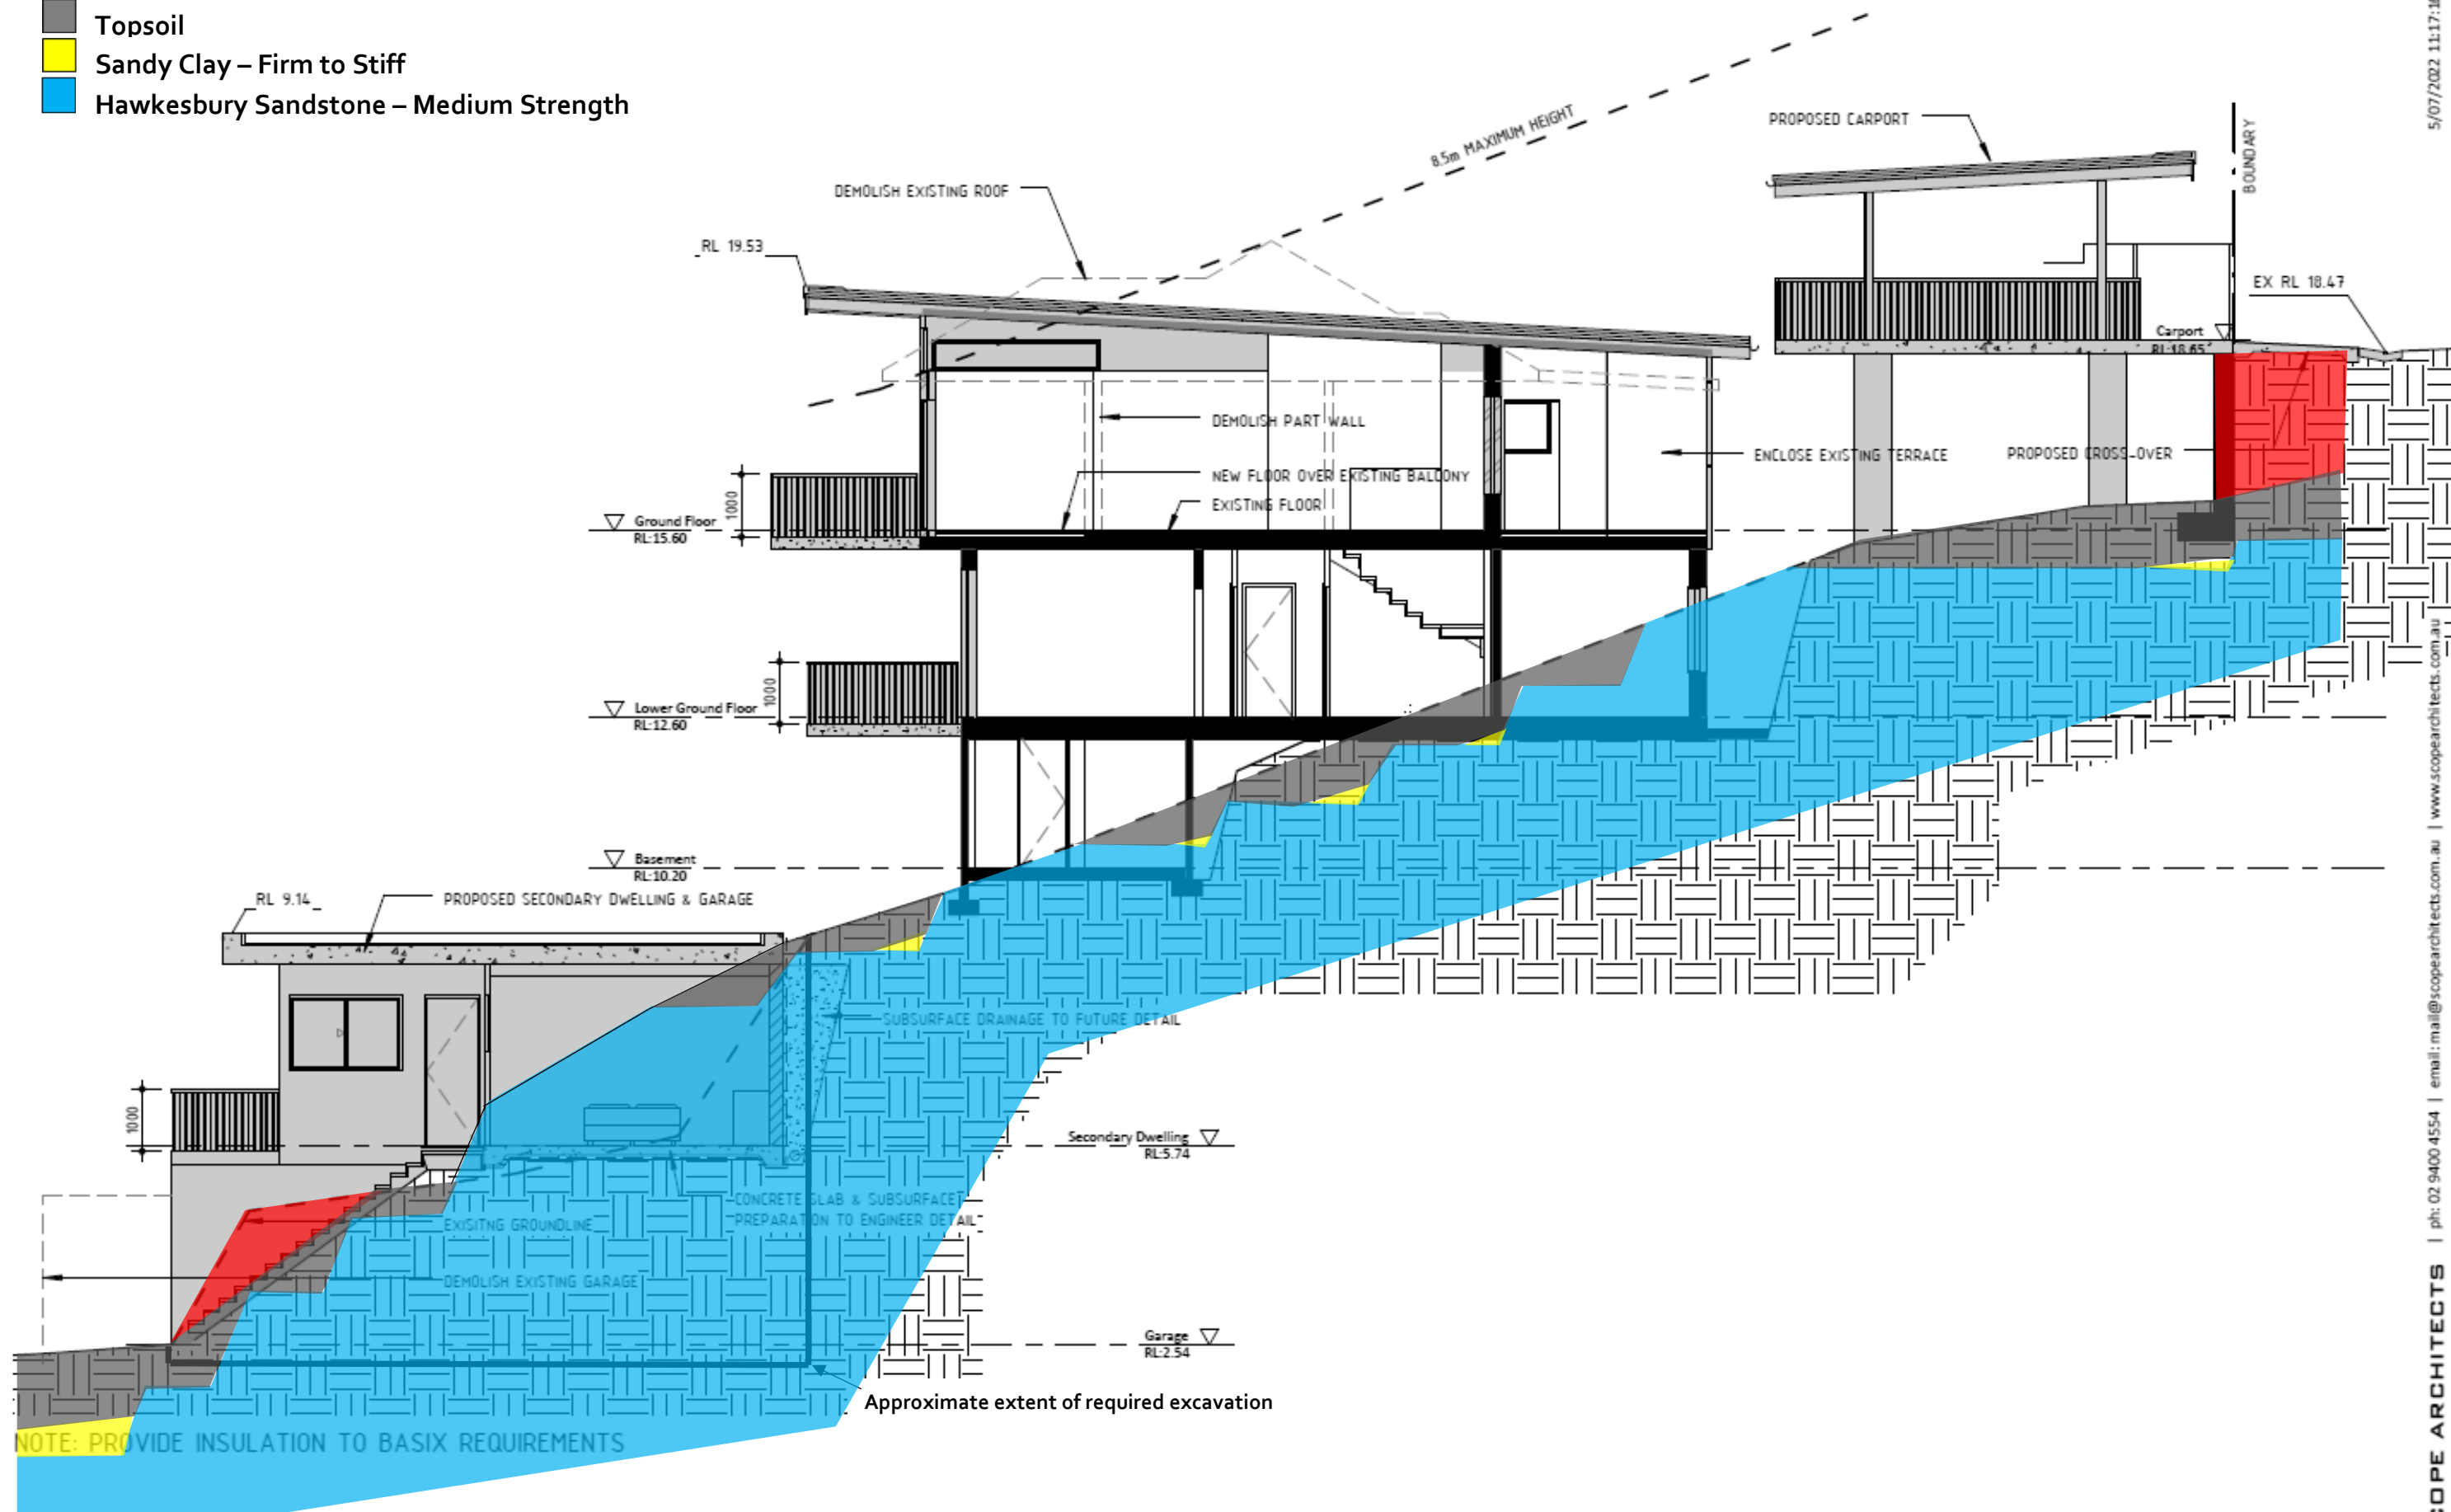
# TYPE SECTION – Diagrammatical Interpretation of expected Ground Materials

The surface features of the block are controlled by the outcropping and underlying sandstone bedrock that steps down the property forming sub-horizontal benches between the steps. Where the grade is steeper, the steps are larger, and the benches narrower. Where the slope eases, the opposite is true. Where the rock is not exposed, it is overlain by natural sandy soils and firm to stiff sandy clays that fill the bench step formation. In the test locations, where it was not exposed, rock was typically encountered at depths of between 0.7 to 1.0m below the current surface. DCP1 was located at the toe of the slope. As such, the rock in this location was encountered deeper than the other tests. The exposed sandstone across the site is estimated to be Medium Strength and a similar strength rock is expected to underly the entire site. See Type Section attached for a diagrammatical representation of the expected ground materials.
