**7 Sherry St, Mona Vale, NSW**

**Site Classification**

**January 2022**

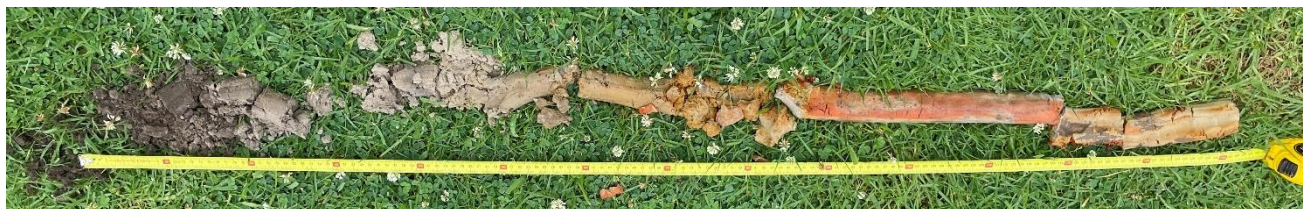
**Figure 2.1:** Borehole 1 sample

Borehole drilling was conducted using thin-wall tube sampling to 1.5m or refusal. DCP testing was conducted to refusal (25+ blows/100mm). The encountered conditions consisted of fine SAND to 0.7m over fine sandy CLAY to 1.4m (terminated). DCP results suggest the clay continues to ~ 2.2m (DCP refusal). The soil was slightly moist at the time of inspection. The borehole results and locations are provided in Appendix B.
