GEOTECHNICAL INVESTIGATION AND ASSESSMENT REPORT

FOR THE PROPOSED NEW DWELLING

38 THE DRIVE, FRESHWATER, NSW

Project No.: 2024-185

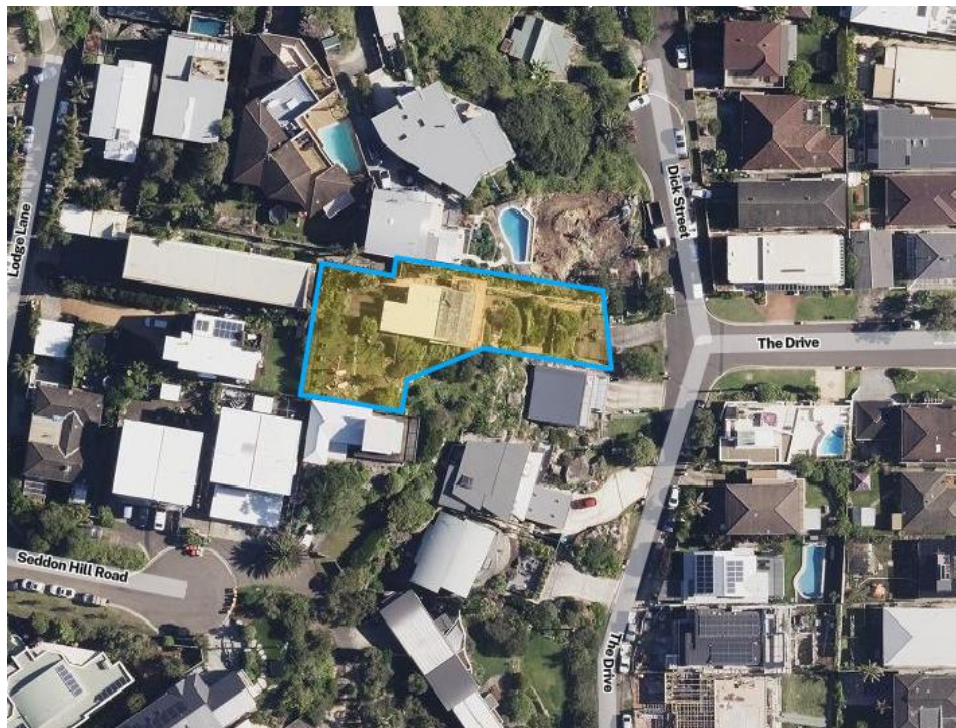
Photograph: 1 – Aerial photo of site and surrounds.
