J4401B. 8<sup>th</sup> June, 2023

3 Orana Road, Mona Vale

#### **GEOTECHNICAL INVESTIGATION:**

New House and Pool at 3 Orana Road, Mona Vale

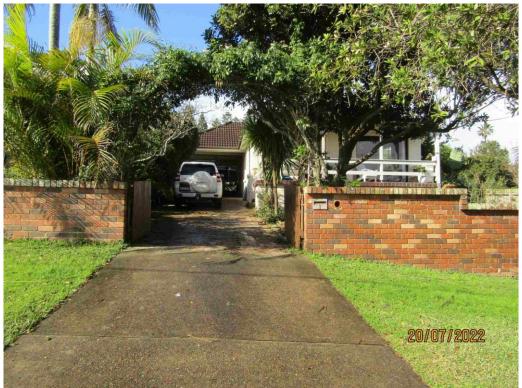
Photo 1

- 2.3 At the road frontage, a concrete and brick paved driveway runs up the slope to a carport beside the house (Photo 1). Between the road frontage and the house is a gently sloping lawn area. The single storey brick house is supported by brick walls and concrete piers (Photos 1 & 2). The supporting walls and piers stand vertical and show no significant signs of movement (Photo 3). Stable low brick retaining walls

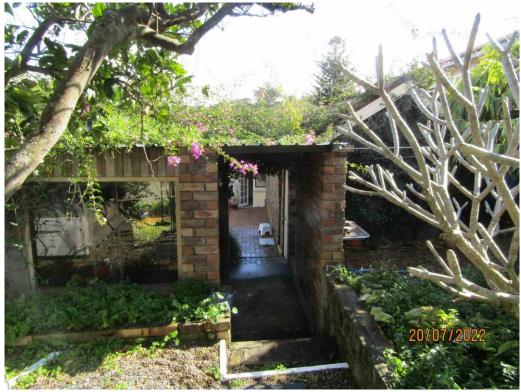
Photo 4

Brick outbuildings that show no significant signs of movement are located uphill of the

house (Photo 4). A gently sloping lawn and garden area extends off the uphill side of

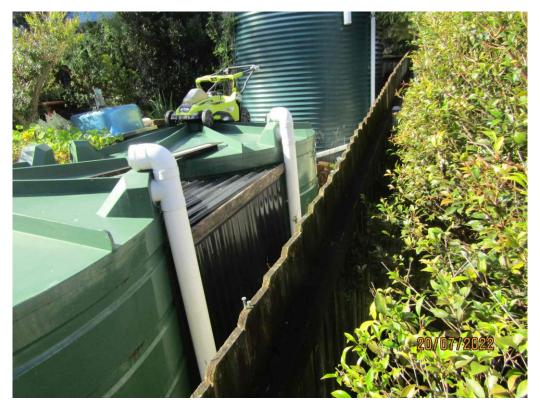
Photo 5

house. Allowing for backwall drainage, the excavation is set back ~0.6m from the NE common

boundary and ~0.9m from the NE neighbouring water tanks (Photo 5). The NE common

boundary and NE neighbouring water tanks will be within the zone of influence of the

Due to the proximity to the NE neighbouring water tanks, The NE side of the cut will require

ground support installed prior to the commencement of the excavation. See the Ground Floor

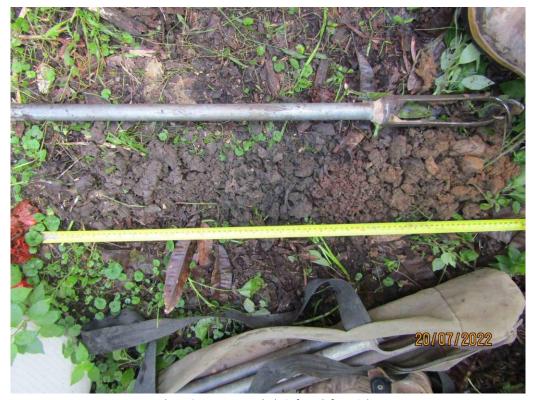
#### **AUGER HOLE 1** (~RL12.7) – AH1 (photo 6)

Depth (m)	Material Encountered
0.0 to 0.7	<b>TOPSOIL</b> , dark brown, with a layer of brown and maroon laterite @ 0.5-0.6m, damp, fine to course grained.
0.7 to 0.9	CLAY, orange/brown, mottled, stiff, damp.

End of Hole @ 0.9m in stiff clay. No watertable encountered.

Photo 6: AH1 – Downhole is from left to right.
