J4683 21st November, 2022 Page 1.

GEOTECHNICAL INVESTIGATION:

Alterations and Additions at 46 Narrabeen Park Parade, Warriewood

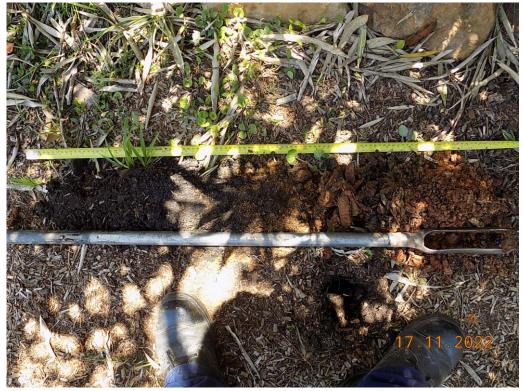
Photo 8 (AH1 – Downhole is from Top to Bottom)

AUGER HOLE 1 (~RL27.8) – AH1 (Photo 3)

| Depth (m) | Material Encountered | | | | | |
| 0.0 to 0.3 | TOPSOIL , clayey soil, dark brown, damp, medium dense, fine to medium grained with fine trace organic matter. | | | | | |
| 0.3 to 0.5 | TOPSOIL , gravely soil, dark brown, medium dense, damp, coarse grained with fine trace organic matter. | | | | | |
| 0.5 to 0.8 | CLAY, orange mottled brown, stiff, dry, fine grained. | | | | | |
| 0.8 to 1.0 | CLAY, derived from weathered shale, red mottled yellow & white, stif | | | | | |
| | to very stiff, dry, fine grained. | | | | | |

End of test @ 1.0m in clay. No water table encountered
