GEOTECHNICAL REPORT

FOR PROPOSED NEW RESIDENTIAL DEVELOPMENT

No.1803- No.1803A PITTWATER ROAD, MONA VALE, NSW

Project No.: 2025-096

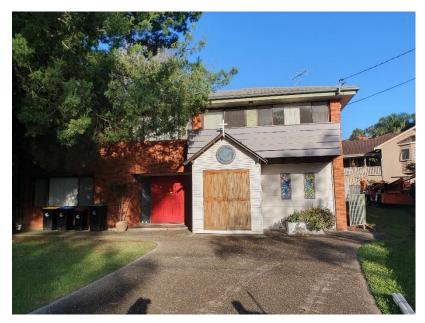
Photograph-2: Front of existing dwelling at No.1803a Pittwater Road. View looking west.

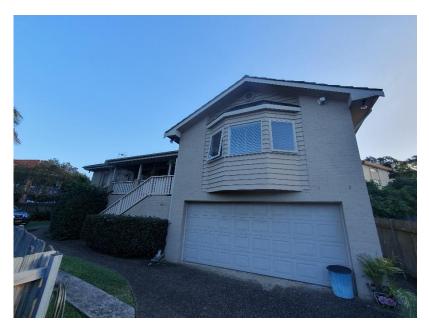
Photograph-3: Front of existing dwelling at No.1803 Pittwater Road. View looking west.

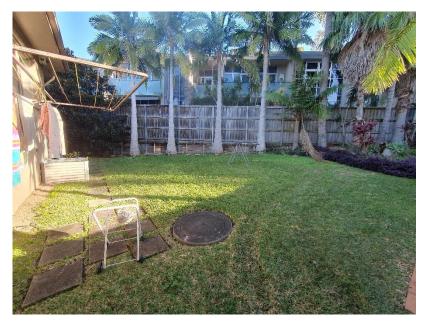
Photograph-4: Rear grass lawn of No.1803. View looking southwest.

A sewer inspection pit was observed within the rear grass lawn of No.1803. Information obtained from available Sydney Water (SW) sewer plans indicates that a SW sewer main is located at the rear of the site and it extends from the inspection pit continuing south-west and south-east into the neighbouring property (No. 44 – No.48 Park Street) and continues south-east parallel and directly adjacent to the common boundary. The sewer main within the site appears to be approximately 1.70m below the existing GSL and it comprises Vitrified Clay (VC) pipe (225mm diameter). The sewer outside the site is concrete encased pipe (150mm diameter) and approximately 1.49m below the neighbouring GSL.
