2131 Pittwater Road, Church Point

Geotechnical Comments for Section 4.55 Plans

GEOTECHNICAL INVESTIGATION:

Additions and Alterations and New Pool at 2131 Pittwater Road, Church Point

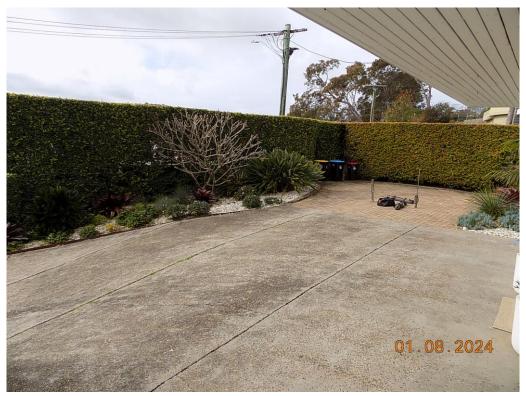
Photo 2

- **2.1** The site was inspected on the 1st August, 2024.
- 2.2 This residential property is on the high side of the road and has a NE aspect. It is located on the gentle to moderately graded lower reaches of a hillslope. The natural slope rises across the property at an average angle of ~9°. The slope above the property continues at moderate angles. The slope below the property eases to near level angles at the waterfront.
- 2.3 At the road frontage, a concrete ROW (Right of Carriageway) and driveway run to a garage under the downhill side of the house (Photo 1). Fill for the driveway and garden bedding between the road frontage (Photo 2) and the house is supported by a

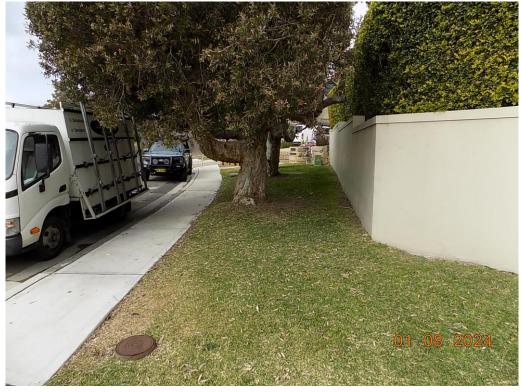
Photo 3

stable rendered masonry retaining wall (Photo 3) which approximates the downhill and SE boundaries. The part two-story house is supported on rendered masonry walls. Horizontal hairline cracking in the rendering was observed in some of the supporting walls. This minor cracking is not attributed to foundation movement. The house foundations are currently considered stable. Most of the supporting walls of the house will be demolished as part of the proposed works. A stable pool (Photo 4) and tiled patio occupies the space between the upper and lower portions of the house. The pool will also be demolished as part of the proposed works. The cut for the patio is supported by a stable rendered masonry retaining wall reaching ~1.5m high (Photo 5). Above the house a cut for level garden bedding is supported by a stable low sandstone block retaining wall which approximates the uphill common boundary (Photo 6).

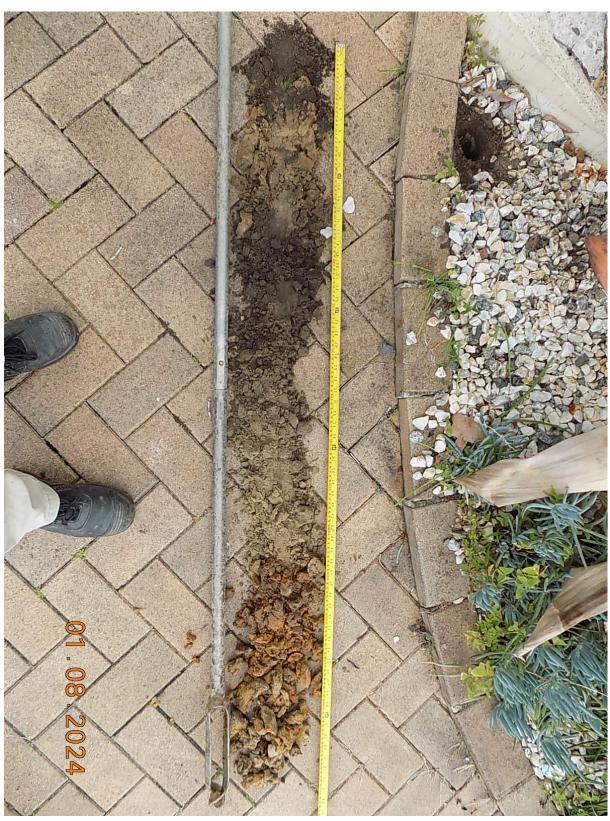
AUGER HOLE 1 (~RL3.8) – AH1 (Photo 7)

Depth (m)	Material Encountered
0.0 to 0.1	FILL, dark brown, Medium Dense, damp, medium grained
0.1 to 0.4	CLAYEY FILL, brown, Soft, damp, fine to medium grained, clay
	fragments included.
0.4 to 0.7	CLAYEY SANDY SOIL, dark brown, Soft, damp, fine to medium grained.
0.7 to 1.2	CLAYEY SAND, brown to light brown, Medium Dense to Dense, damp,
	fine to medium grained.
1.2 to 1.5	CLAY, mottled maroon, orange, yellow, grey, Very Stiff, damp, charcoal
	inclusions.
1.5 to 1.7	CLAY, derived from weathered shale, mottled orange and grey, Stiff,
	damp.

End of test @ 1.7m in clay derived from weathered shale. No water table encountered.

Photo 7 – AH1 – downhole is top to bottom

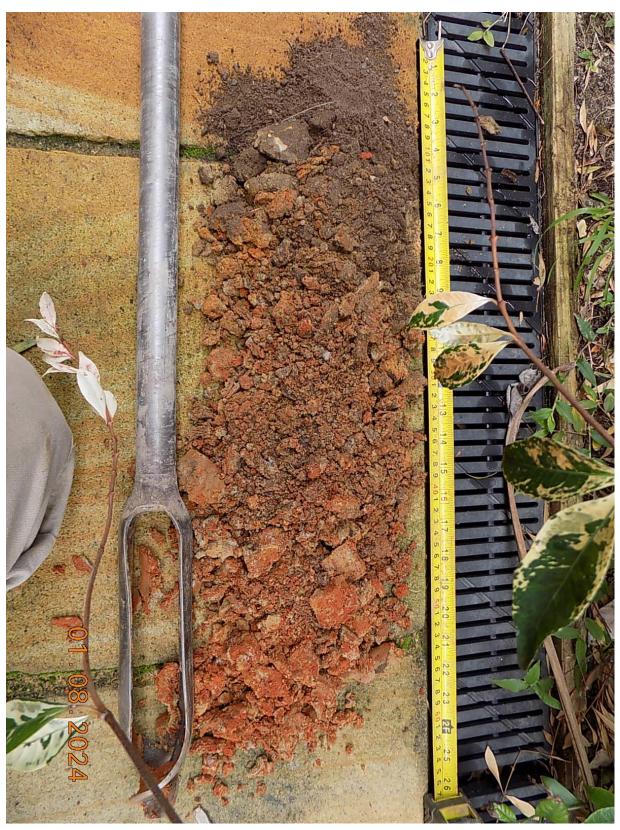
AUGER HOLE 2 (~RL8.5) - AH2 (Photo 8)

Depth (m)	Material Encountered
0.0 to 0.2	FILL, brown, Dense, dry, fine to medium grained.
0.2 to 0.4	CLAY, mottled orange and grey, Hard, dry, fine to medium grained, soil
	lenses present.
0.4 to 0.6	SANDY CLAY, derived from weathered shale, mottled maroon, orange,
	and grey, Hard, dry, fine to medium grained.

End of test @ 0.6m in clay derived from weathered shale. No water table encountered.

Photo 8– AH2 – downhole is top to bottom
