Report on  
Limited Preliminary Site Investigation for  
Contamination

Proposed Self-contained Dwellings  
Lot 1113 in Deposited Plan 752038, Frenchs Forest

Project 86678.01  
April 2019

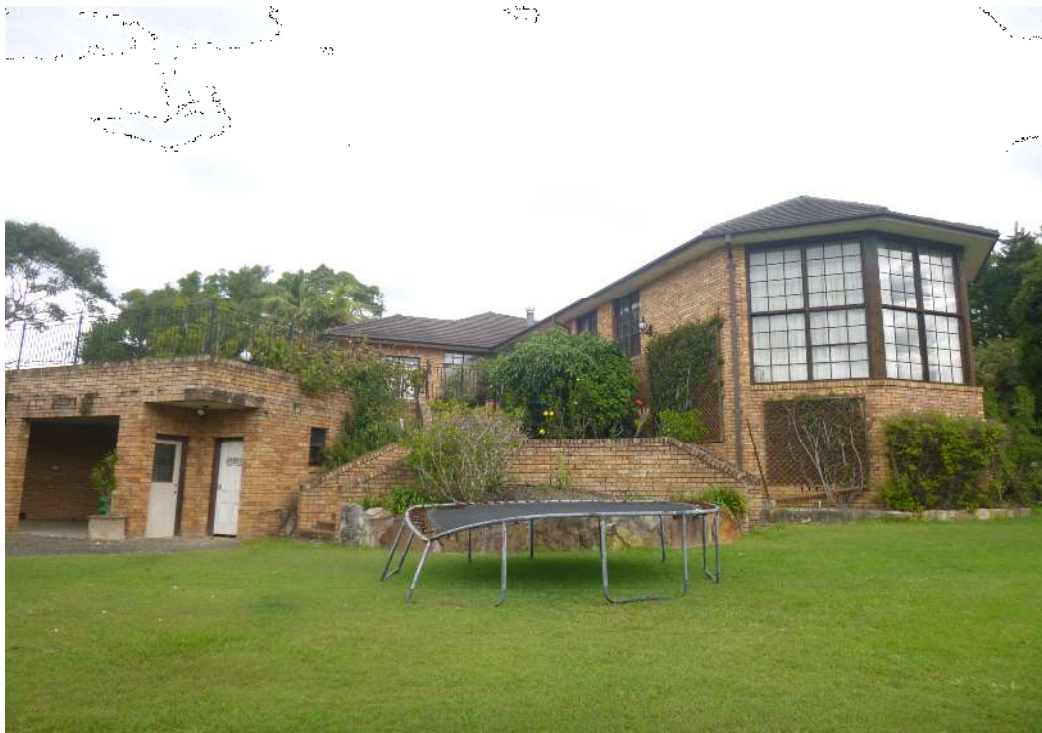
- A large brick residence at the south, surrounded by lawns and landscaping accessed by an asphalt driveway from Barnes Road (Photographs 1 and 2, Appendix D);

Photograph 1 - Existing Residence

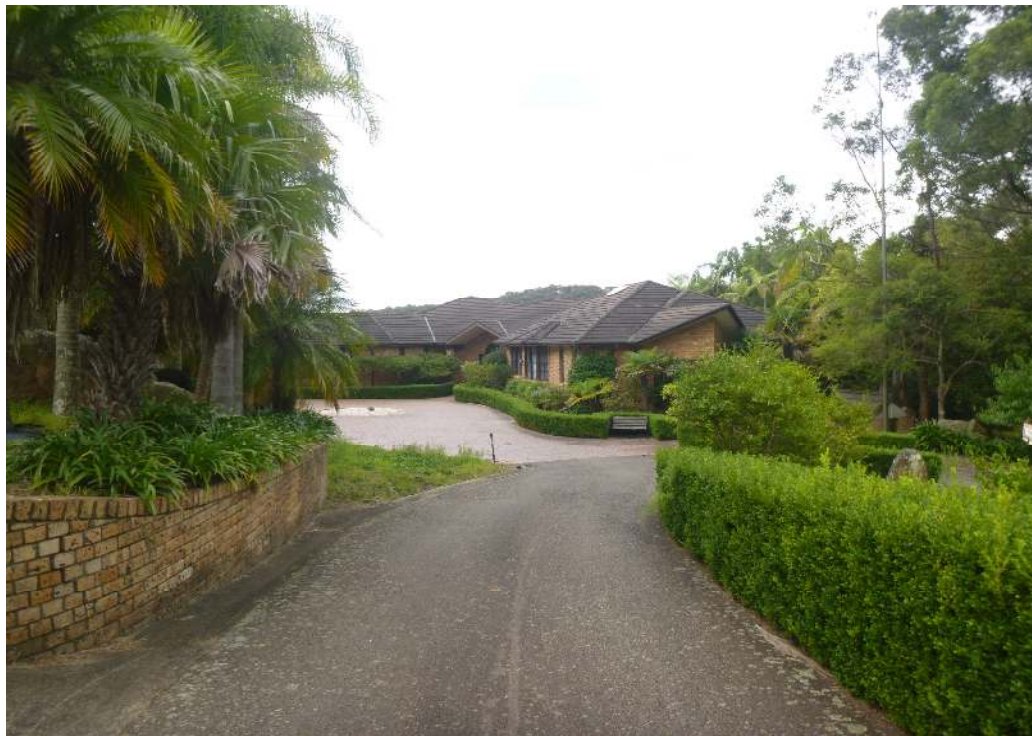
Photo 2 - Driveway Access to Residence

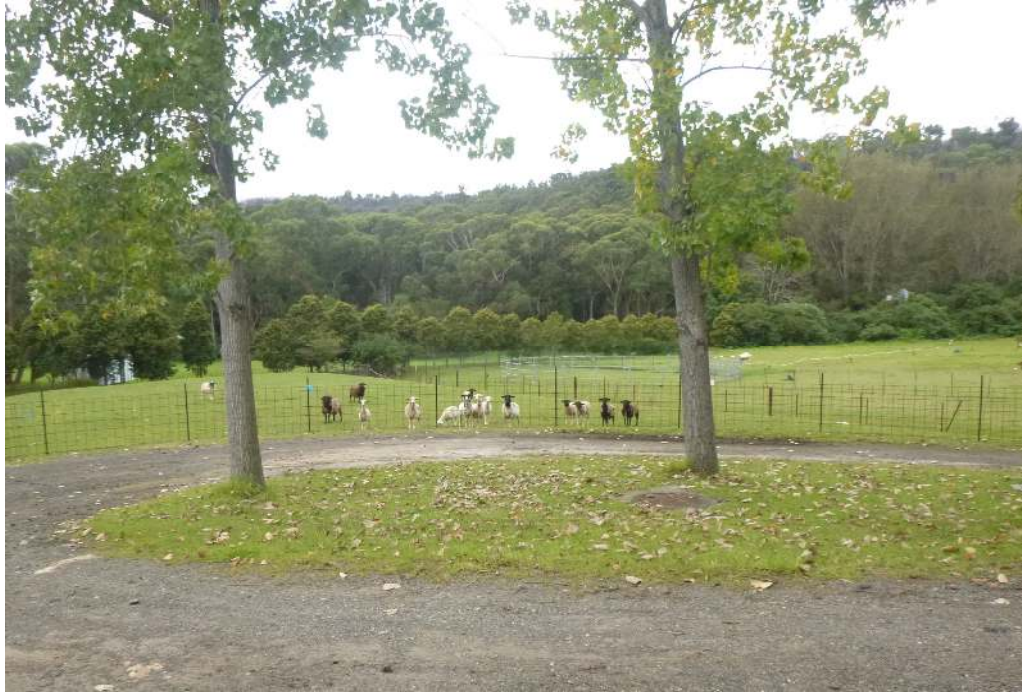
- A grassy paddock at the north for sheep and horse grazing (Photograph 3, Appendix D). The paddocks are accessed by a gravel driveway. A shelter was at the southern part of the paddock (Photograph 4, Appendix D);

Photograph 3 - Paddock at South

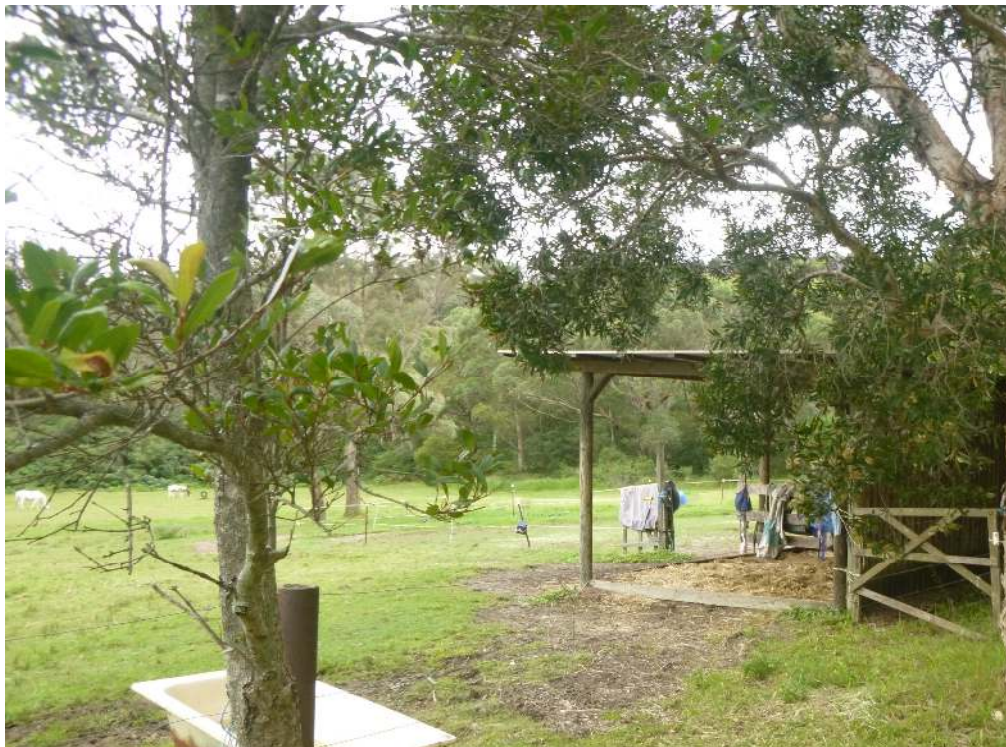
Photograph 4 - Shelter at Paddock

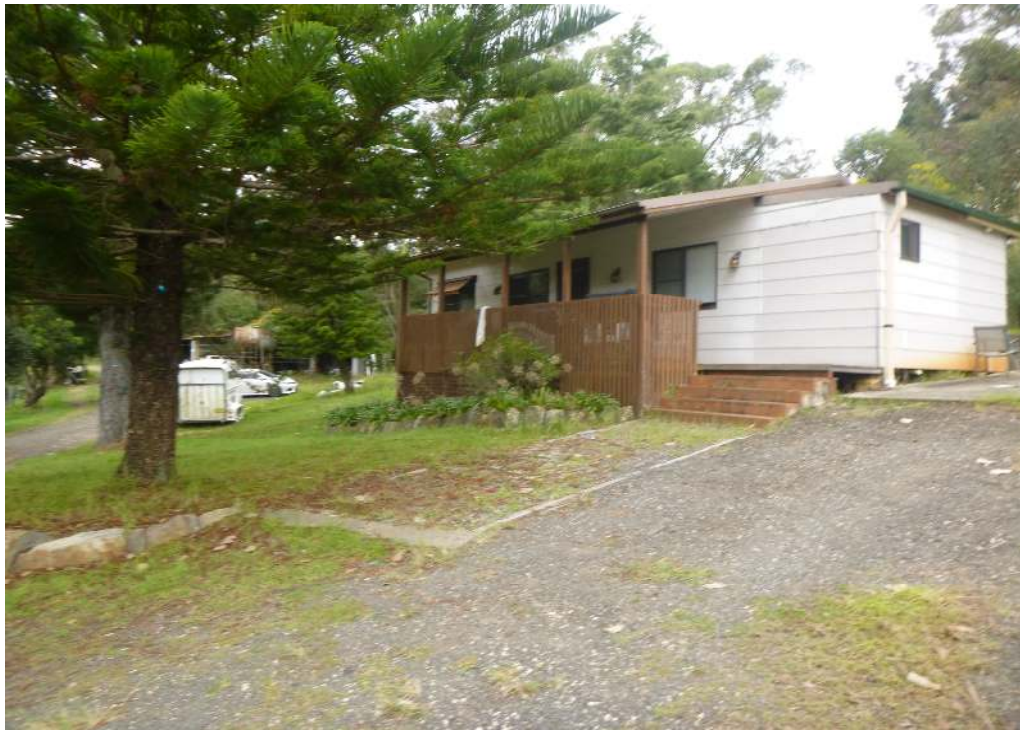
- A cottage near the eastern site boundary which is also accessed by the gravel driveway (Photograph 5, Appendix D);
- A workshop (metal shed) at the central part of the site (Photograph 6 and 7, Appendix D). Old oil drums and paint cans were present at the workshop. The floor of the shed was soil and had some broken pavers. Waste materials such as scrap metal, car parts and old tyres were present on either side of the shed (Photographs 8 to 10, Appendix D);

Photograph 5 - Cottage

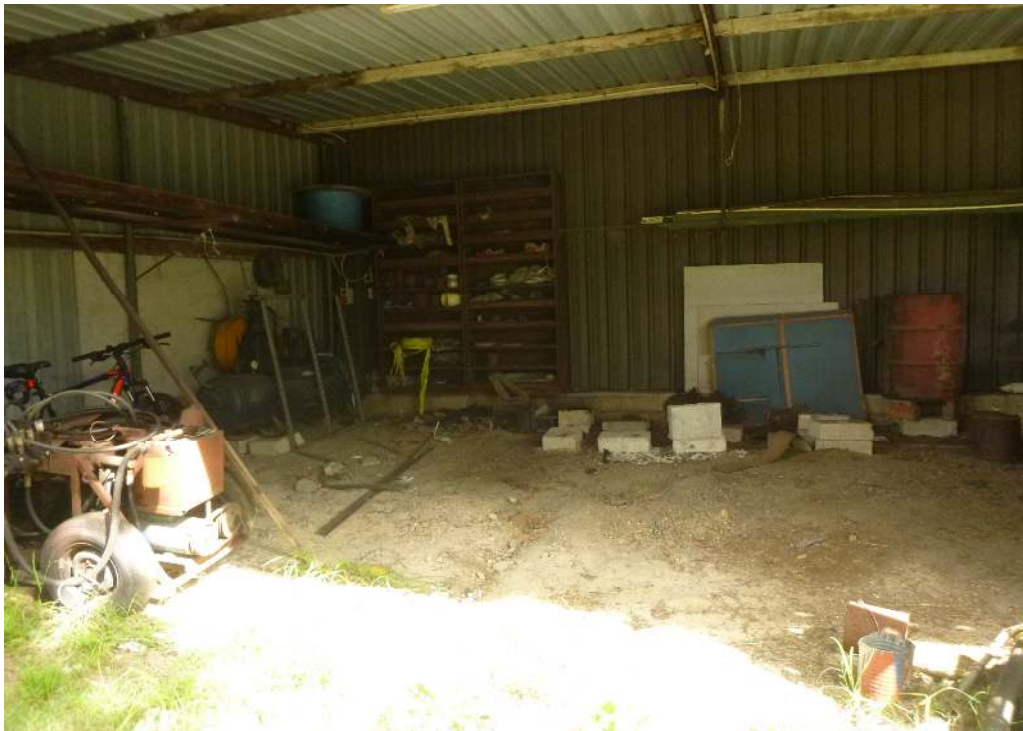
- (S2) Spills or leaks of oils and/or chemicals at the workshop. Potential contaminants include TPH, BTEX, phenols, PAH, metals (such as lead) and volatile organic compounds (VOC);

Photograph 6 - Workshop

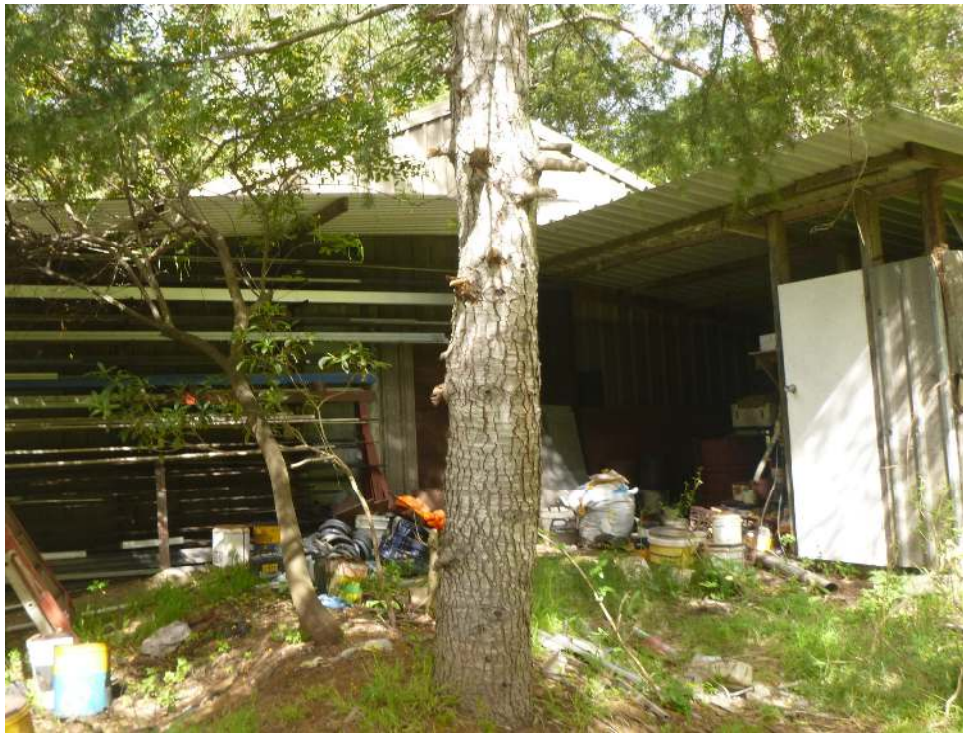
Photograph 7 - Waste Materials at Workshop

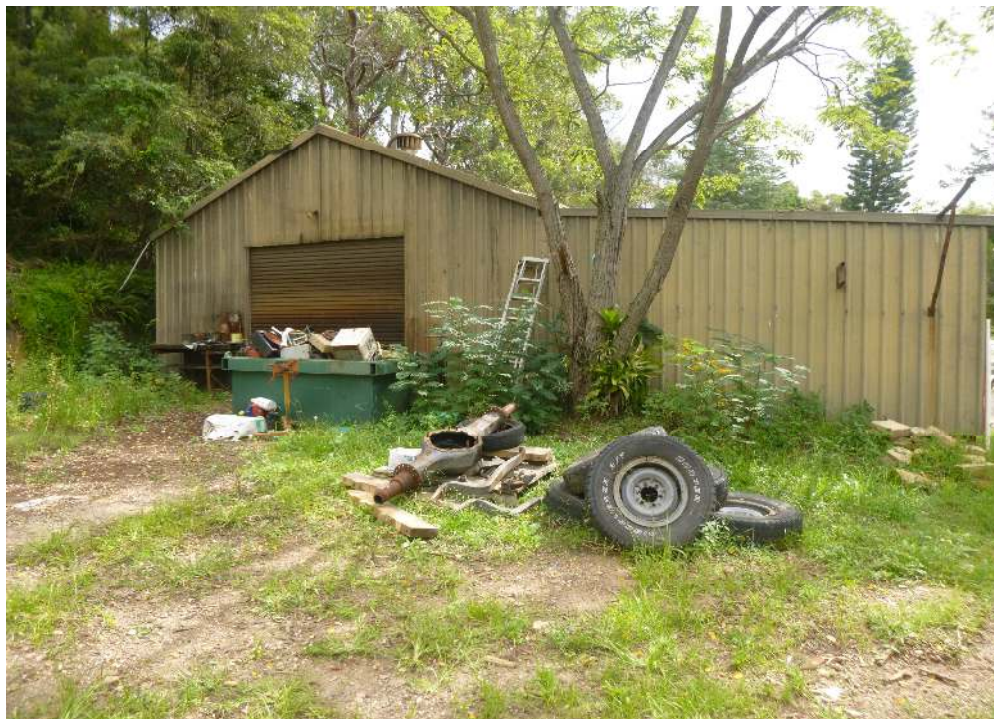
Photograph 8 - Waste Materials next to Workshop

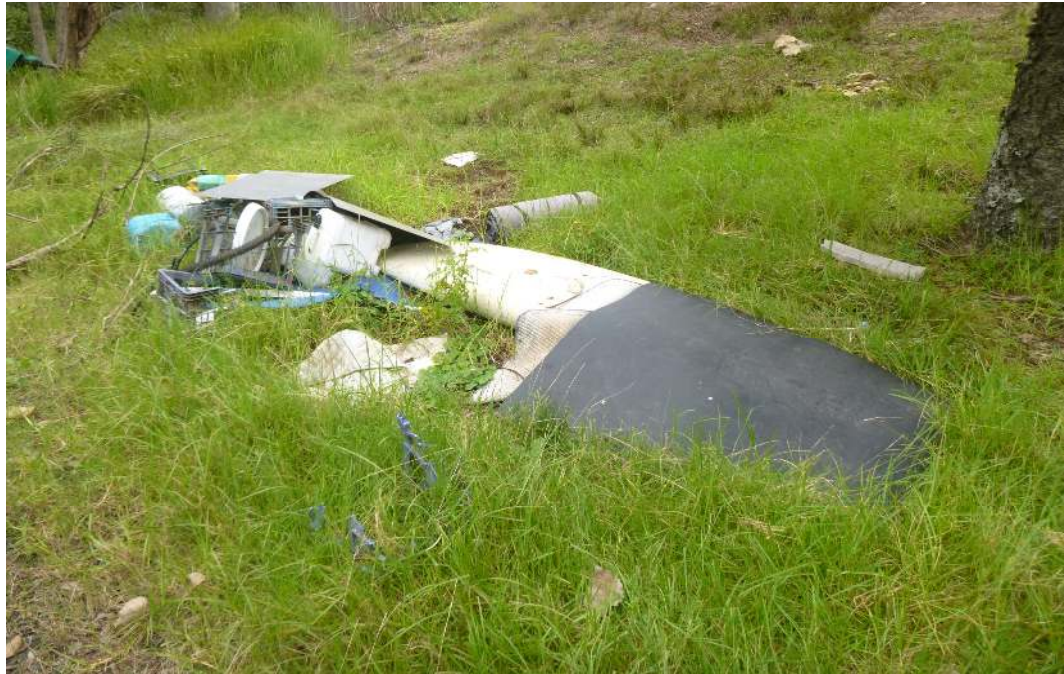
Photograph 9 - Waste materials

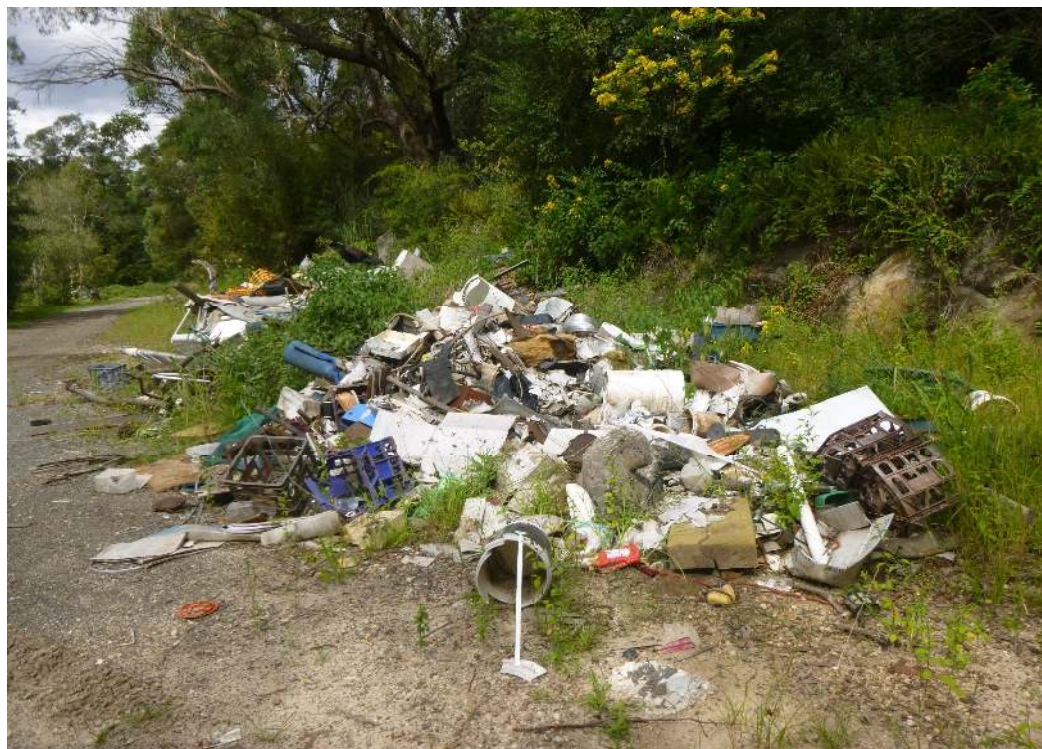
Photograph 10 - Waste materials

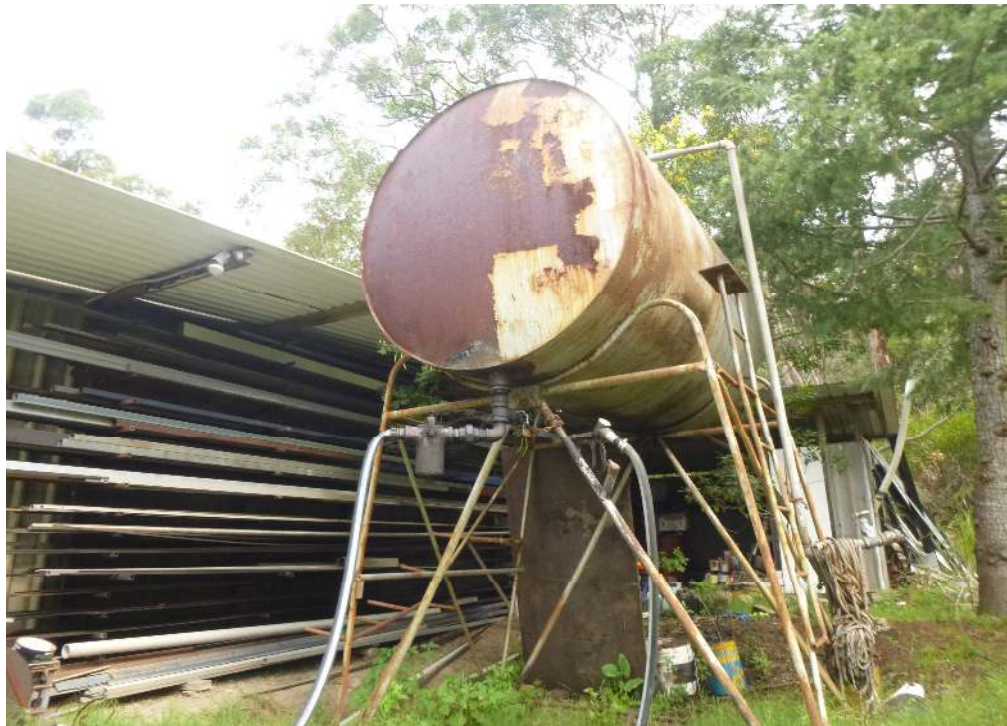
- An old above ground storage tank on the western side of the workshop, presumably used to store diesel (Photograph 11, Appendix D). Exposed soil was present beneath the tank;

- (S1) Spills or leaks of fuel from the above ground storage tank next to the workshop. Potential contaminants include total petroleum hydrocarbons (TPH); benzene, toluene, ethyl benzene and xylenes (BTEX); metals (such as lead); polycyclic aromatic hydrocarbons (PAH); and phenols;

Photograph 11 - Above Ground Storage Tank

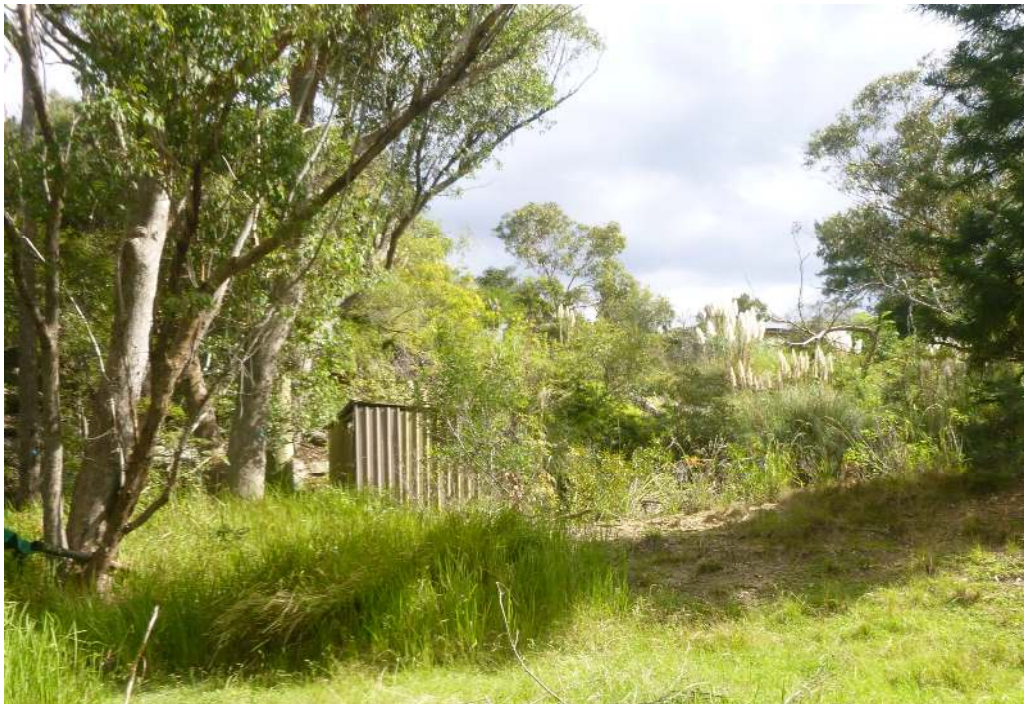
- A small metal shed at the central part of the site (Photograph 12, Appendix D);
- A remnant tennis court which was covered in vegetation at the south-eastern part of the site (Photograph 13, Appendix D); and

Photograph 12 - Small Metal Shed

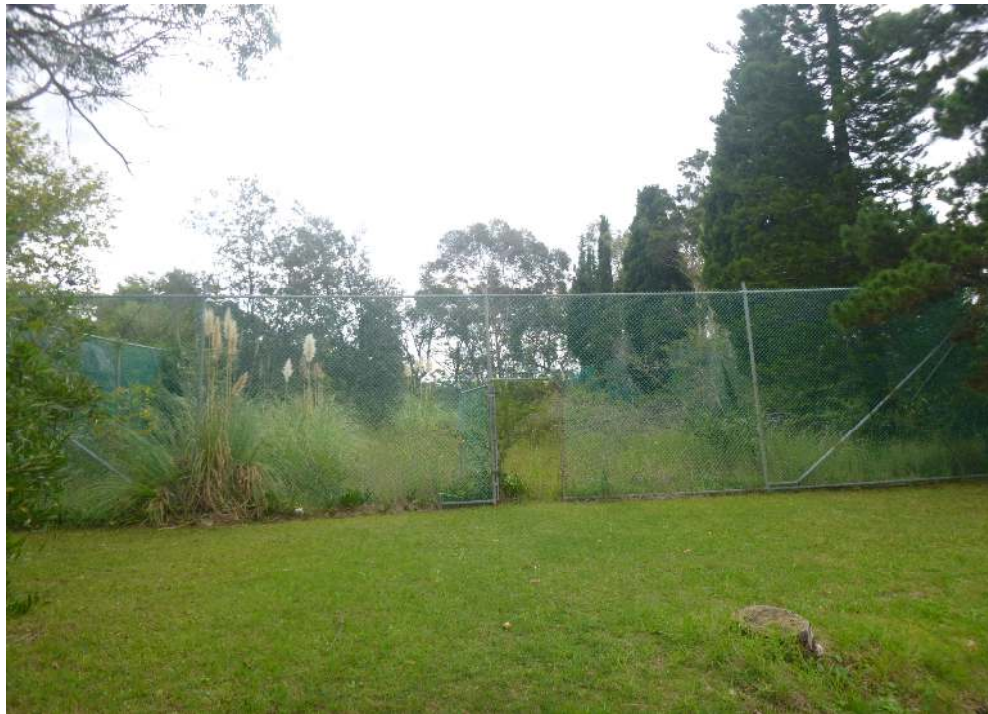
Photograph 13 - Remnant Tennis Court

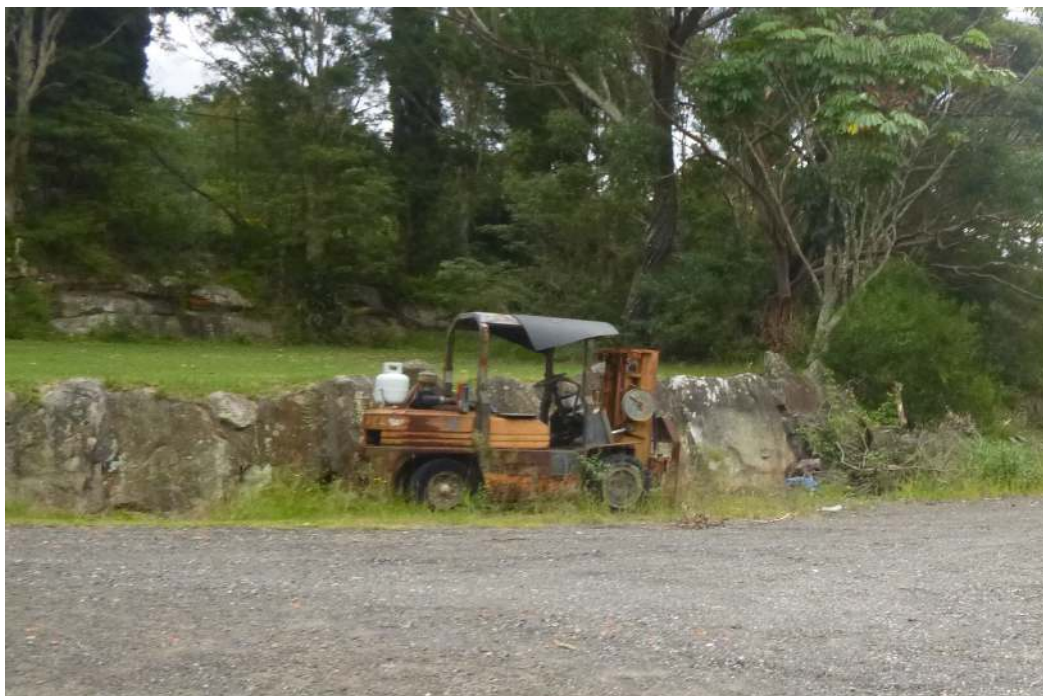
- A number of retaining walls, particularly at the central and southern parts of the site (Photographs 14 to 16, Appendix D).

Photograph 14 -Retaining Wall

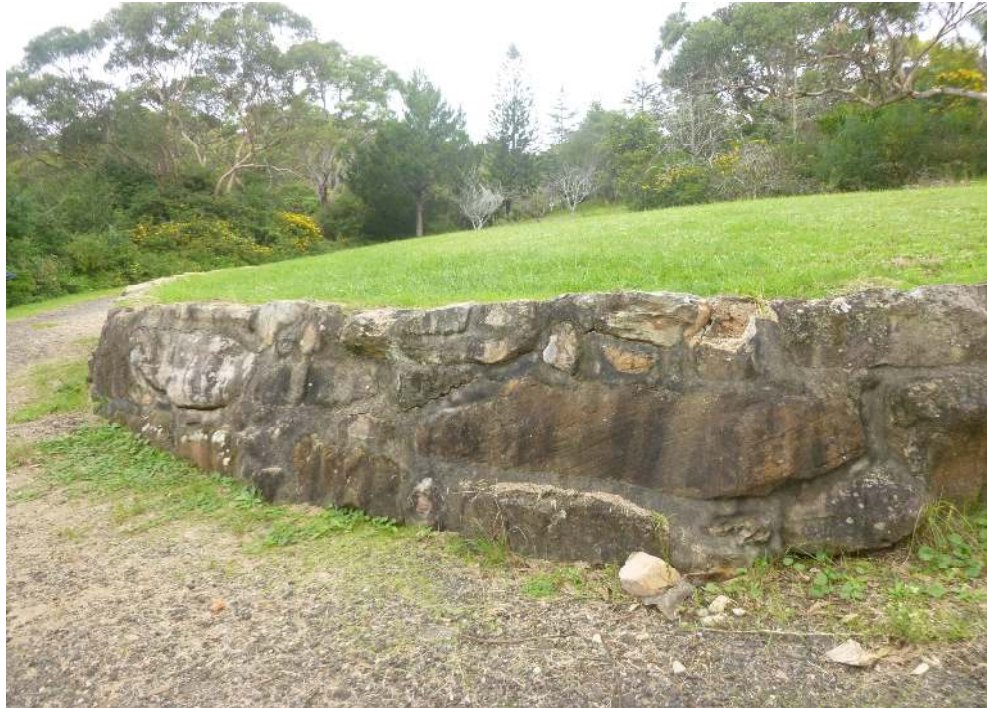
Photograph 15 - Retaining Wall

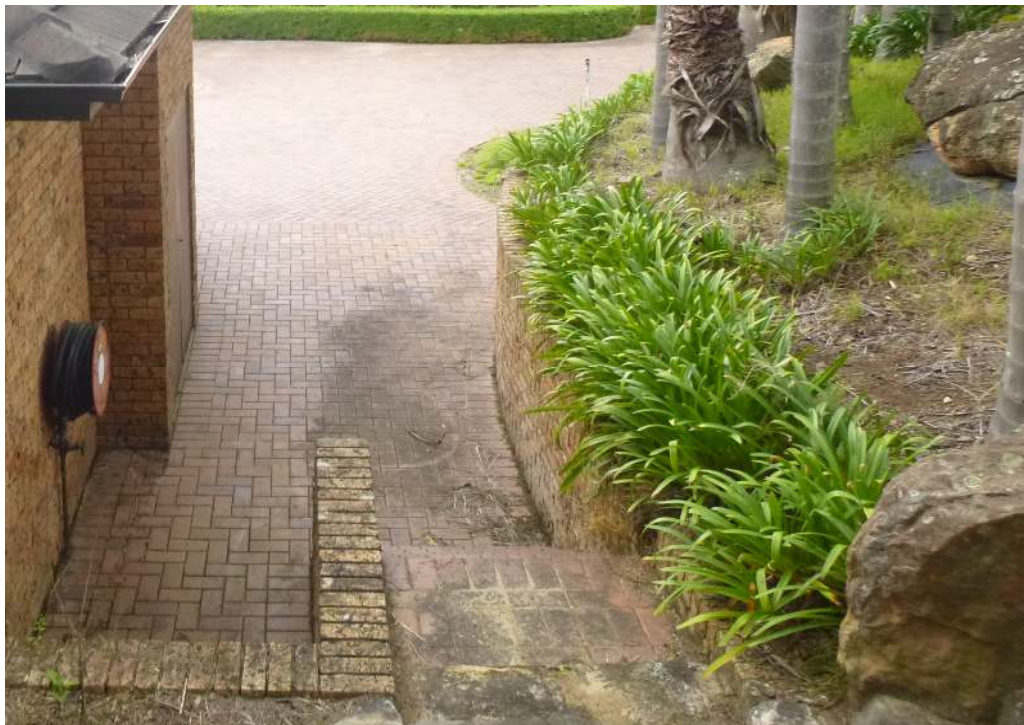
Photograph 16 - Retaining Wall at Residence
