# **REPORT ON GEOTECHNICAL INVESTIGATION**

## **PROPOSED RETAIL AND RESIDENTIAL DEVELOPMENT**

### **55 KALANG ROAD ELANORA HEIGHTS**

**PROJECT: TGE21732**

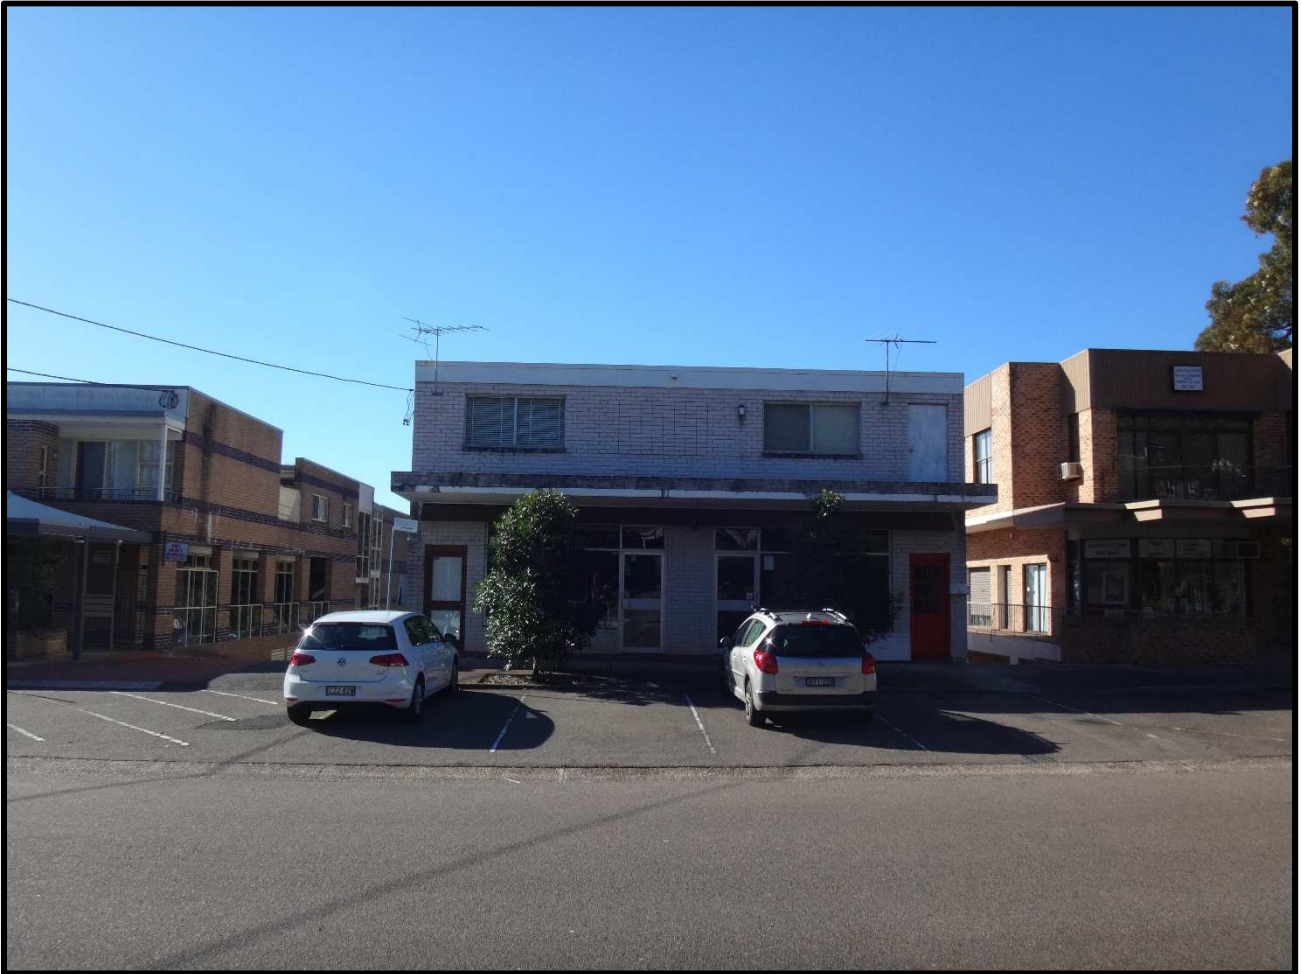
Photo 1 – View of site from Kalang Road, looking east.

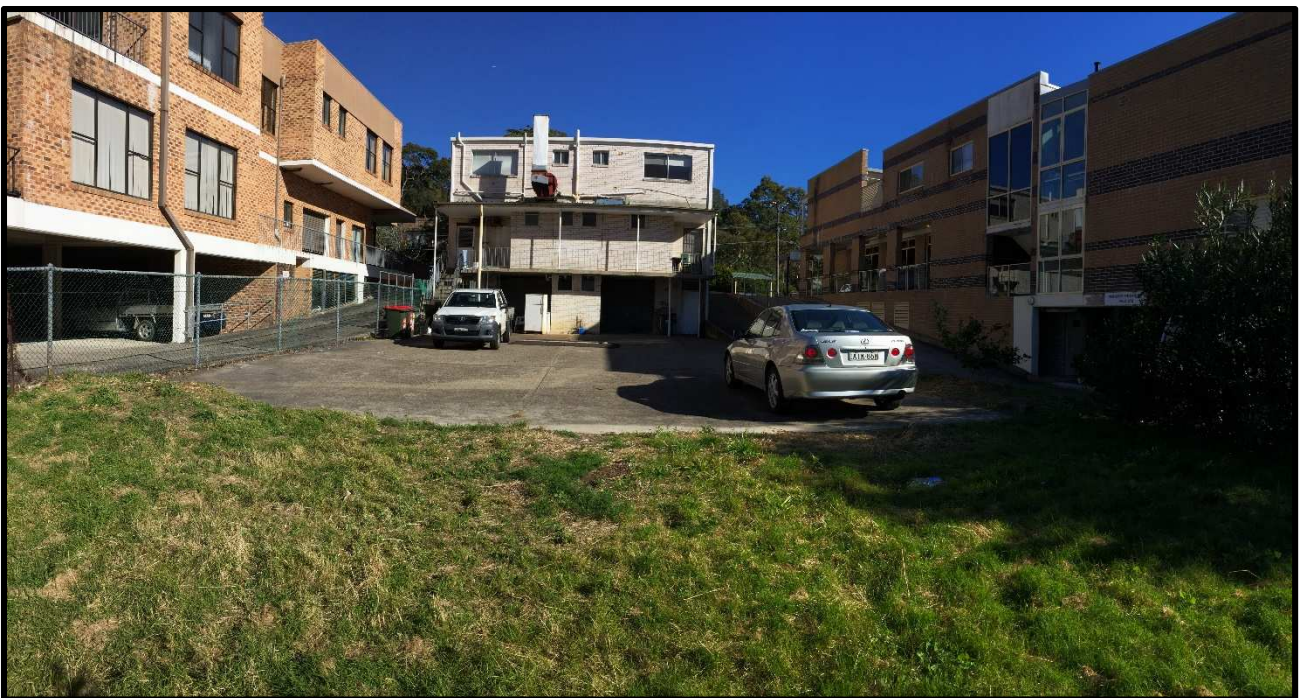
Photo 2 – View of site from rear boundary, looking west.
