GEOTECHNICAL INVESTIGATION:

New Pool, Cabana & Garage at **15 Chisholm Avenue, Avalon Beach**

1. Proposed Development

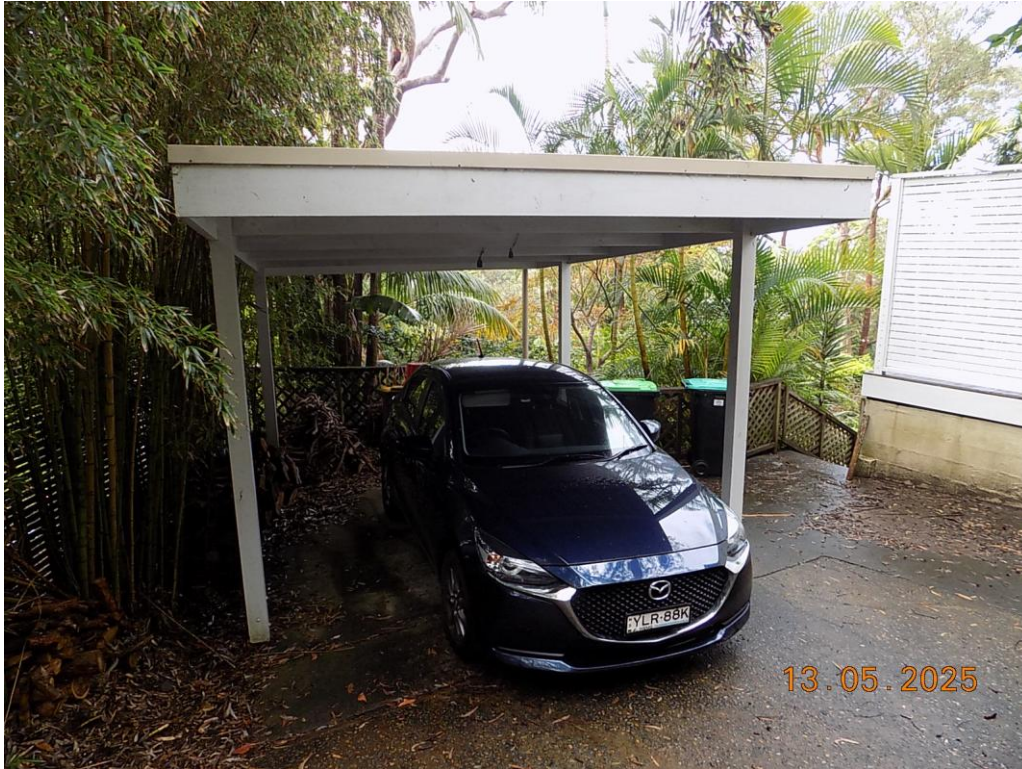
Photo 1

- 2.1** The site was inspected on the 13th May, 2025.
- 2.2** This residential property is on the low side of the road and has an E aspect. It is located on the moderately graded middle reaches of a hillslope. The natural slope falls across the property at an average angle of ~13°. The slope above and below the property continue at similar angles.
- 2.3** At the road frontage, a shared concrete driveway runs down the slope to a carport to the N of the house (Photo 1). The fill for the carport is supported by a stable

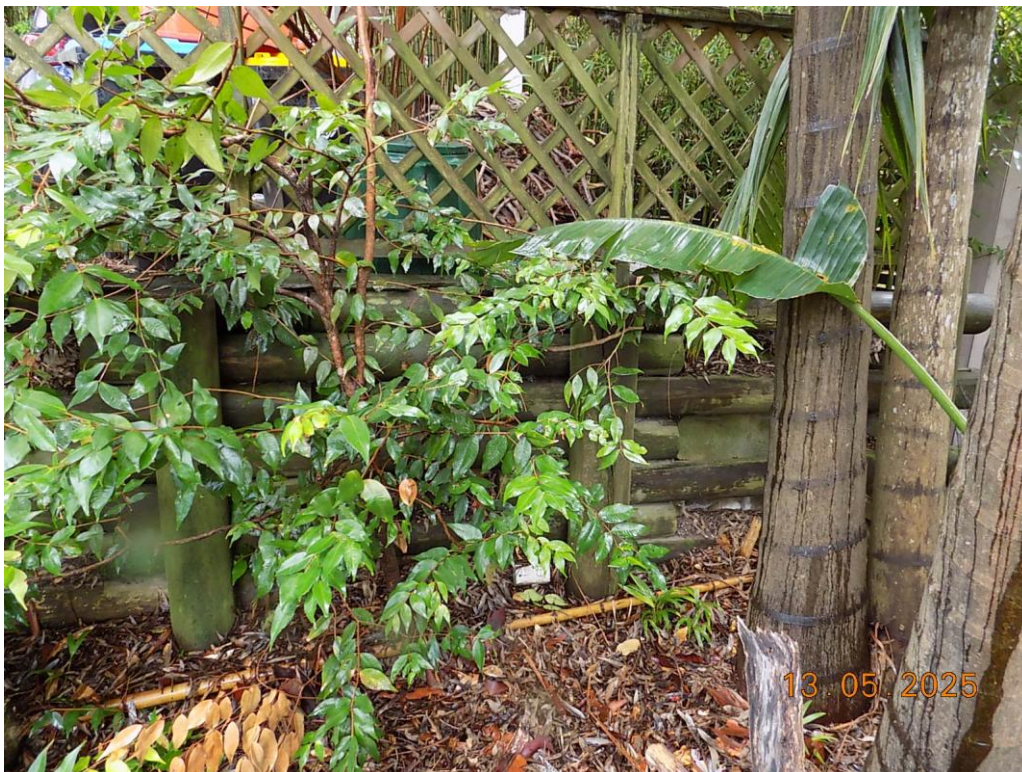
Photo 2

timber retaining wall reaching ~1.0m high (Photo 2). The moderately graded slope between the road frontage and the house is densely vegetated (Photo 3). The part two-story fibre board clad house is supported on brick walls and brick piers (Photo 4). Thin stepped cracking was observed in the uphill supporting wall of the house (Photo 5). This cracking is typical in houses of this age and construction and we attribute it to minor settlement. The moderately graded slope below the house which is the location of the proposed works is terraced in retaining walls of timber and mortared sandstone construction and reaching ~1.3m high (Photos 6 to 8). These walls were largely observed to be stable. One of the walls to the S of the house was observed to be tilting slightly (Photo 9). However, due to the wall's low height and location, it is not considered a threat to life or property should further movement occur. The remainder of the subject property down to the lower common boundary is a moderately graded lawn (Photo 10).

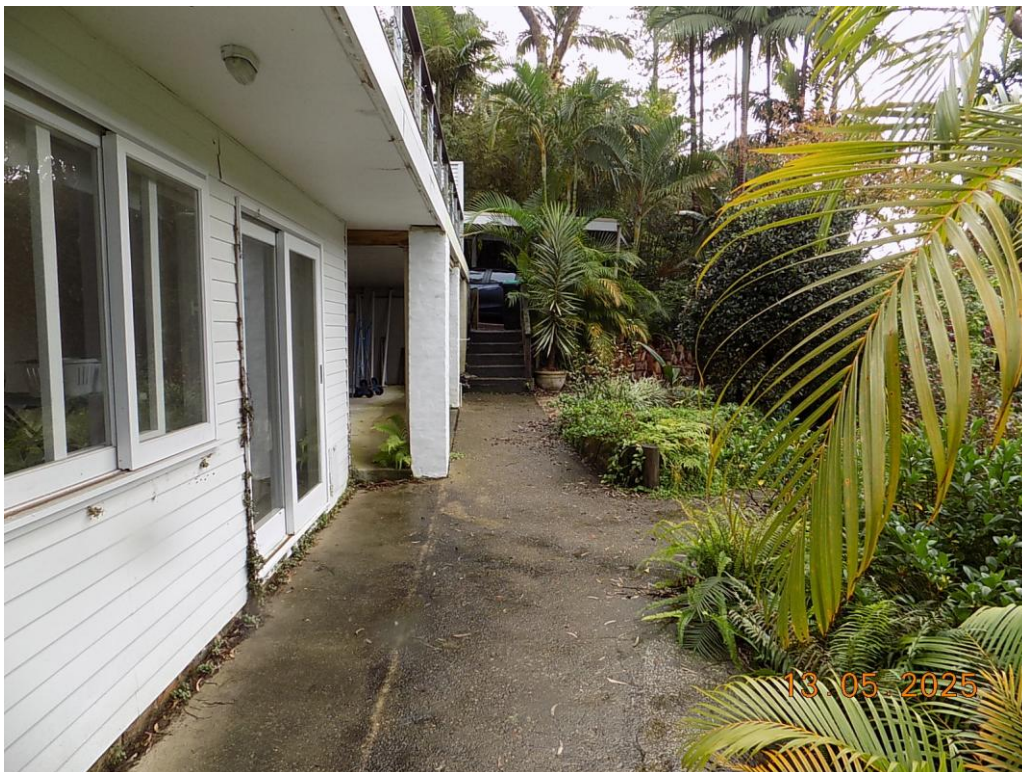
Photo 4

- The landscaping excavation will reach a maximum depth of ~1.8m and come ~flush with a concrete slab on the downhill side of the house and ~0.7m from the supporting brick piers of the existing deck (Photo 4).
- The excavation for the cabana will reach a maximum depth of ~1.8m will be sufficiently set back from any nearby structures and boundaries.

As such, the concrete slab and brick piers will lie within the zone of influence of the proposed landscaping excavation. In this instance, the zone of influence is the area above a theoretical

Where the slab and piers fall within the zone of influence of the excavation, exploration pits along them will need to be put down by the builder to determine the foundation depth and material. These are to be inspected by the geotechnical consultant.

If the foundations are confirmed to extend below the zone of influence of the proposed excavation, the excavation may commence. If they are not, the brick piers of the balcony/slab will need to be underpinned to below the zone of influence of the cut prior to the excavation commencing. See the site plan attached for the minimum extent of the required exploration pits/underpinning.

- The exploration pits to determine the foundation material along the concrete slab and brick piers (Photo 4) are to be inspected by the geotechnical consultant to determine if underpinning is necessary. This is to occur before the bulk excavation for landscaping commences.
- During the excavation process, the geotechnical consultant is to inspect the cuts in 1.5m intervals as they are lowered, while the machine/excavation equipment is on site, to ensure the ground materials are as expected and the shoring is adequate.
- All footings are to be inspected and approved by the geotechnical consultant while the excavation equipment and contractors are still onsite and before steel reinforcing is placed or concrete is poured.

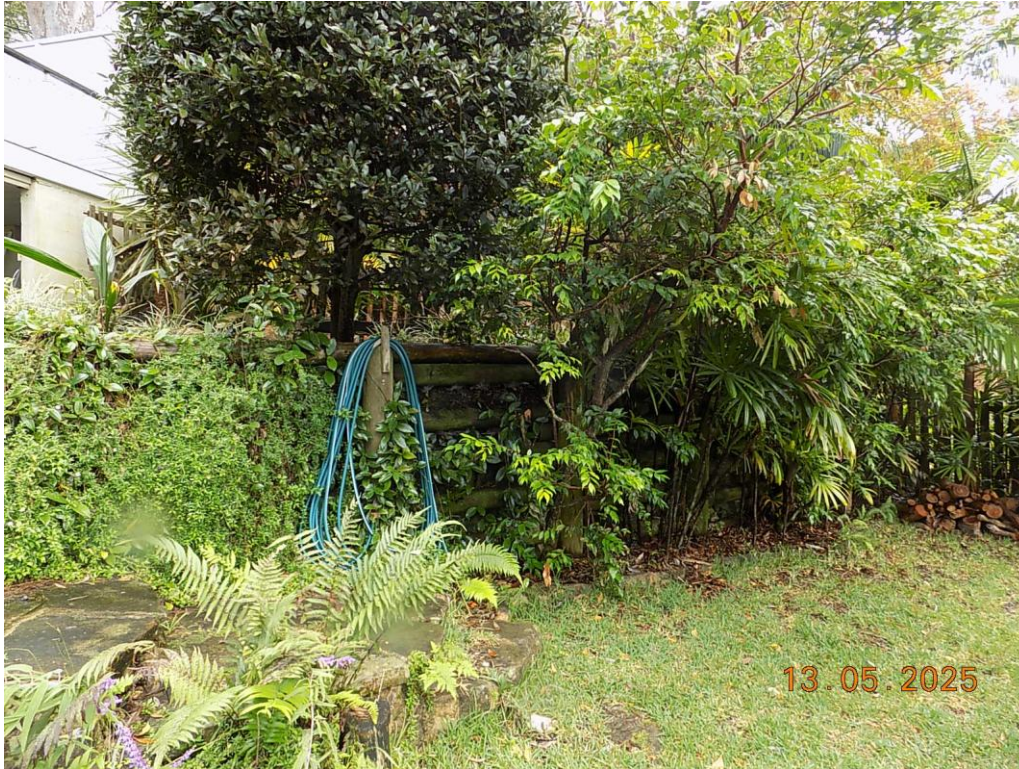
Photo 7

Timber retaining walls reaching ~1.3m which terrace the slope in this location are proposed to be demolished in order to landscape the property and construct the cabana (Photos 7 & 8). The walls are to be demolished from the top down in an orderly manner with the fill behind the walls being systematically lowered at the same time. The soil batter slope is not to exceed 1.0 Vertical to 1.7 Horizontal (30°) as the walls are demolished.

Due to the grade of the slope, any new excavations are to be temporarily supported prior to the commencement of the excavation, or during the excavation process in a staged manner, so cut batters are not left unsupported. See the site plan attached for the minimum extent of the required shoring. The support will need to be designed/approved by the structural engineer in consultation with the Geotechnical Consultant.

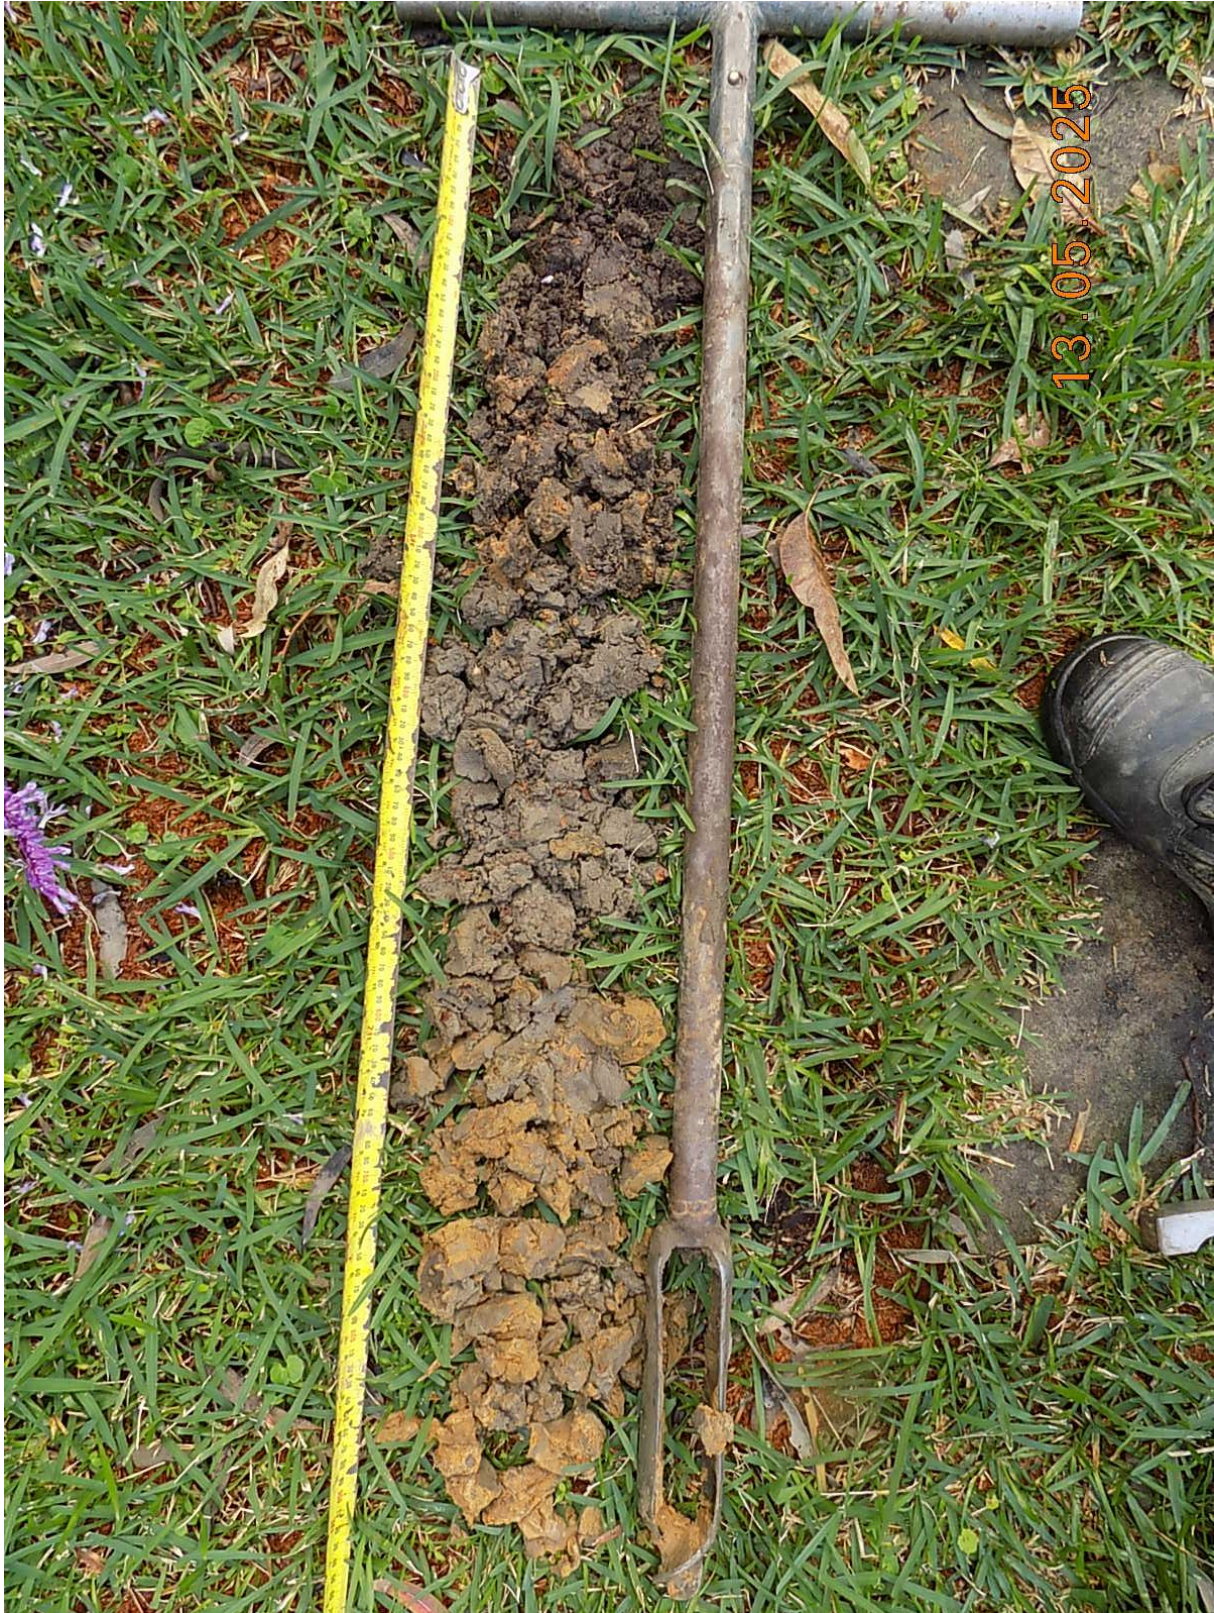
Photo 11

AUGER HOLE 1 (~RL40.8) – AH1 (Photo 11)

Depth (m)	Material Encountered
0.0 to 0.3	FILL , clayey soil, derived from natural clays, brown, Soft, damp, fine to medium grained.
0.3 to 0.6	CLAY , sandy clay, grey Soft, damp, fine to medium grained.
0.6 to 0.9	RESIDUAL CLAY , sandy clay, derived from weathered Very Low to Low Strength Rock or Better, mottled brown and orange, Firm to Stiff, dry, fine to medium grained.

End of test @ 0.9m in residual clay. No water table encountered.

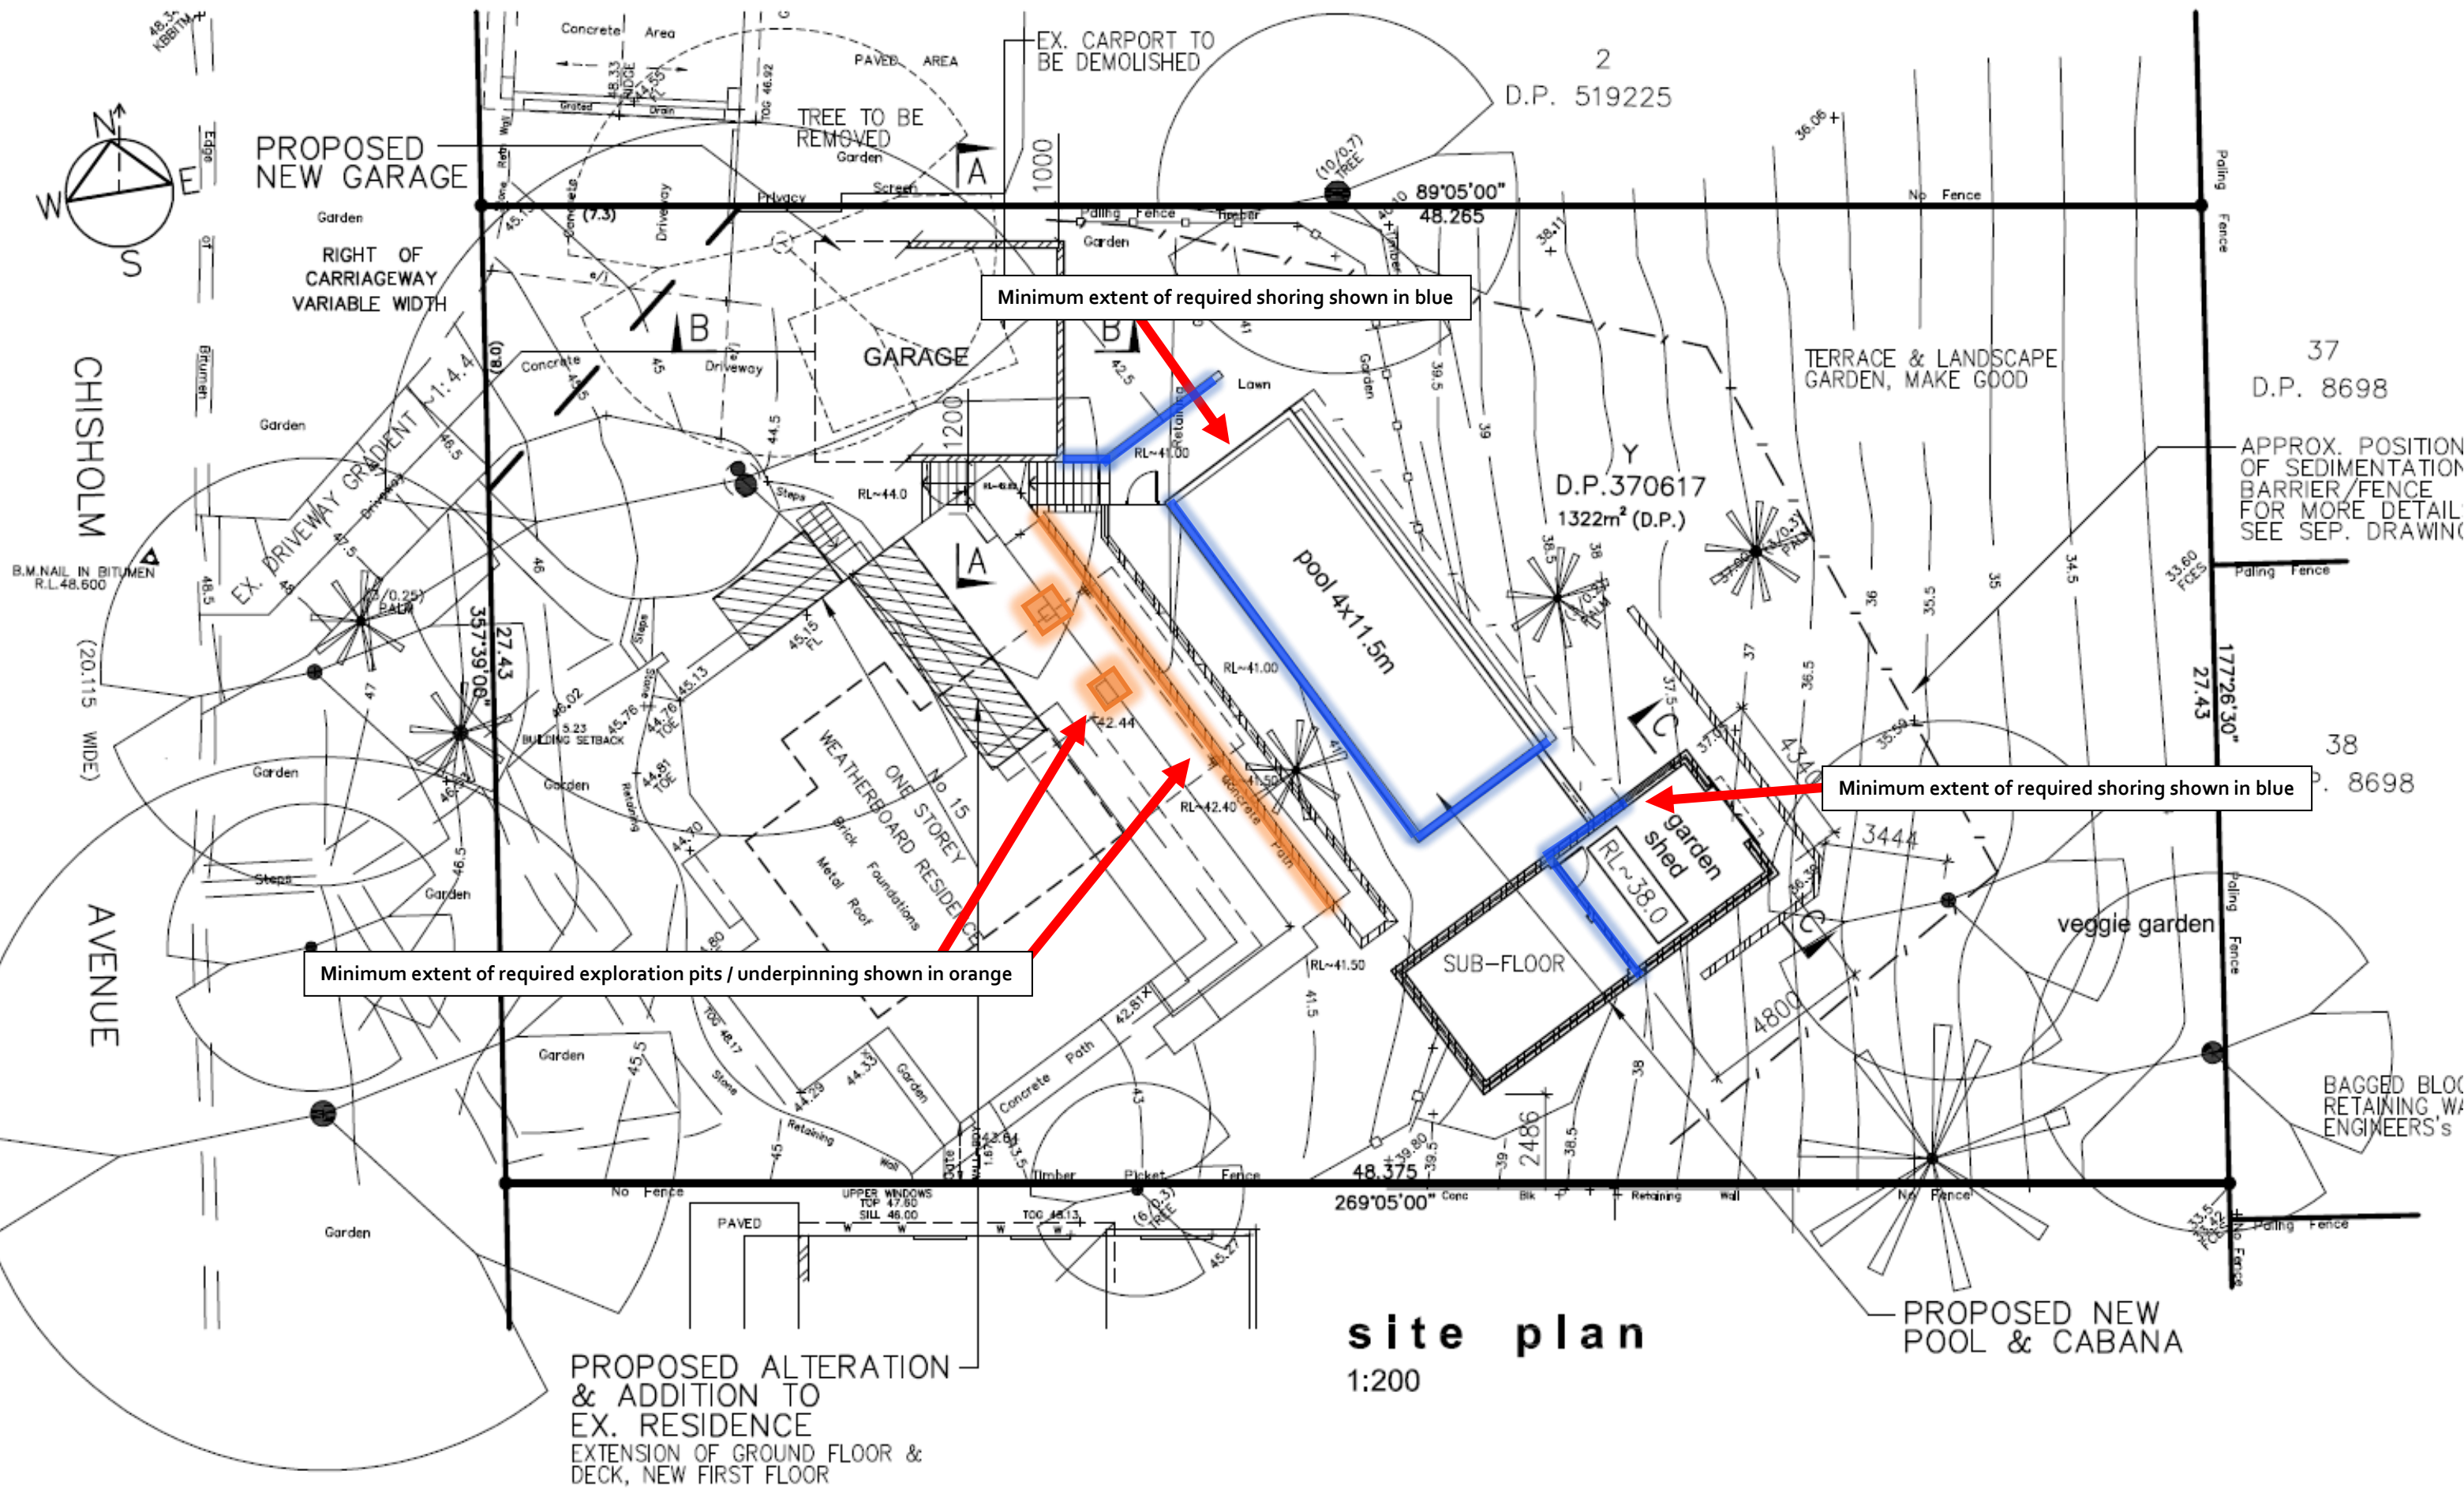
SITE PLAN – showing minimum extent of required shoring

Minimum extent of required shoring shown in blue

Due to the depth of the excavation, we recommend the SW and SE sides of the cut for the pool be temporarily supported with typical pool shoring such as braced sacrificial form ply,

until the pool structure is in place. The support will need to be designed by the structural engineer. See site plan attached for extent of minimum required shoring shown in blue.
