arboricultural site audit - may 2021

207 forest way, belrose

28th May 2021

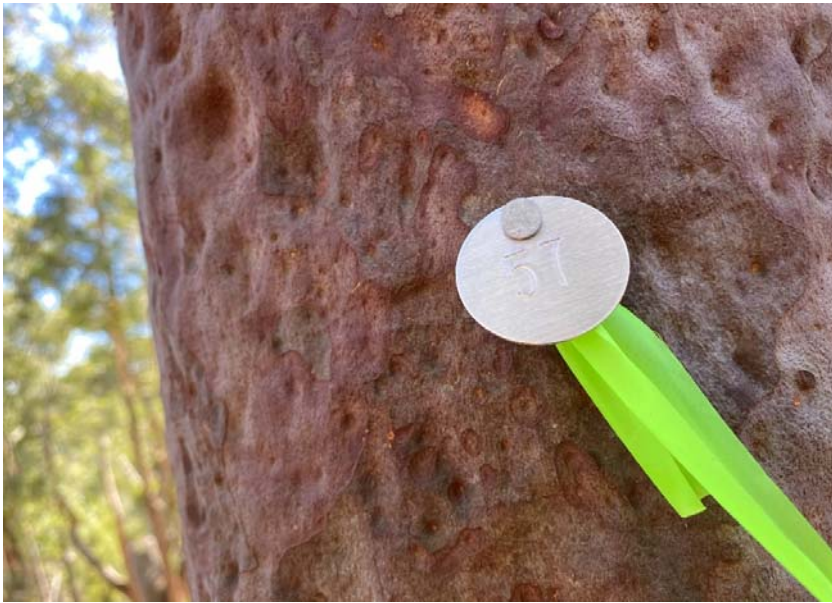
Figure 6.1 Installed tree tags with tree reference numbers of trees to be RETAINED

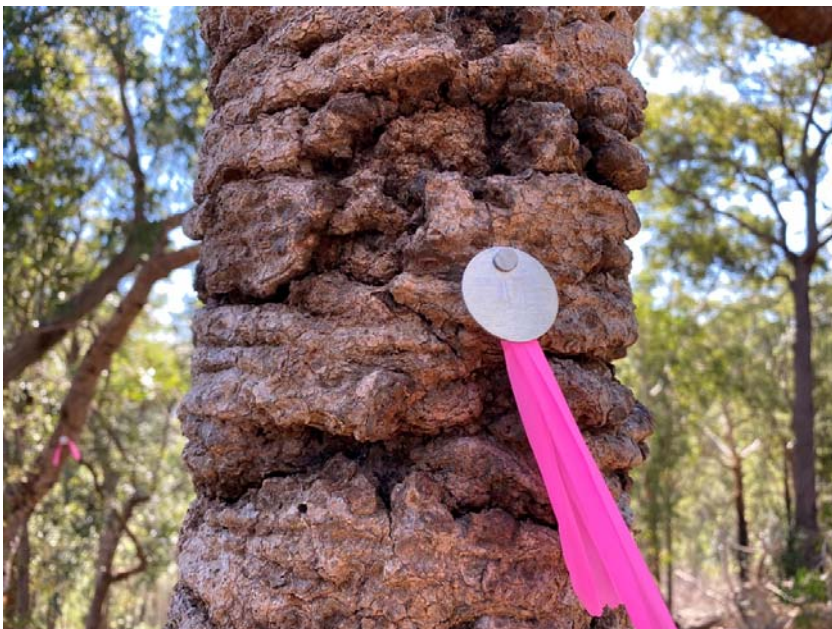
Figure 6.2 Installed tree tags with tree reference numbers of trees to be REMOVED

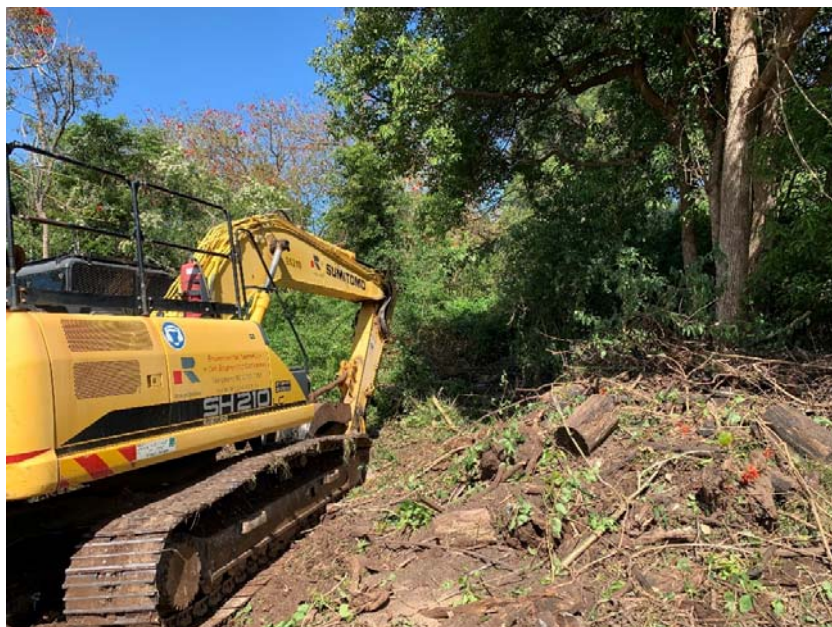
Figure 6.3 Clearing of vegetation within the unmade road reserve at the rear of 199 Forest Way, Belrose.

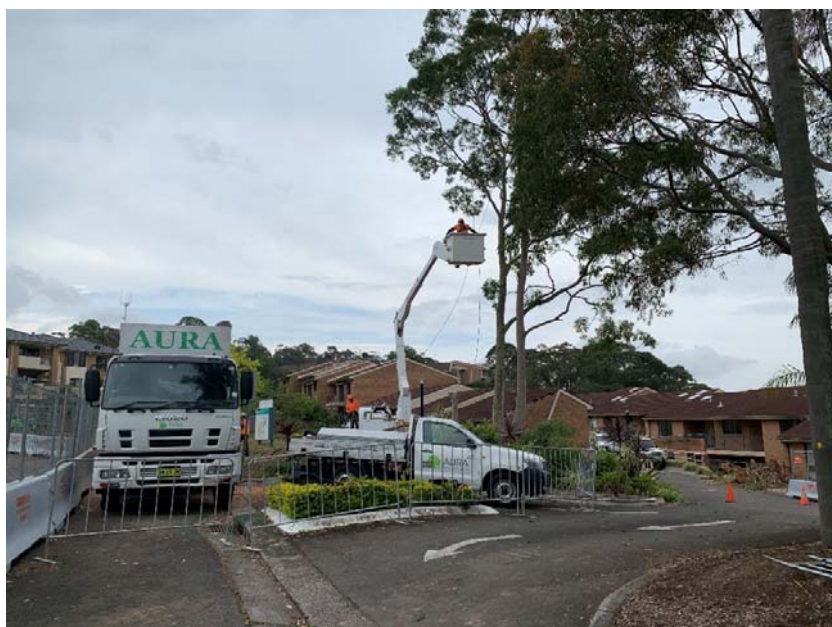
Figure 6.4 Tree removal on the site as of 29/09/20.

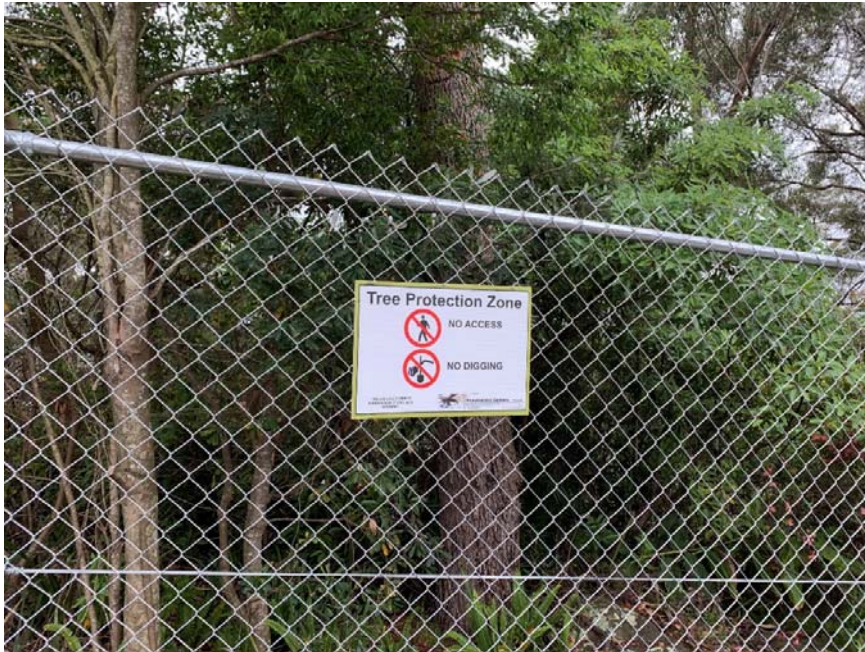
Figure 6.5 Tree Protection Fencing as of 26/10/20.

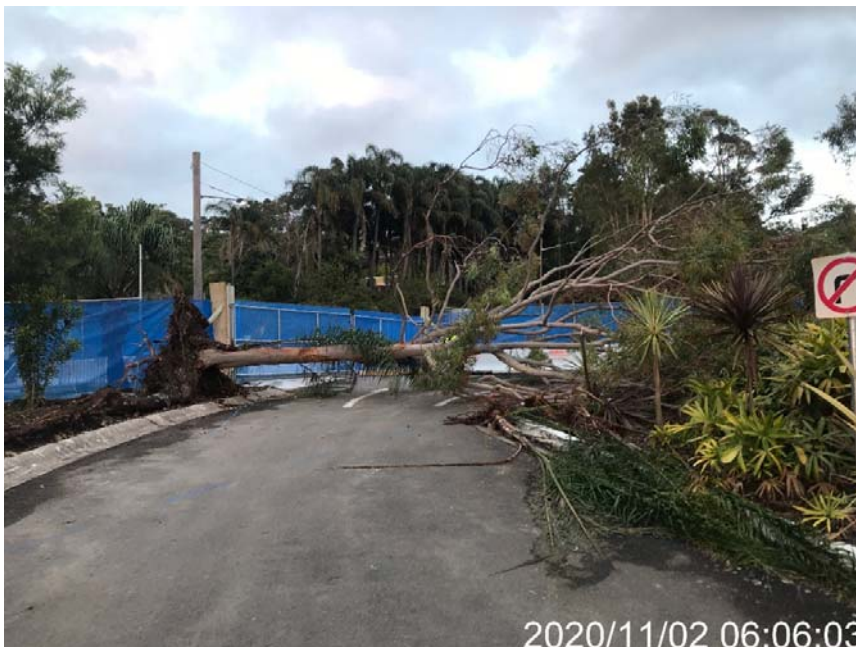
Demolition works has commenced along with the removal of a sandstone block feature wall at the entrance to the site. During a storm event over the weekend 31st October & 1st November 2020, Tree No. 126 failed at the base.

Figure 6.6 Tree No. 126 failed at the base during a storm event on 31/10-20 - 01/11/20 (photo provided by Lend Lease).

Tree No. 126 failed at the base during a storm event during 31st October & 1st November 2020. Tree protection for Tree No. 126 is therefore no longer required.

- The certifying authority note that Tree No. 126 was identified as being retained in the Arboricultural Impact Assessment (Footprint Green 31/07/2018) and this tree failed at the base during a storm event in November 2020 and no longer exists.

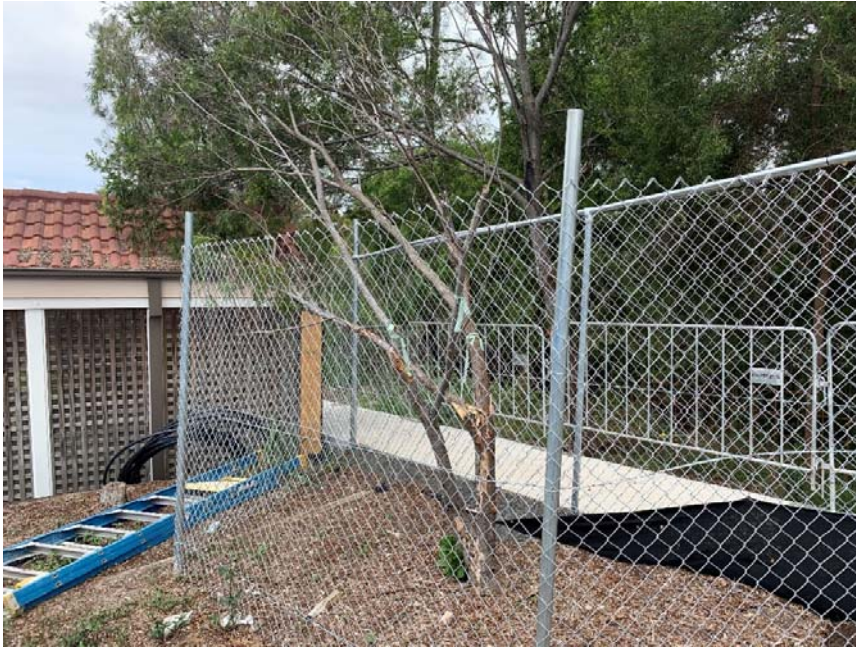
On the 30th November 2020, one of the main leaders of Tree No. 113 failed in a storm event and subsequently failed at the base. There was evidence of borer activity which is likely to have contributed to the failures.

Figure 6.7 Tree No. 113 with a failed leader during a storm event on 30/11/20.

- The certifying authority note that Tree No. 113 was identified as being retained in the Arboricultural Impact Assessment (Footprint Green 31/07/2018) and this tree suffered substantial damage during a storm event in November 2020 and is dead.

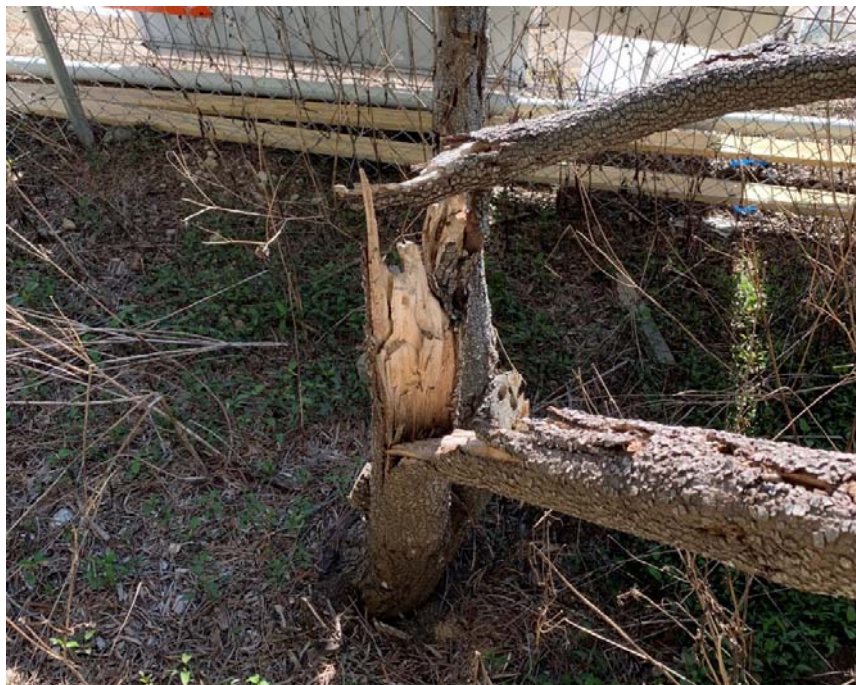
Figure 6.8 Tree No. 113 subsequently failed at the base with signs of borer activity.

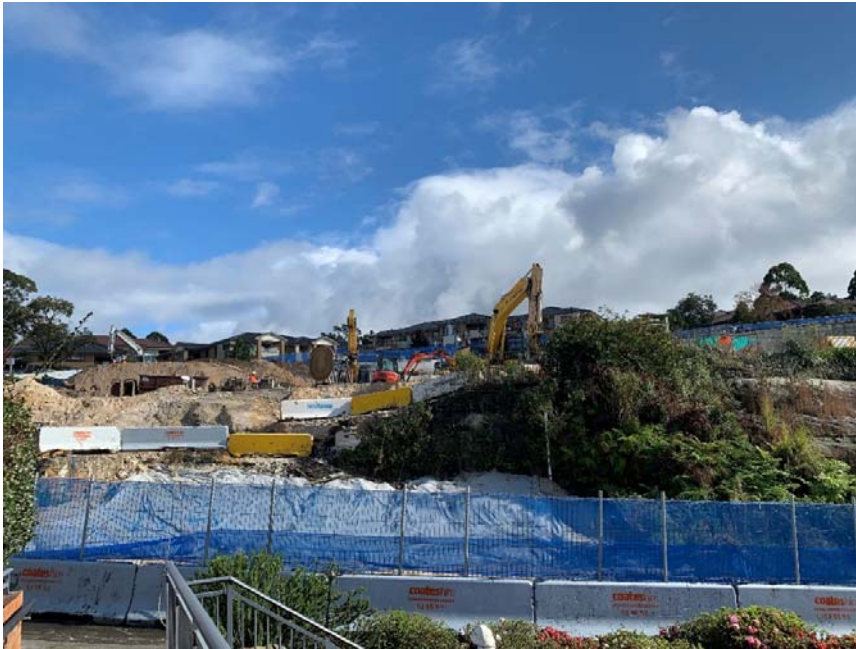
Figure 6.10 Excavation works associated with the lower levels of the main buildings as of 24/05/21.

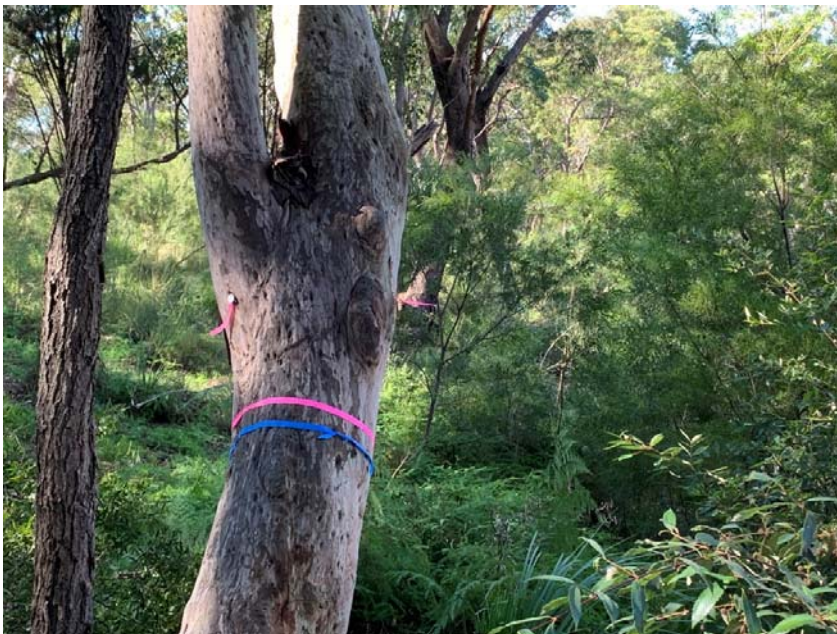
Figure 6.10 Trees identified for removal with pink banding tape with additional blue tape for trees with habitat hollows as of 17th May 2021.

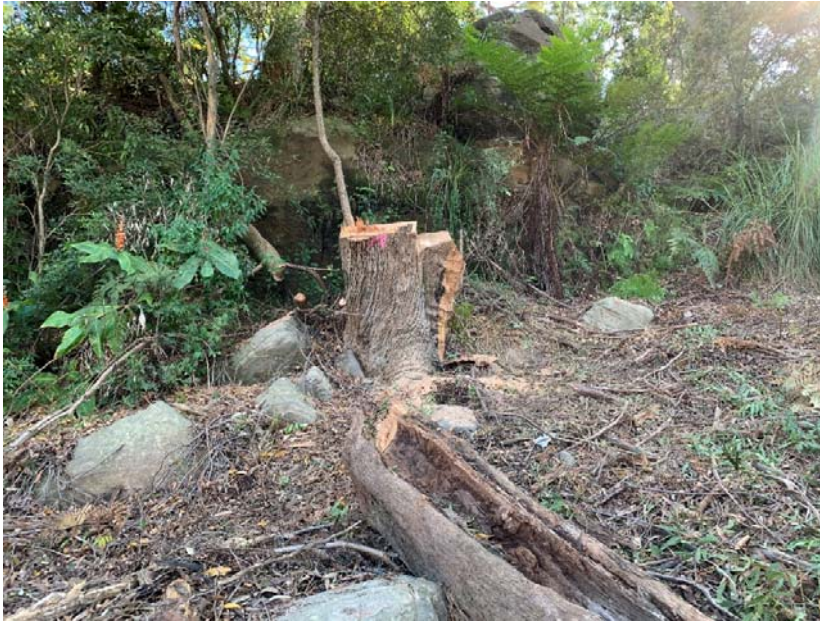
Figure 6.11 The stump remains of Tree No. 28 after tree removal works as of 28th May 2021.

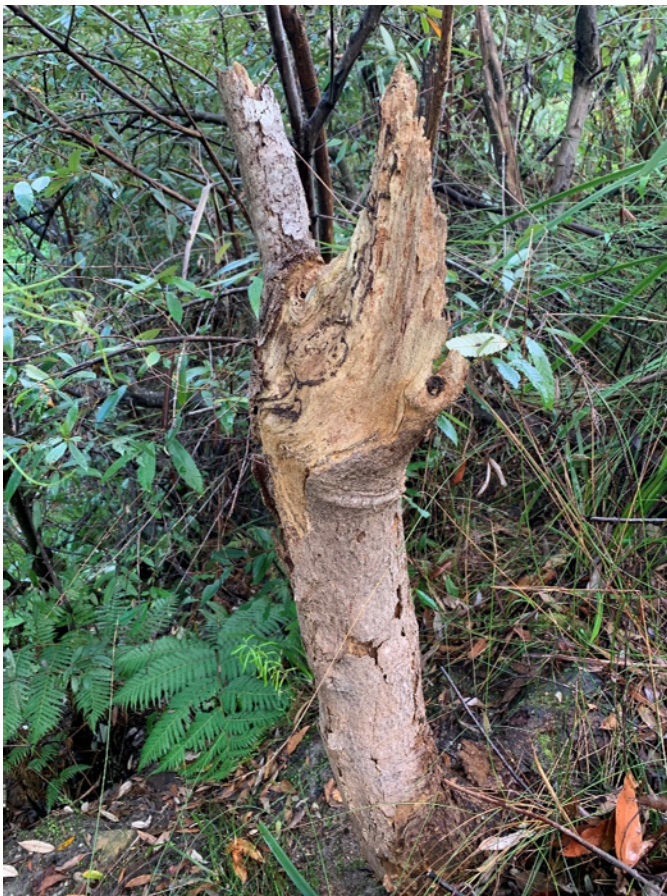
It was noted that the trunk of Tree No. 65 had failed at approximately 1.2m several months ago where decay was evident in the trunk. Tree No. 65 was identified as being removed as part of DA2018/1332.

Figure 6.12 The remains of Tree No. 65 which appears to have failed several months ago with evidence of decay in the remaining stump as of 28th May 2021.
