REPORT

316 Hudson Parade, Clareville Upgraded Boatshed Works Coastal and Marine Damages Assessment

Reference: PA1959MARP1901310938

Date: 31 January 2019

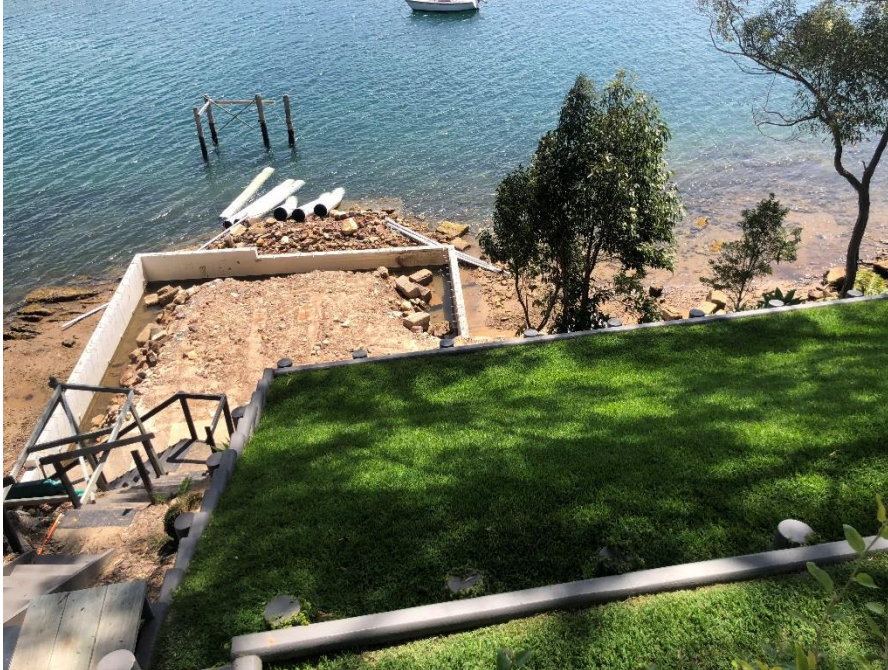
Photo 1 Dintel foundation wall enclosing demolished former boatshed. Toe of former ramp just visible below the waterline beyond the pile of demolished materials

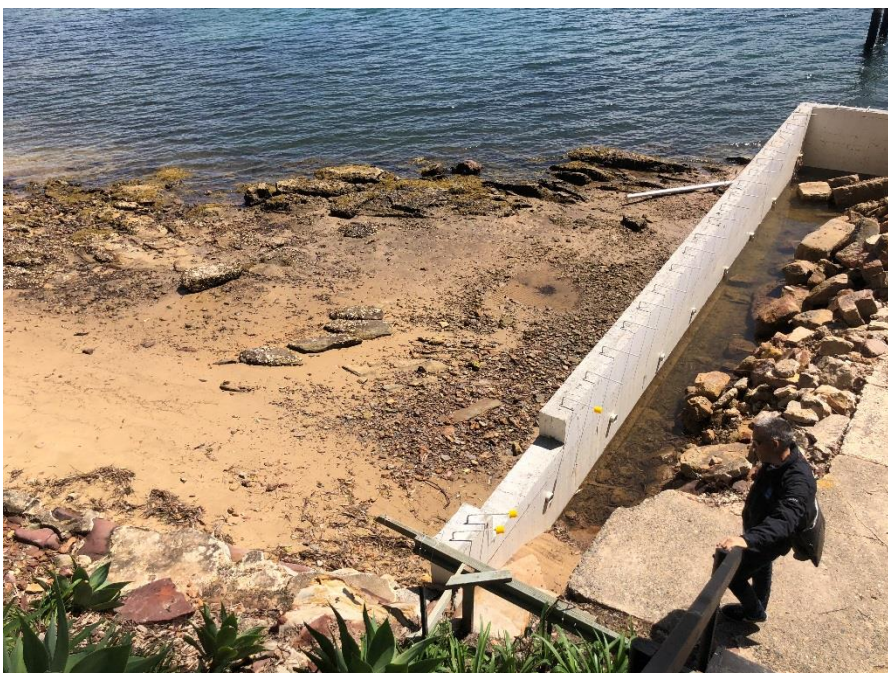
Photo 2 Southern Dintel foundation wall showing edge of rock shelf and sand overlay spread naturally from adjacent pocket beach

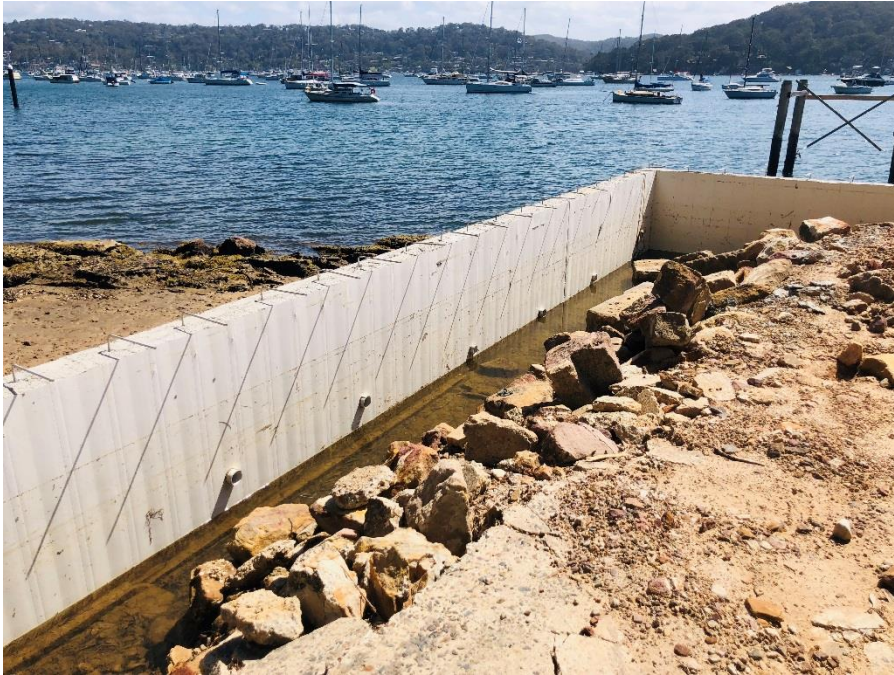
Photo 3 Southern Dincel foundation wall with outer poles of former jetty behind

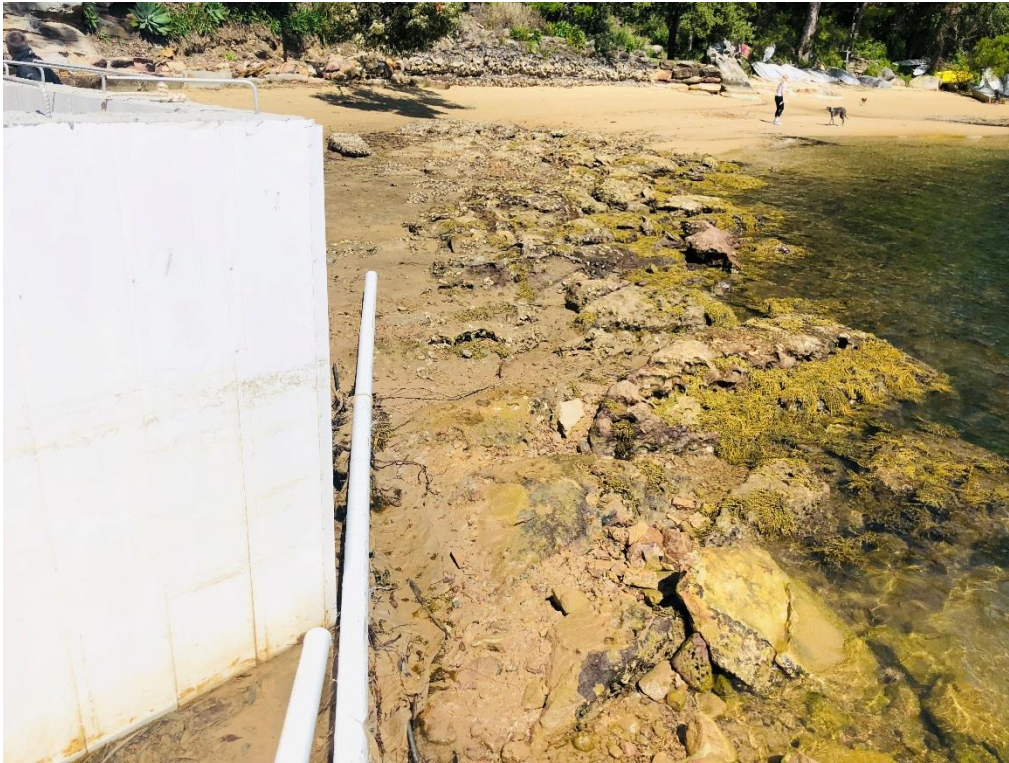
Photo 5 SW corner of Dintel foundation wall looking south showing fringing rock reef with pocket beach beyond

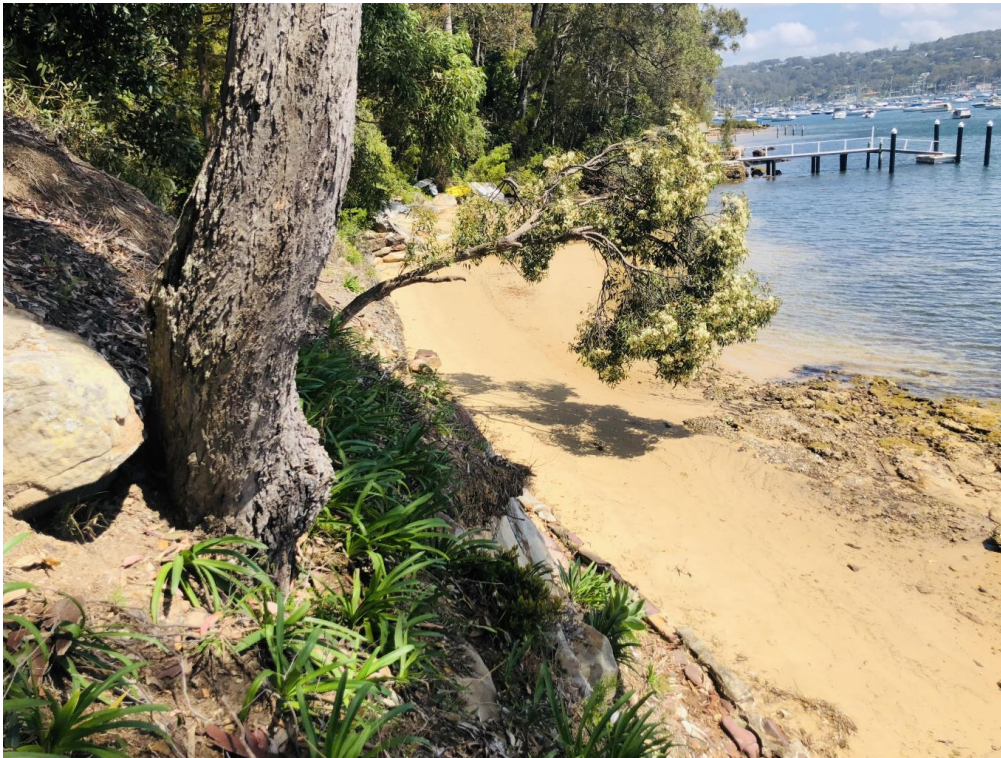
Photo 6 Pocket beach immediately south of boatshed site

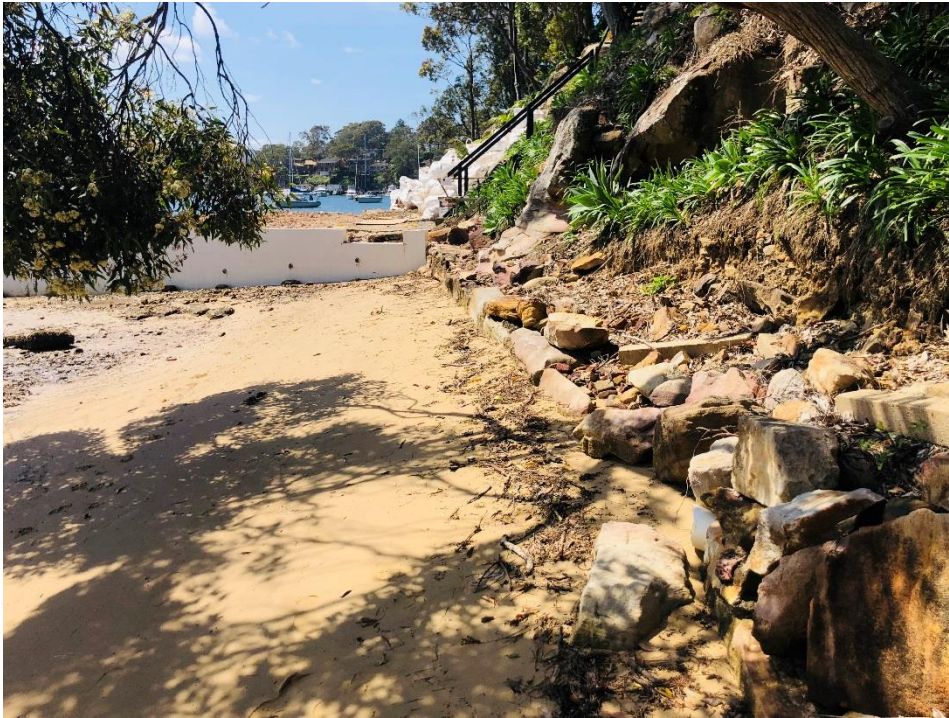
Photo 7 Pocket beach backed against dilapidated former seawall with southern Dintel foundation wall in background

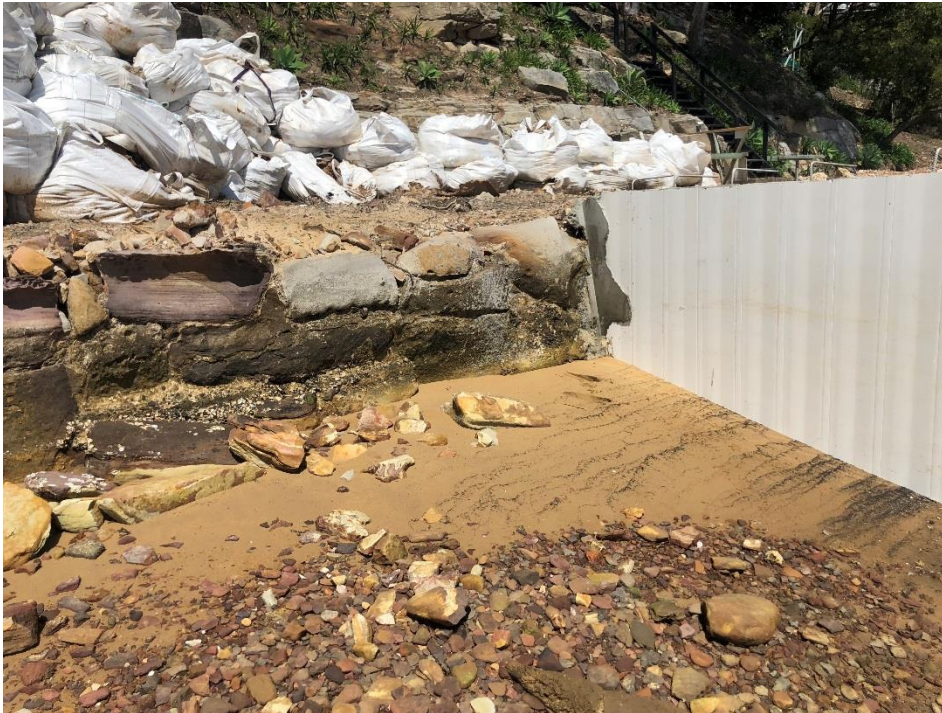
Photo 9 Minor sand fillet washed into corner against dilapidated rock seawall and northern flank of Dincel foundation wall

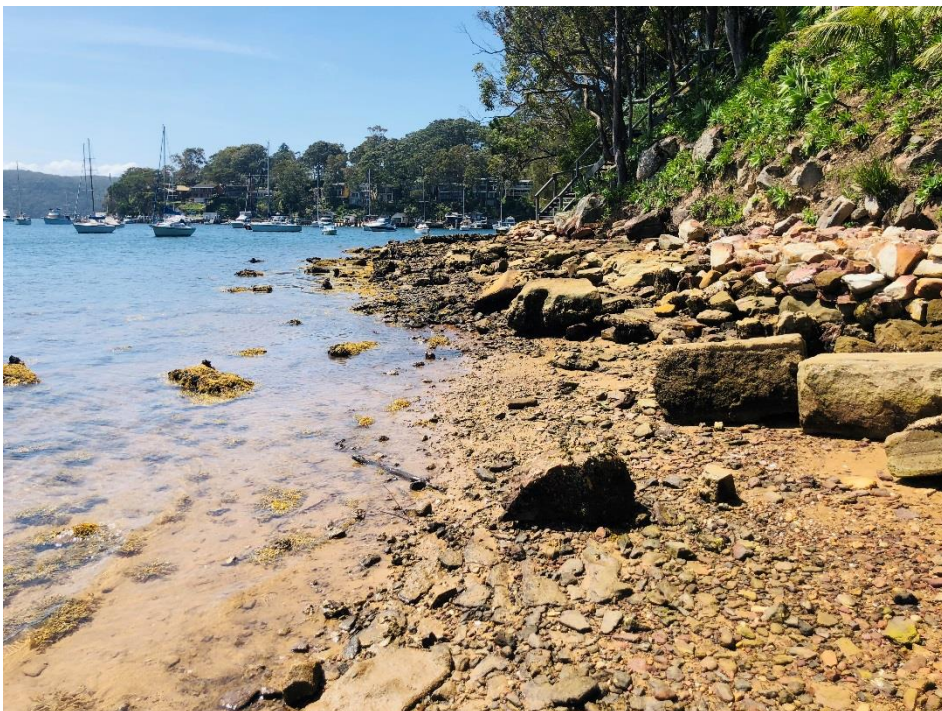
Photo 10 Rocky foreshore immediately north of boatshed site

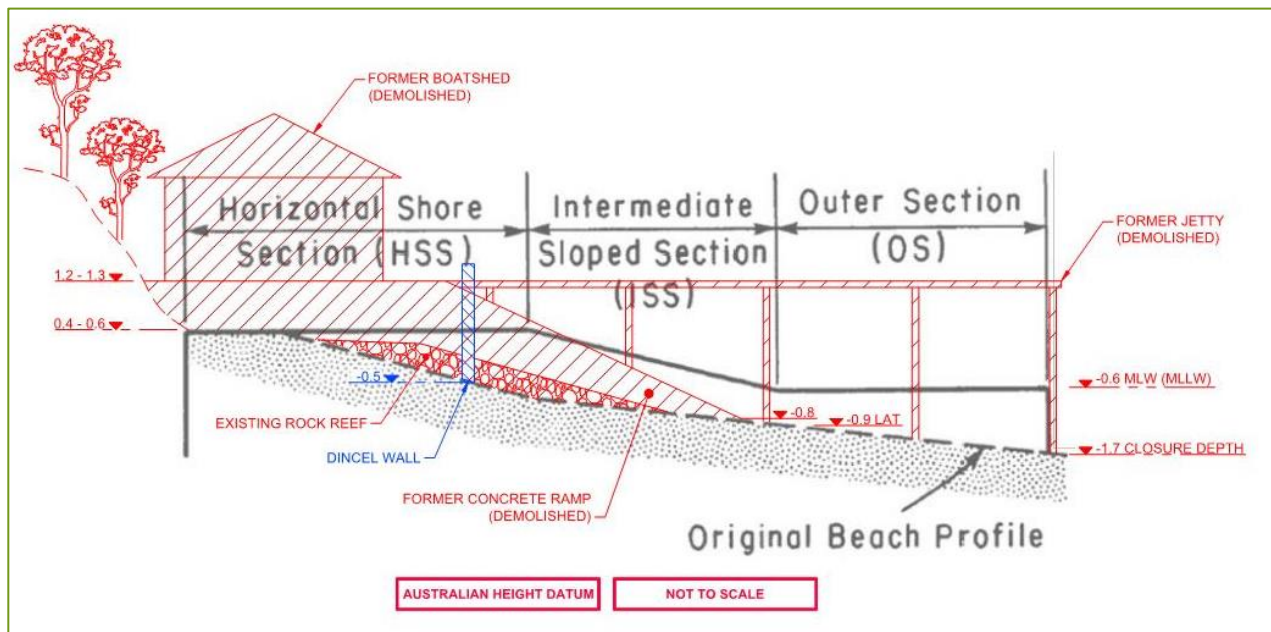
Figure 6 Theoretical sectional design of a groyne overlaid with marine structures at 316 Hudson Parade, Clareville (CERC, 1984)

In a cross shore sense the pocket beach at the site is denoted by the dashed black line extending from 0.4-0.6m AHD at the back of the beach, out to below low water. The beach is, for all intents and purposes, contained within the HSS and ISS sections. The bedrock reef protrudes above the profile of the pocket beach, and is also confined to the HSS and ISS sections.

It follows from the geometry of the cross-shore section that the bedrock reef and former boatshed present as a partial groyne. **Figure 6** shows that a theoretical groyne section, if it were to fully contain updrift sand from moving downdrift, would need to occupy the OS out to a “closure level” calculated as -1.7m AHD (**Section 5.4**). While the former timber jetty did extend out this far, it was a suspended structure hence permeable to sand movement so would have provided no groyne retention function.

Importantly for the reason 5 matter, the Dintel walls are effectively located inside the HSS. While they may have a slightly higher elevation than the former boatshed floor level of 1.2-1.3m AHD, their influence as a groyne on littoral drift (or longshore sediment transport) would exhibit no material difference to that compared to the former boatshed and ramp structures.
