J4920A. 2nd May, 2024 Page 1.

6 Net Road, Avalon

Comments on Updates to Plans

Alterations and Additions at 6 Net Road, Avalon

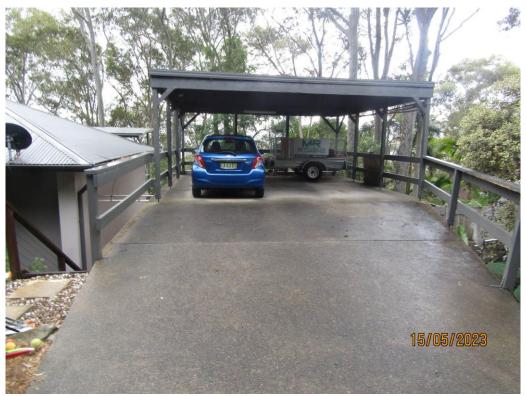
Photo 1

2.3 At the road frontage, a concrete driveway runs to a carport with rendered

masonry studio below on the E side of the house (Photos 1 & 2). The external walls

supporting the studio show no significant signs of movement. Another concrete

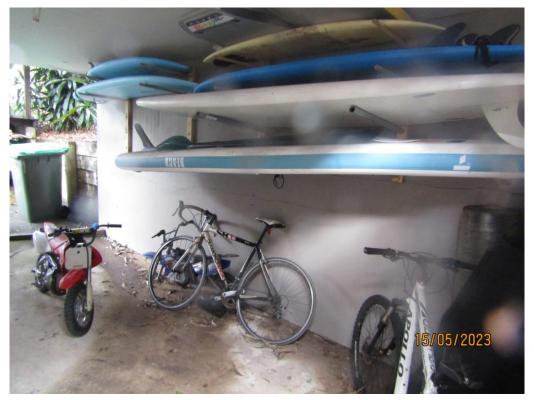
Photo 3

driveway runs to the E side of the carport and to a storage area on the uphill side of

the studio (Photos 3 & 4). A cut provides a level platform for the driveway and storage

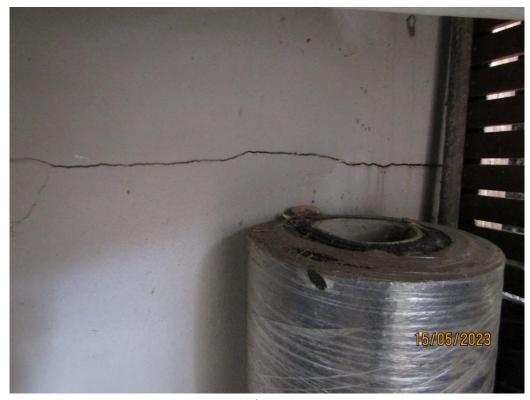
Photo 4

area. The cut is supported by timber and rendered masonry retaining walls up to

~1.5m high. The timber retaining wall displays minor bulging and the rendered

masonry wall displays two horizontal cracks (Photos 4 & 5). See 'Section 17 Ongoing

The bulging timber retaining wall and cracked rendered masonry wall (Photos 2 to 4) are to

be monitored by the owners on an annual basis or after heavy and prolonged rainfall events,

whichever occurs first. A photographic record of these inspections is to be kept. Should

further movement occur the walls are to be remediated so they meet current engineering

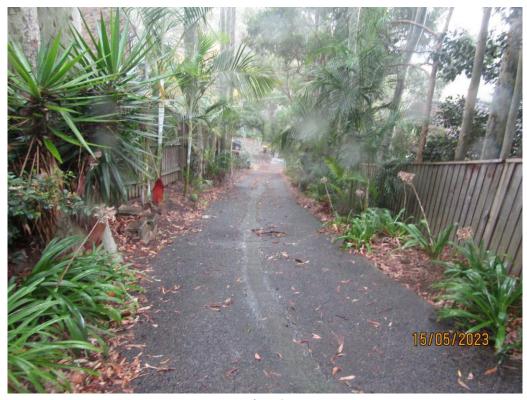
Photo 6

Maintenance'. A gravel and concrete driveway on the W side of the house runs from

Net Road to a turning area on the NW side of the house and runs down the slope to

the NW before reaching Gunyah Place (Photos 6 & 7).

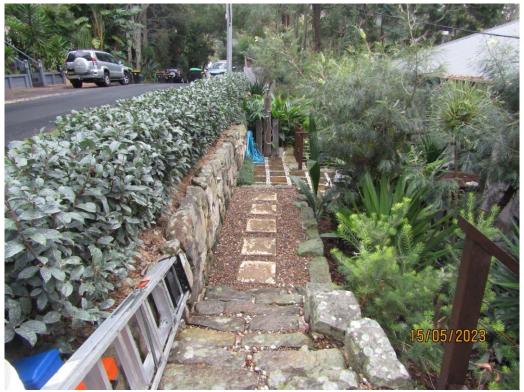
Photo 7

Cuts and fills provide level platforms for garden areas on the uphill side of the house

and a level platform for the lower floor of the house. The cuts and fills are supported

by stable sandstone block and rendered masonry retaining walls up to ~1.5m high

(Photos 7 to 8). The two storey rendered masonry house is supported by masonry

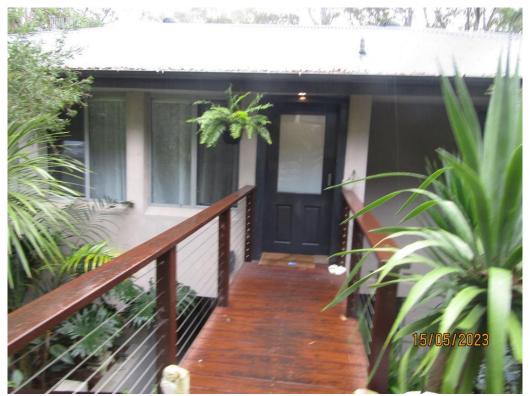
Photo 9

walls (Photos 9 & 10). The external supporting walls show no significant signs of

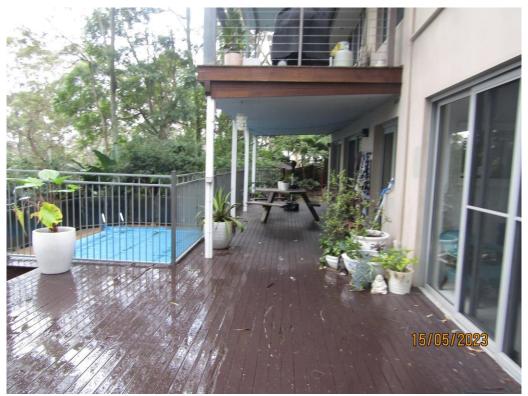
Photo 11

movement. A timber deck and stable pool are located on the downhill side of the

house (Photo 11). No signs of slope instability were observed on the property. The

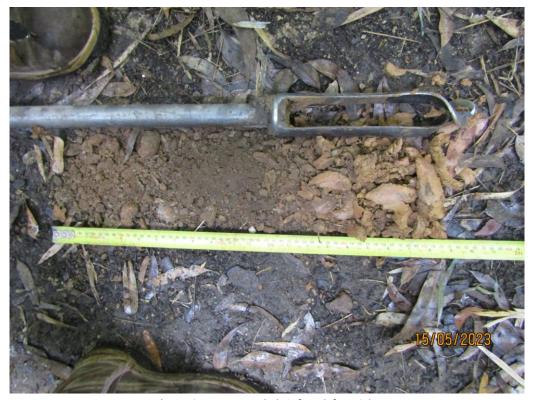
AUGER HOLE 1 (~RL31.5) – AH1 (Photo 12)

Depth (m)	Material Encountered
0.0 to 0.2	FILL, soil and clay, brown, dry, fine to coarse grained.
0.2 to 0.4	TOPSOIL, dark brown, dry, fine to medium grained.
0.4 to 0.5	CLAY, orange brown, firm to stiff, dry.

End of Hole @ 0.5m in firm to stiff clay. No watertable encountered.

Photo 12: AH1 – Downhole is from left to right.
