## *Arboricultural Impact Assessment & Tree Protection Plan*

Commissioned by: Dick Crampton

Site: 918 Barrenjoey Road Palm Beach 2108

Date of Inspection: 18 August 2021

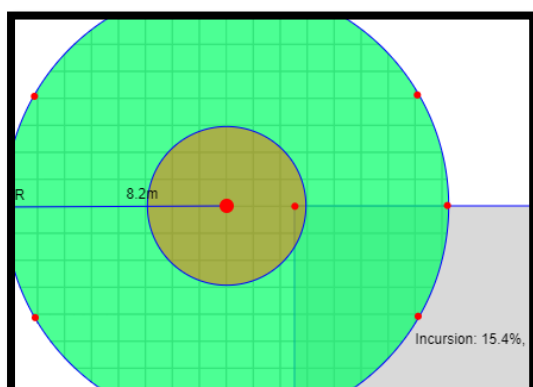
Figure 3 - Tree 2 Incursion calculation

The mature Sydney Peppermint tree is growing on the shared property boundary with the majority within 920 Barrenjoey Road and is considered a priority for removal. This tree is growing on a 45 degree lean towards the South. The lean appears to have corrected itself overtime as most of the canopy from 15 metres above ground level is up right. This heavily phototropic lean is putting significant strain on the tension roots of the tree within the loamy sand. The canopy of the tree is in fair health, however, it is sparse. The tree contains over 30% deadwood with significant tip dieback within every branch in the canopy. This tree has poorly structured branch unions throughout the overextended stem. With most of the canopy over the existing dwelling and over the proposed dwelling, it falls in a moderate risk category. The excavations required for the installation of the inclinor, side access and proposed dwelling will have a significant impact on the SRZ and TPZ of this tree (figure 3). The proposed construction will have an irreversible effect on this tree.

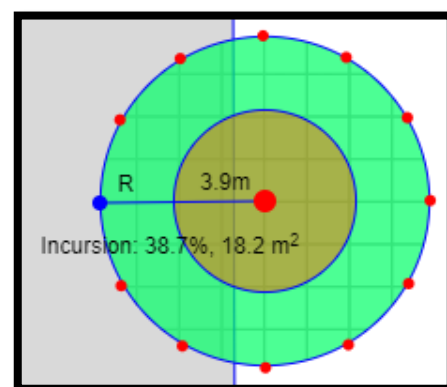
Figure 1 - Tree 3 Incursion Calculation

The mature Red Bloodwood tree is growing on the shared property boundary with 916 Barrenjoey Road. This tree is in good health and good structure with no obvious defects. The tree is growing at 2.8 metres from the external wall of the current dwelling within the site. The canopy of the tree has been significantly crown raised to accommodate both dwellings in proximity of this tree. The canopy of the tree is in good health and good structure with no obvious defects. The tree has 30% epicormic growth, likely as a result of reduced sunlight availability from the surrounding canopy trees to the north. The construction of the proposed dwelling will be 95cm from the base of the tree at ground level. This is an unacceptable incursion of 38% within the structural root zone of this tree. Significant design modifications will be required to retain this tree; however, this is not considered a viable option due to the trees low landscape and low retention value. This tree is considered a priority for removal.
