**RE: DA NO: 170/09**  
**111 NORTH STEYNE, MANLY NSW**

The certificate relates to the erection of a new four storey residential flat building with Basement carparking at the above address, and has been issued for CC1: Excavation and shoring only.

The development at 111 North Steyne Road comprises the demolition of an existing 3 level apartment block and the construction of a 4 level apartment block with underground car parking. It is noted that the development is hand demolishing and providing a continuous shoring wall to the basement. These building techniques are designed to minimize any possible affect to the neighbours .

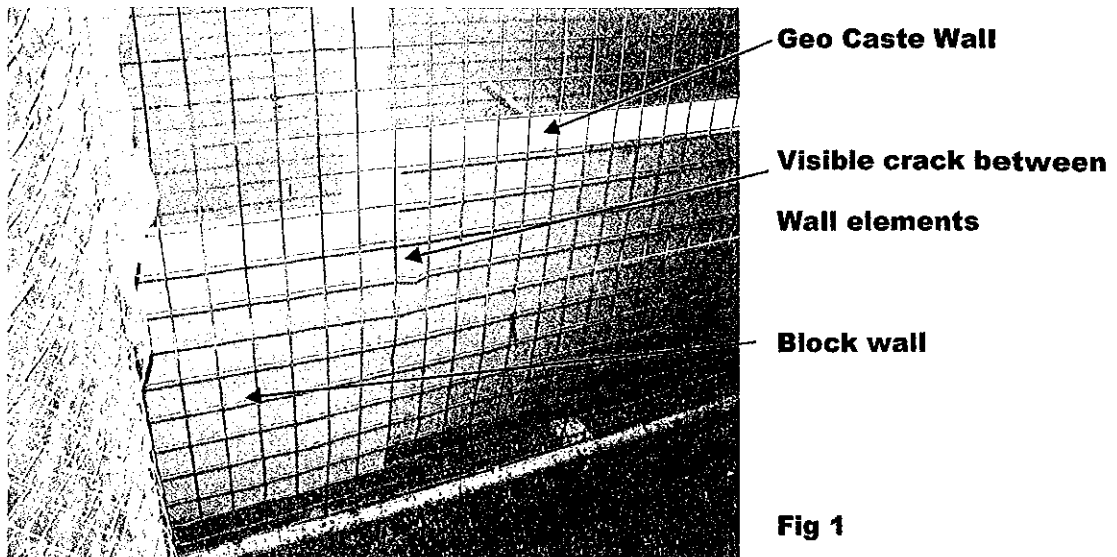
From North Steyne Road to the driveway wall numerous shrinkage cracks are evident. These cracks by the detritus in them and staining have been present for a long time. No construction joints have been installed in this wall.

The junction of the Geo Caste wall and the driveway block wall has an expansion joint but this has separated in places from the Geo caste wall

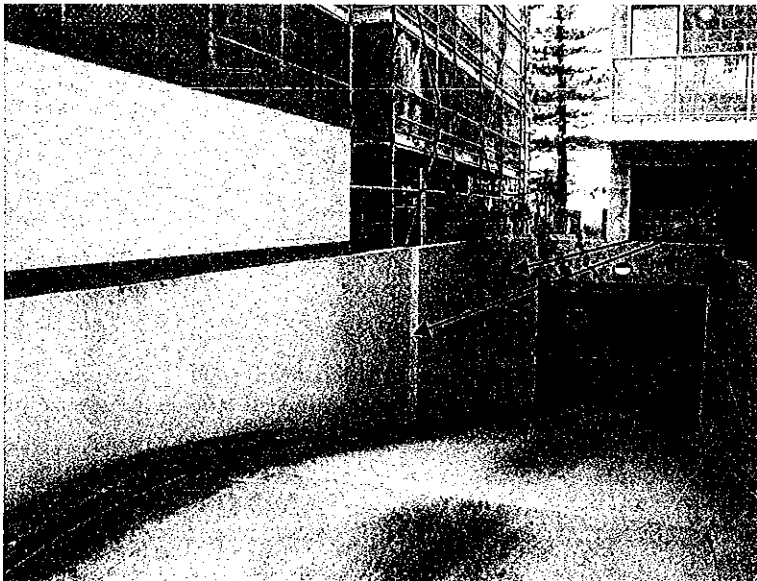
**Fig 3**

**Driveway block wall**  
**Has numerous shrinkage**  
**Cracks**

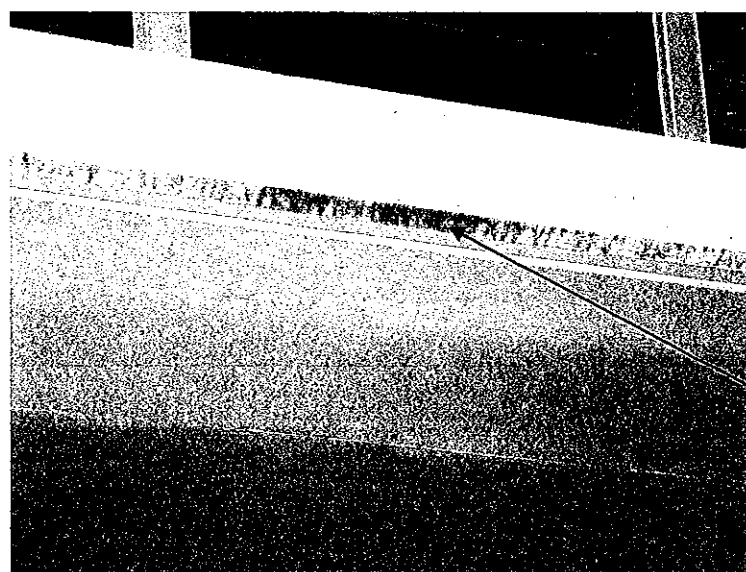
**Fig 5**

**The exterior of the building**  
**Is free of visible cracks but**  
**has some salt and fungal**  
**staining. Rust stains from**  
**construction tie wires are**  
**evident in some spots.**

**Fungal stain**

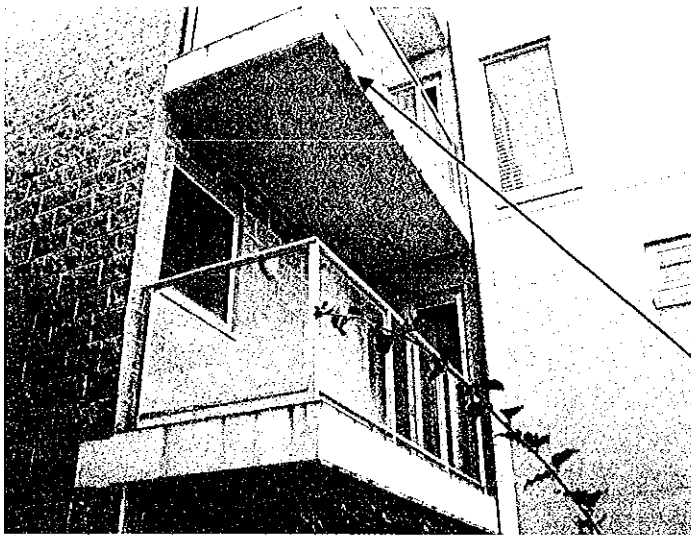
Fig 6

The exterior of the building is free of visible cracks but has some salt and fungal staining. Rust stains from construction tie wires are evident in some spots.

Stains to decks

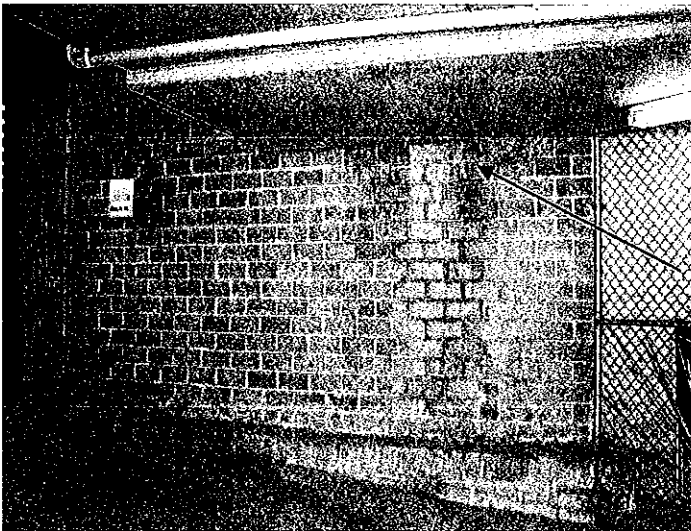
Fig 7

Basement car park showing Boundary wall. The skin masonry wall hides the actual boundary wall. No obvious defects are evident apart from some water seepage from the balcony above.

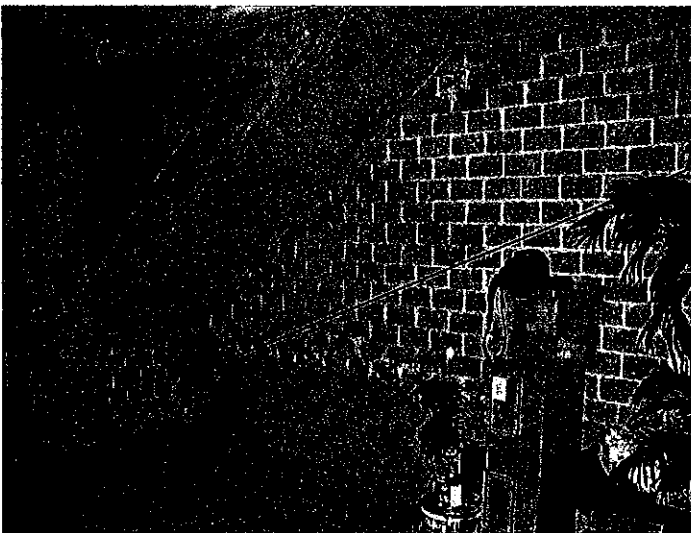
Fig 8

Mid section of basement boundary wall. No obvious defects showing on the masonry skin wall apart from minor seepage

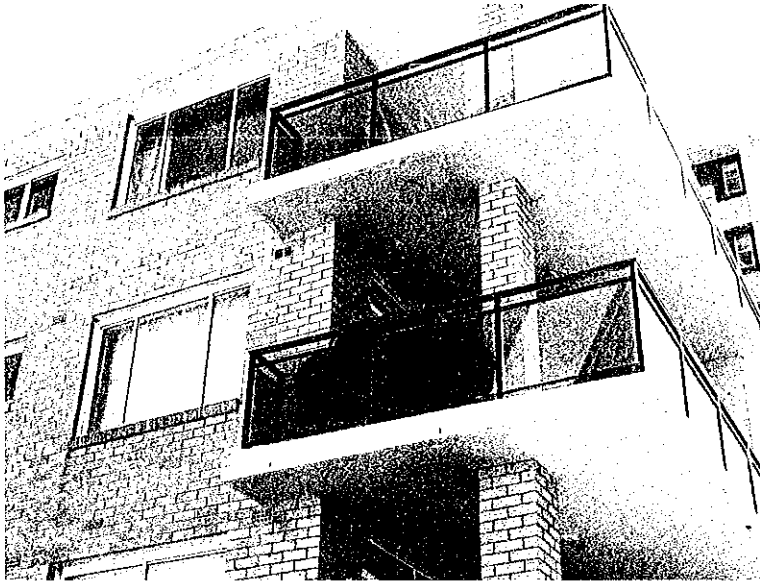
**Fig 9**

The building is in generally good condition with no visible cracks in the masonry walls. The balconies do exhibit areas of concrete cancer and rust marks from construction tie wire. Numerous arch bars over the windows exhibit mild corrosion,

**Balconies exhibit areas of concrete cancer and tie wire rust marks**

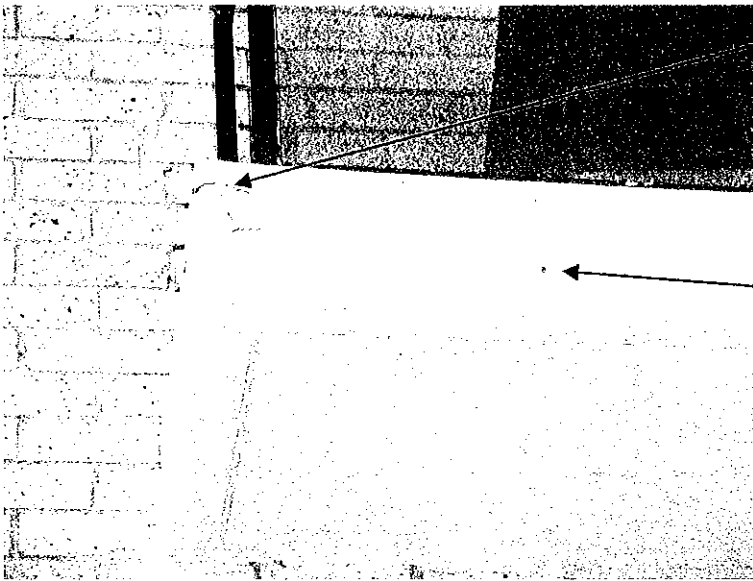
**Fig 10**

**Concrete cancer**

**Tie wire rust mark**

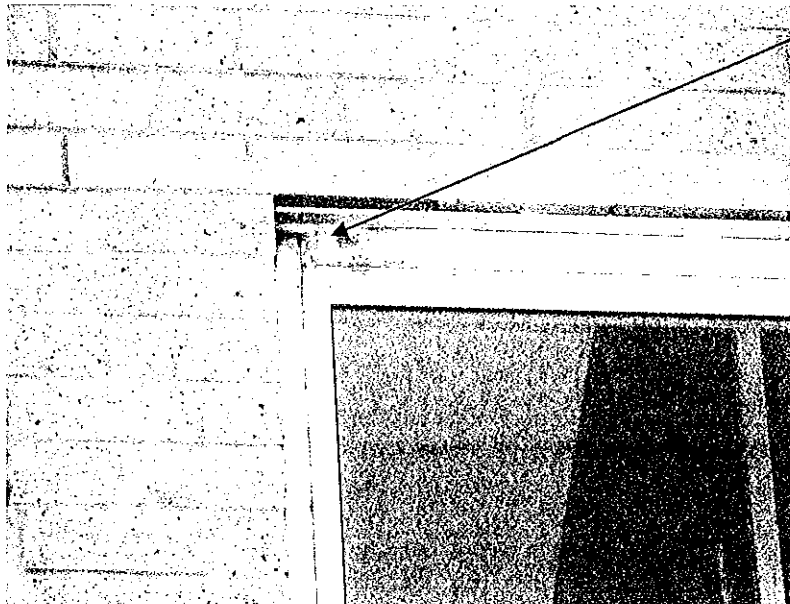
**Fig 12**

**Corrosion on arch bars**

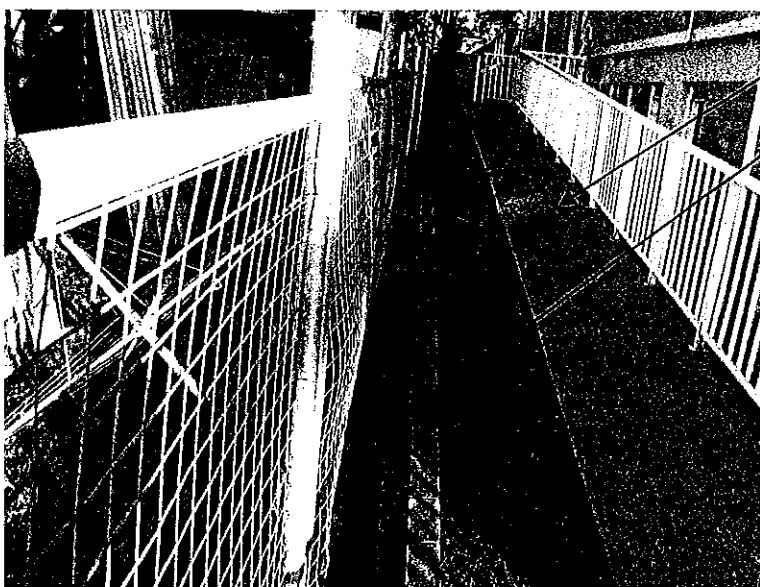
**Fig 14**

The building has a raised path on the boundary with the subject site to enable entry to the lobby over the ground floor car park. This pathway has a masonry retaining wall on the boundary which has a 100mm lean on it caused by the lateral pressure of the fill it is retaining. No cracks are yet visible in this wall.

**Raised entry pathway with boundary masonry retaining wall leaning in 100mm into the subject site.**

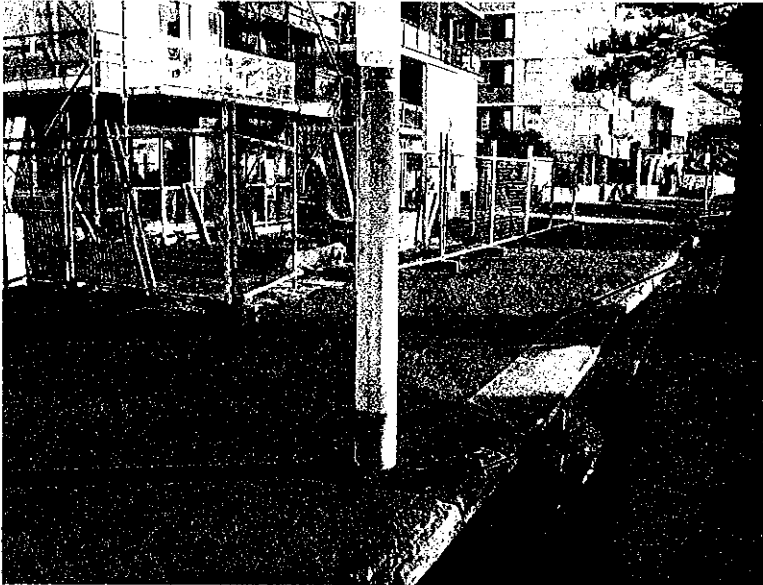
**Fig 15**

The pathway, driveway and gutter have numerous defects of potholes, land movement and settlement.

**Bitumen pathway, driveway and kerbing has numerous defects of cracks and settlement**

**Potholes**

**Cracks**

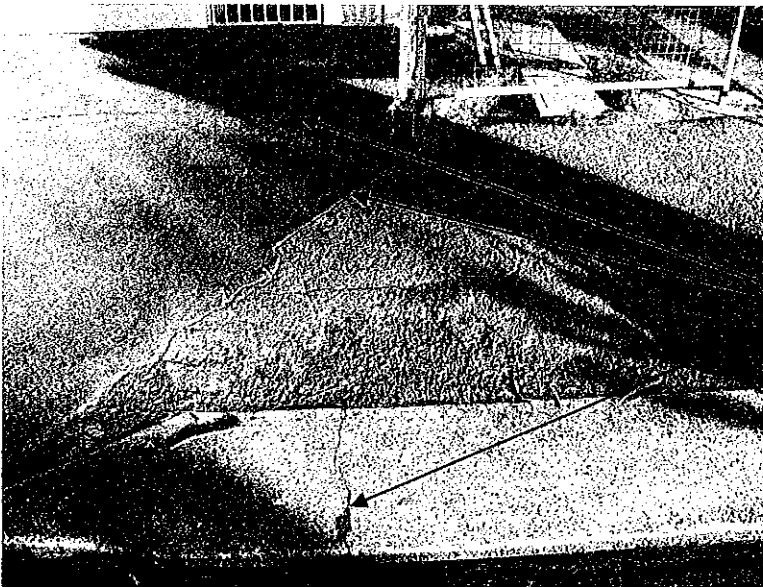
**Fig 16**

**Pathway at boundary of 110 & 111 North Steyne Road.**

**Cracks**

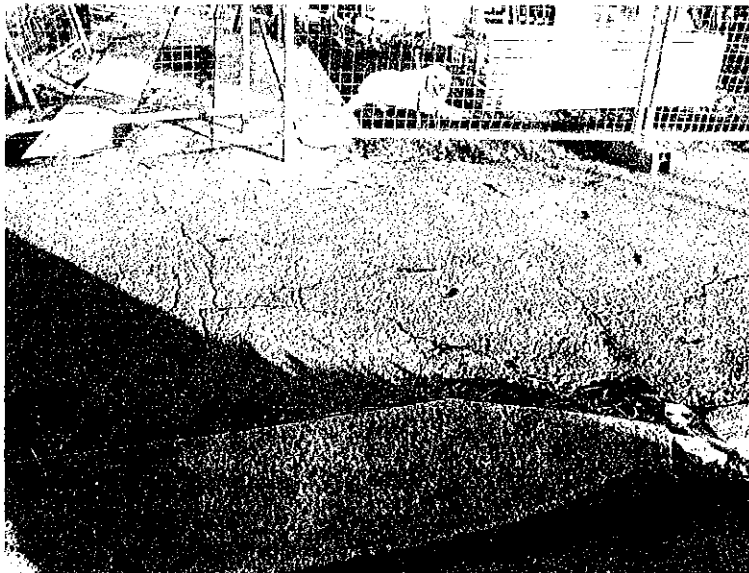
**Fig 17**

**Subject lands driveway showing state of repair of threshold and bitumen pavement**

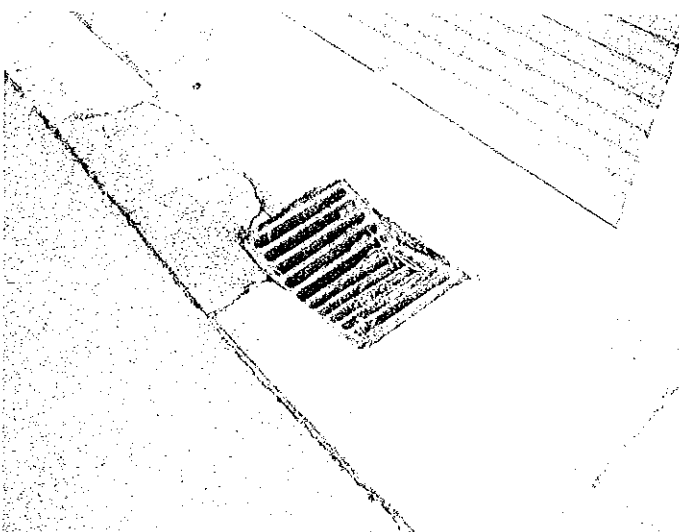
**Fig 24**

The rear lane to the subject land is known as Pine lane. It has no pedestrian pavements or kerbing. A storm water dish drain is installed to each edge of the lane and on the subject sites southern boundary a storm water grill and trap is installed. The metal grate supports to this drain have failed and the grate at the moment is supported on bricks.

**Failed grate and trap. Dish drain is cracked**

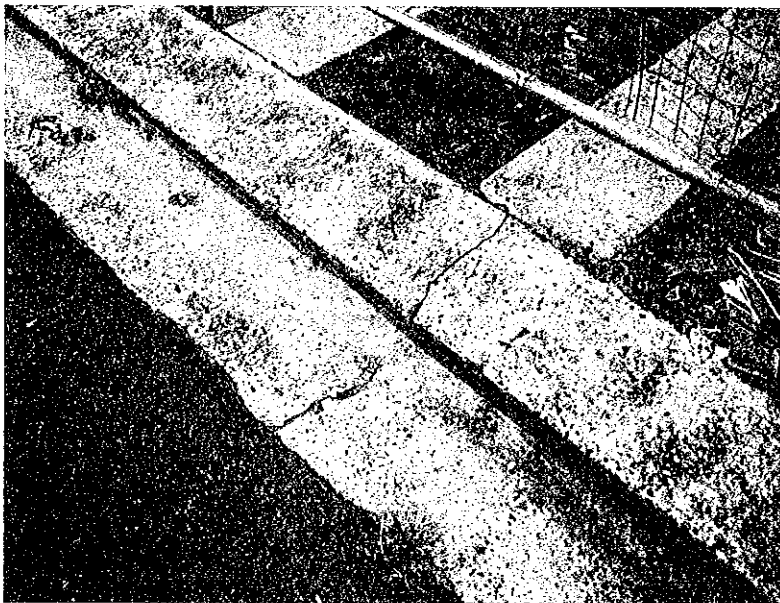
**Fig 26**

**Cracks of Dish Drain and grate in middle of site**

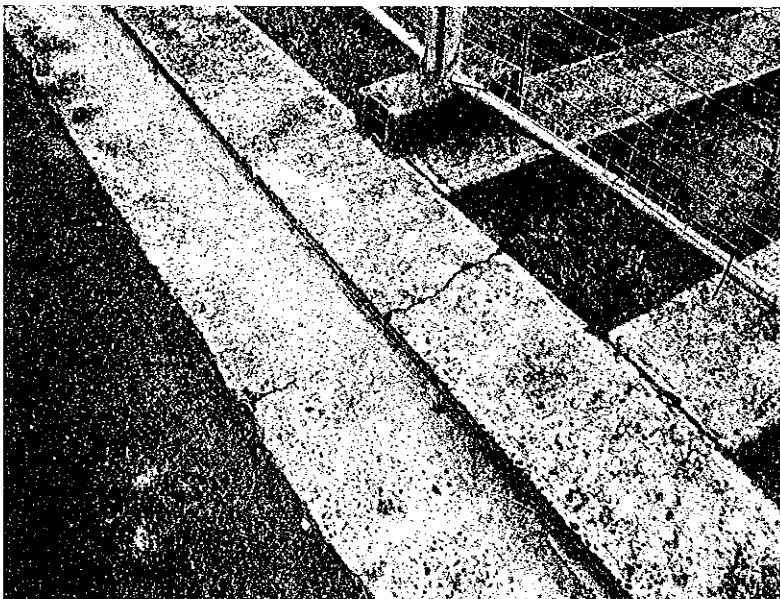
**Fig 27**

**Cracks of Dish Drain and grate in middle of site**
