# Geotechnical Assessment

**Project:** Alterations & Additions  
1 Kimo Street, North Balgowlah NSW

**Ref:** AG 25280  
4 July 2025

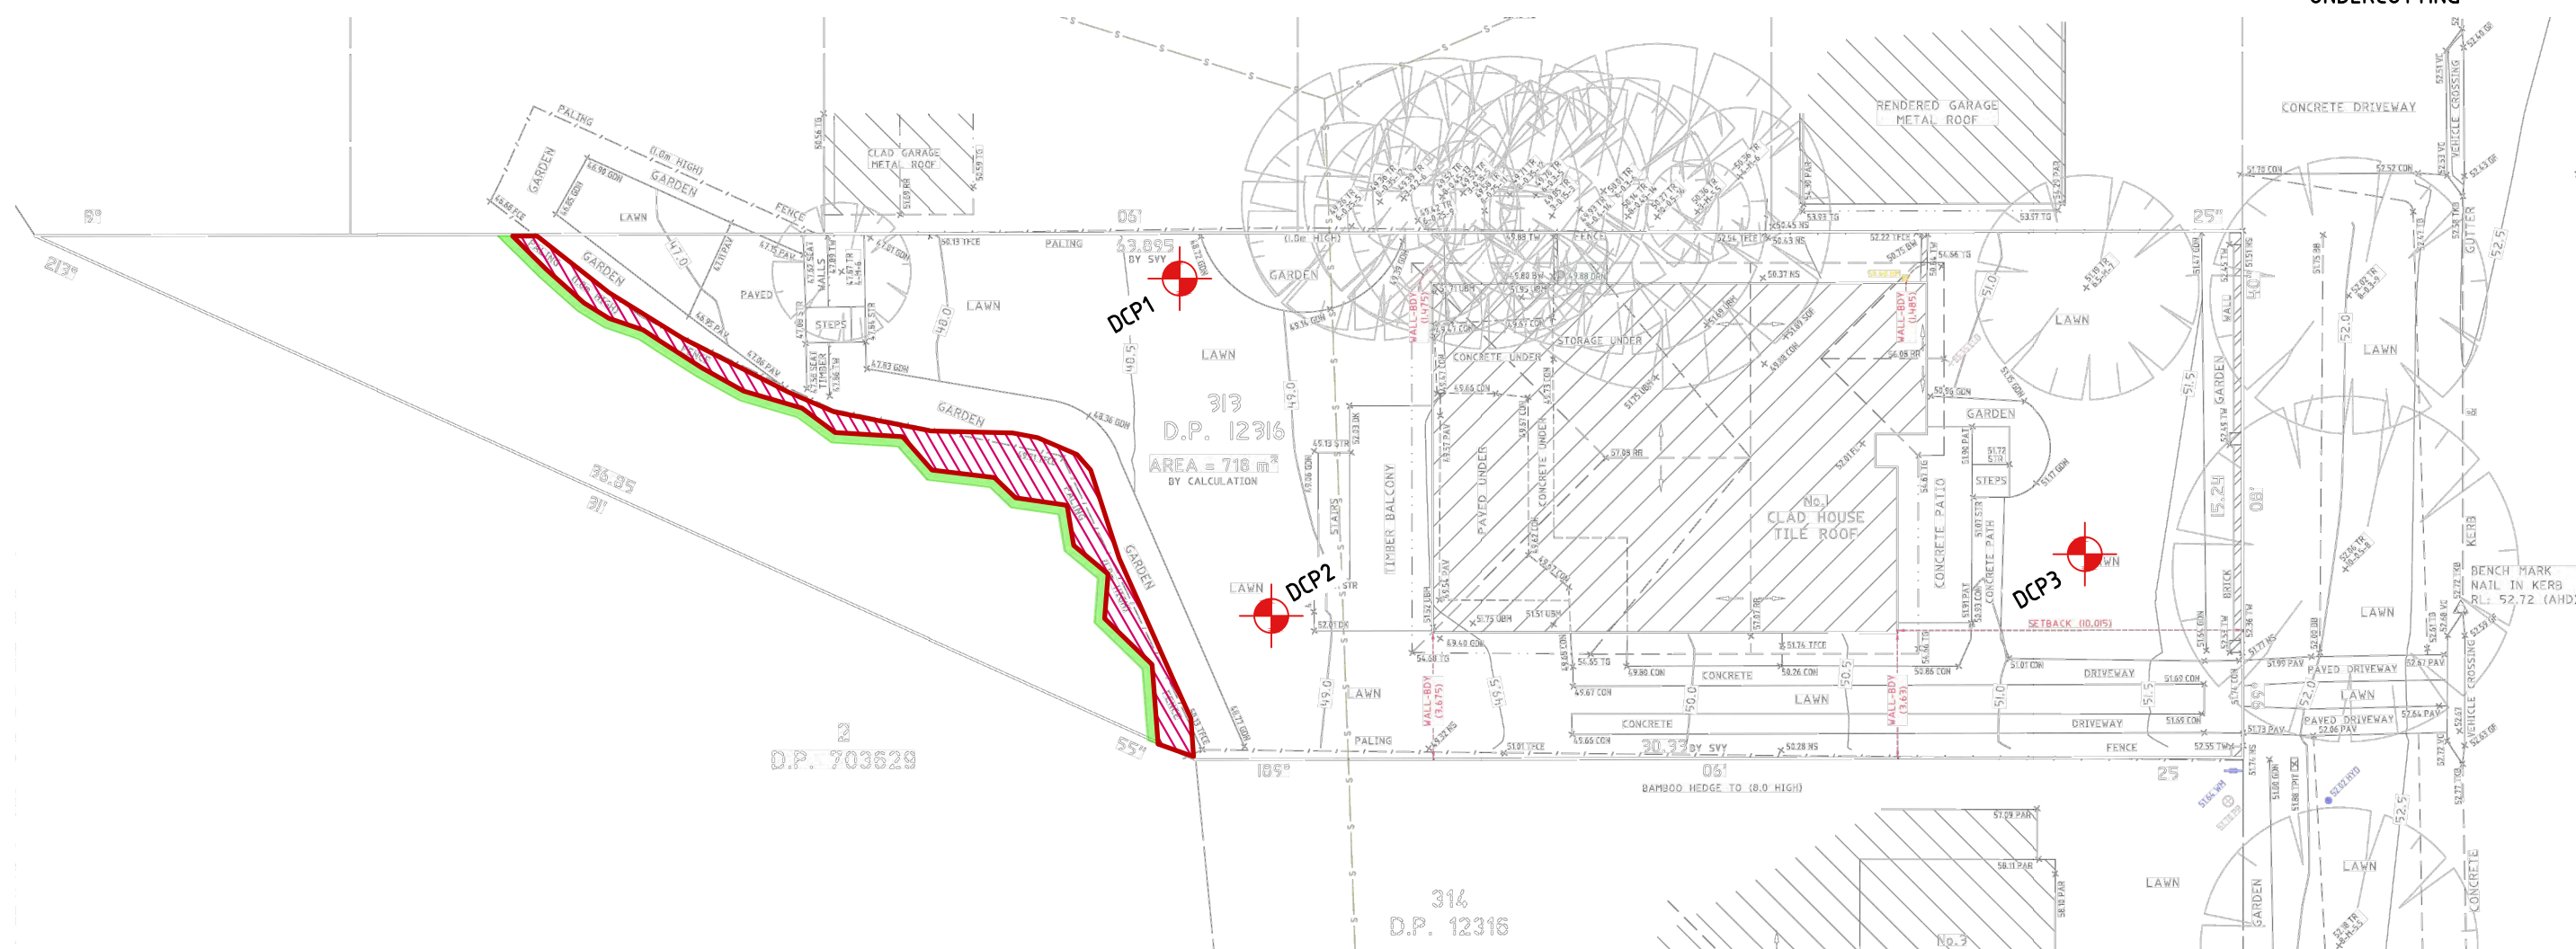
## SITE PLAN/GROUND TEST LOCATIONS

APPROXIMATE ZONE OF UNDERCUTTING

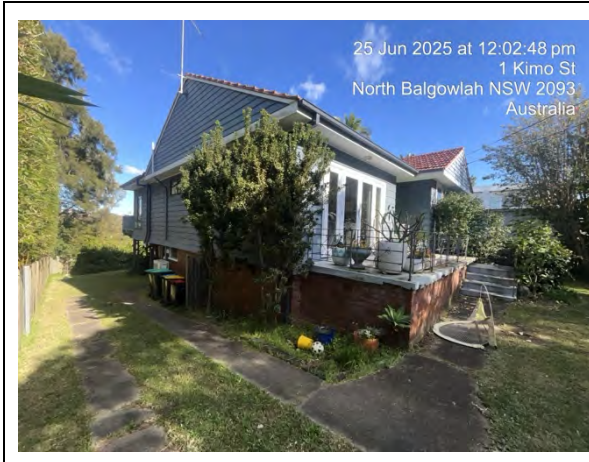
**Photo 1:** Northeastern corner of the residence

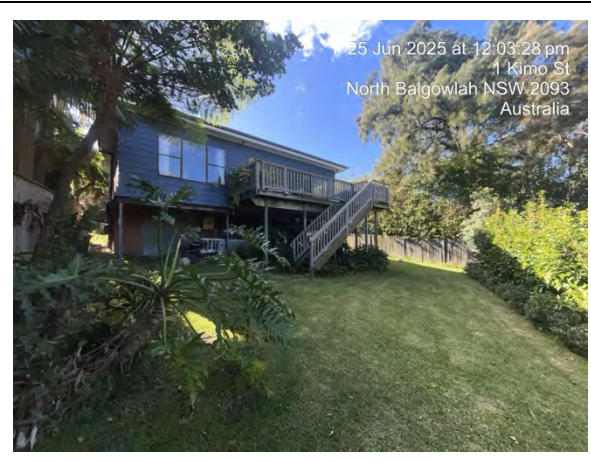
**Photo 2:** Southwestern corner and southern face of the residence

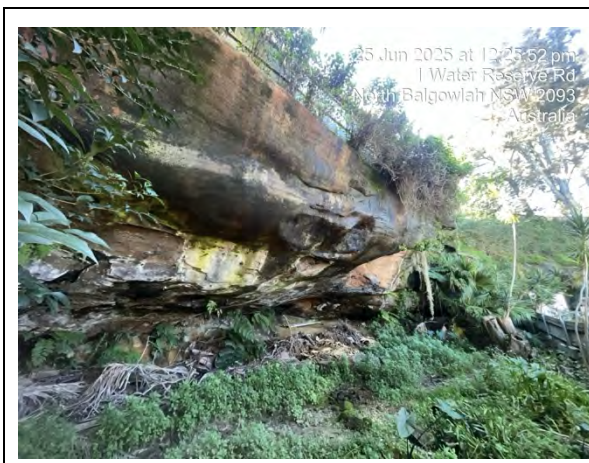
The escarpment is approximately 6–7m high and is comprised of massively bedded Sandstone, with no significant vertical jointing and or significant bedding defects observed within the subject site. The escarpment is undercut towards its base within the subject site to a maximum depth of approximal 6m, the thickness of the overburden is locally variable. No significant seepage was observed in the rock face however based on the moss growth on the bedrock face and the shallow soil profile above the escarpment, it is likely that the escarpment receives surface flows. The escarpment extends into the properties to the east and south-west of the subject site where undercutting continues and where broad undulations in the bedding are present.

**Photo 3:** Looking north-east along undercut sandstone escarpment in the rear of the site.

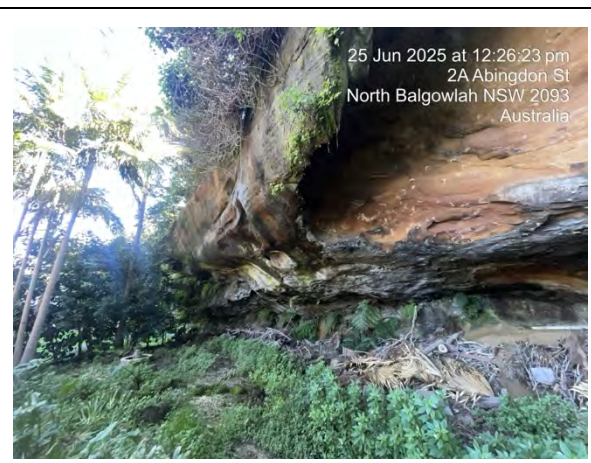
**Photo 4:** Looking south-west along undercut sandstone escarpment in the rear of the site.
