**Re: Inspection and assessment of existing structure  
at 11 VICTORIA PARADE, MANLY  
Job N° 170768**

At the request of Mr Ces Koutsos, Stewart McGeady of Northern Beaches Consulting Engineers inspected the above property in July 2017. The purpose of the visit was to examine and comment on the condition of the existing heritage façade and attached structures in relation to the proposed new development detailed on architectural drawings prepared by Blackmore Design Group dated 15 June 2015.

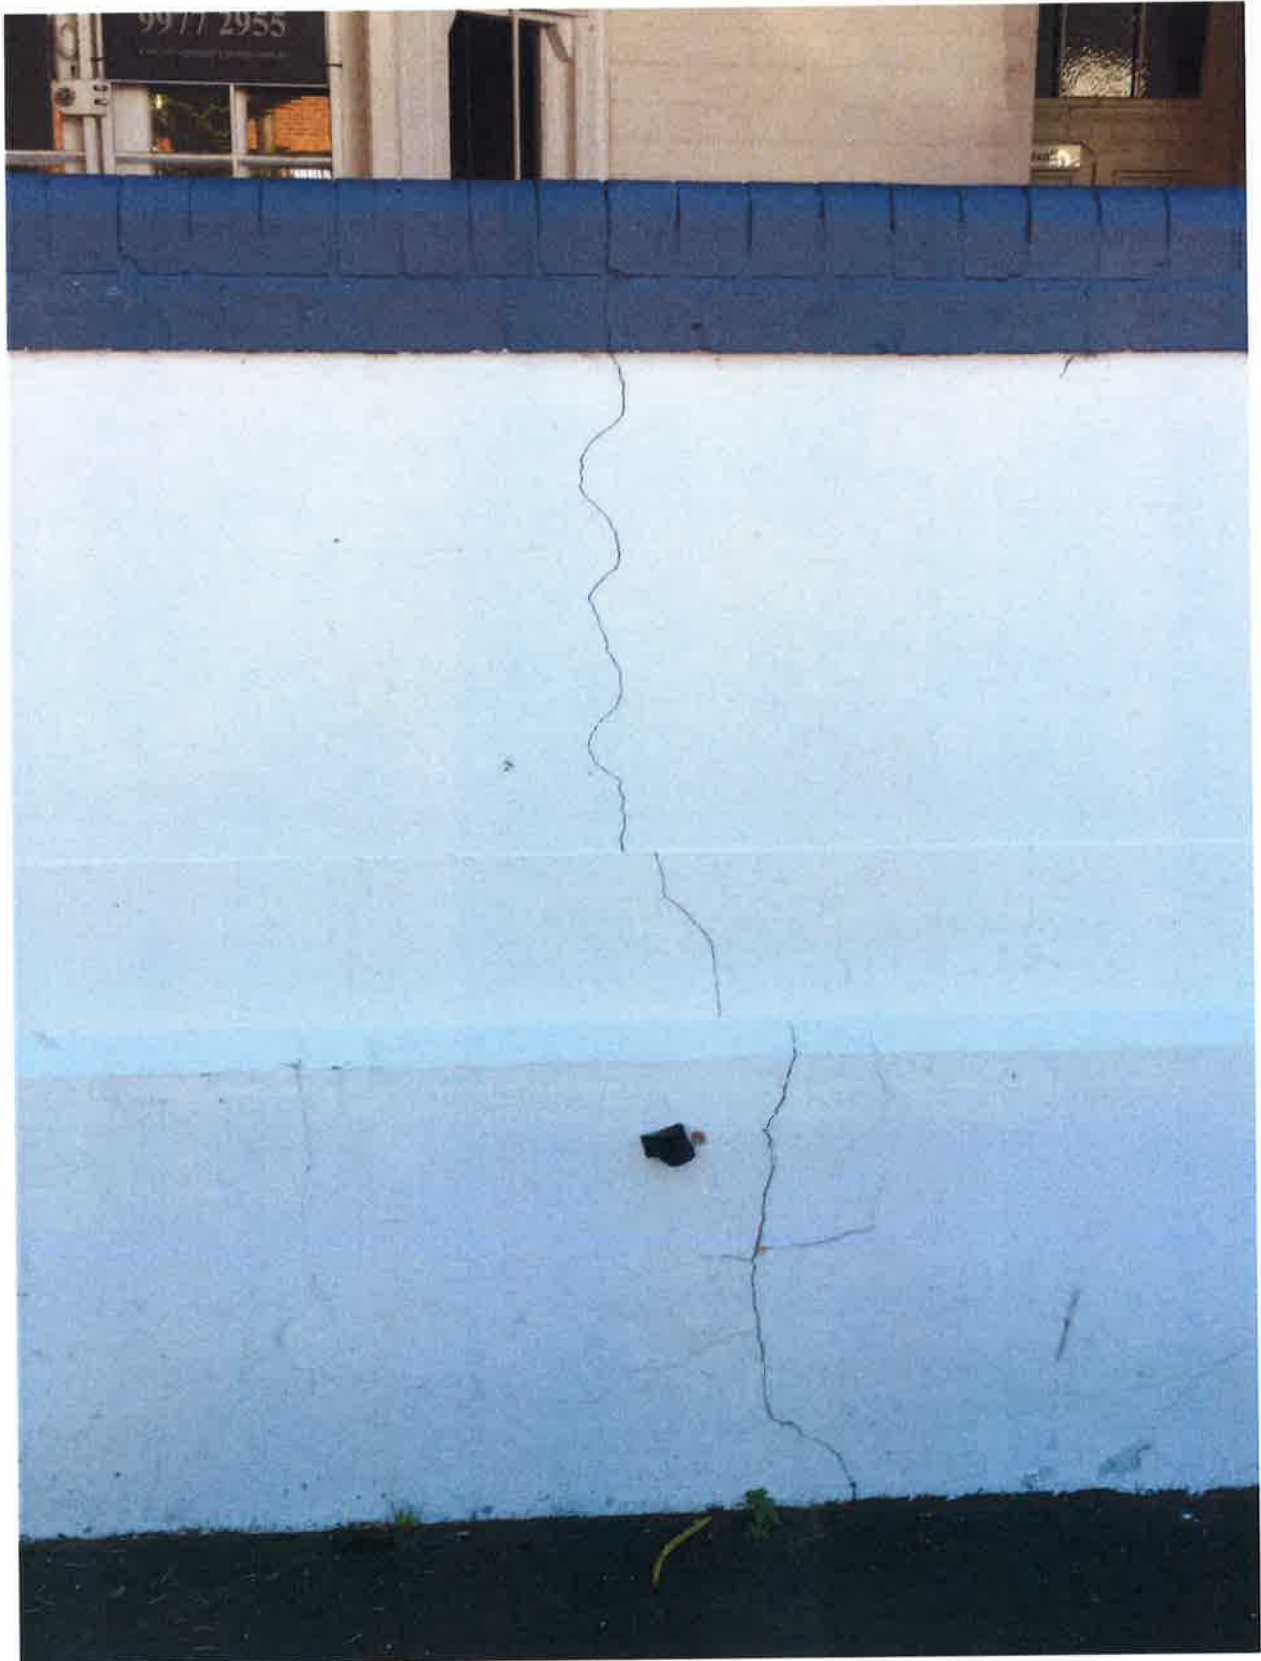
1. The lower brickwork wall that supports the front façade brickwork, concrete columns and corbels exhibits cracking that indicates footing movement has occurred. Refer photograph 1. The existing concrete columns and corbels can be salvaged and reinstated to match the original style.
2. Cracking and separation to the brickwork at the concrete corbels has resulted from the same footing movement as noted in item 1. Refer photograph 2. A crack stitch repair is a not long term practical solution and continual differential movement will occur.
3. The perimeter concrete beams to the front balcony exhibit spalling and corroded lintel bars. Refer photograph 3. The extent of spalling has progressed beyond the limit of practical remedial repair.

P01 – Cracking to lower brickwork supporting front façade brickwork, columns and corbels.

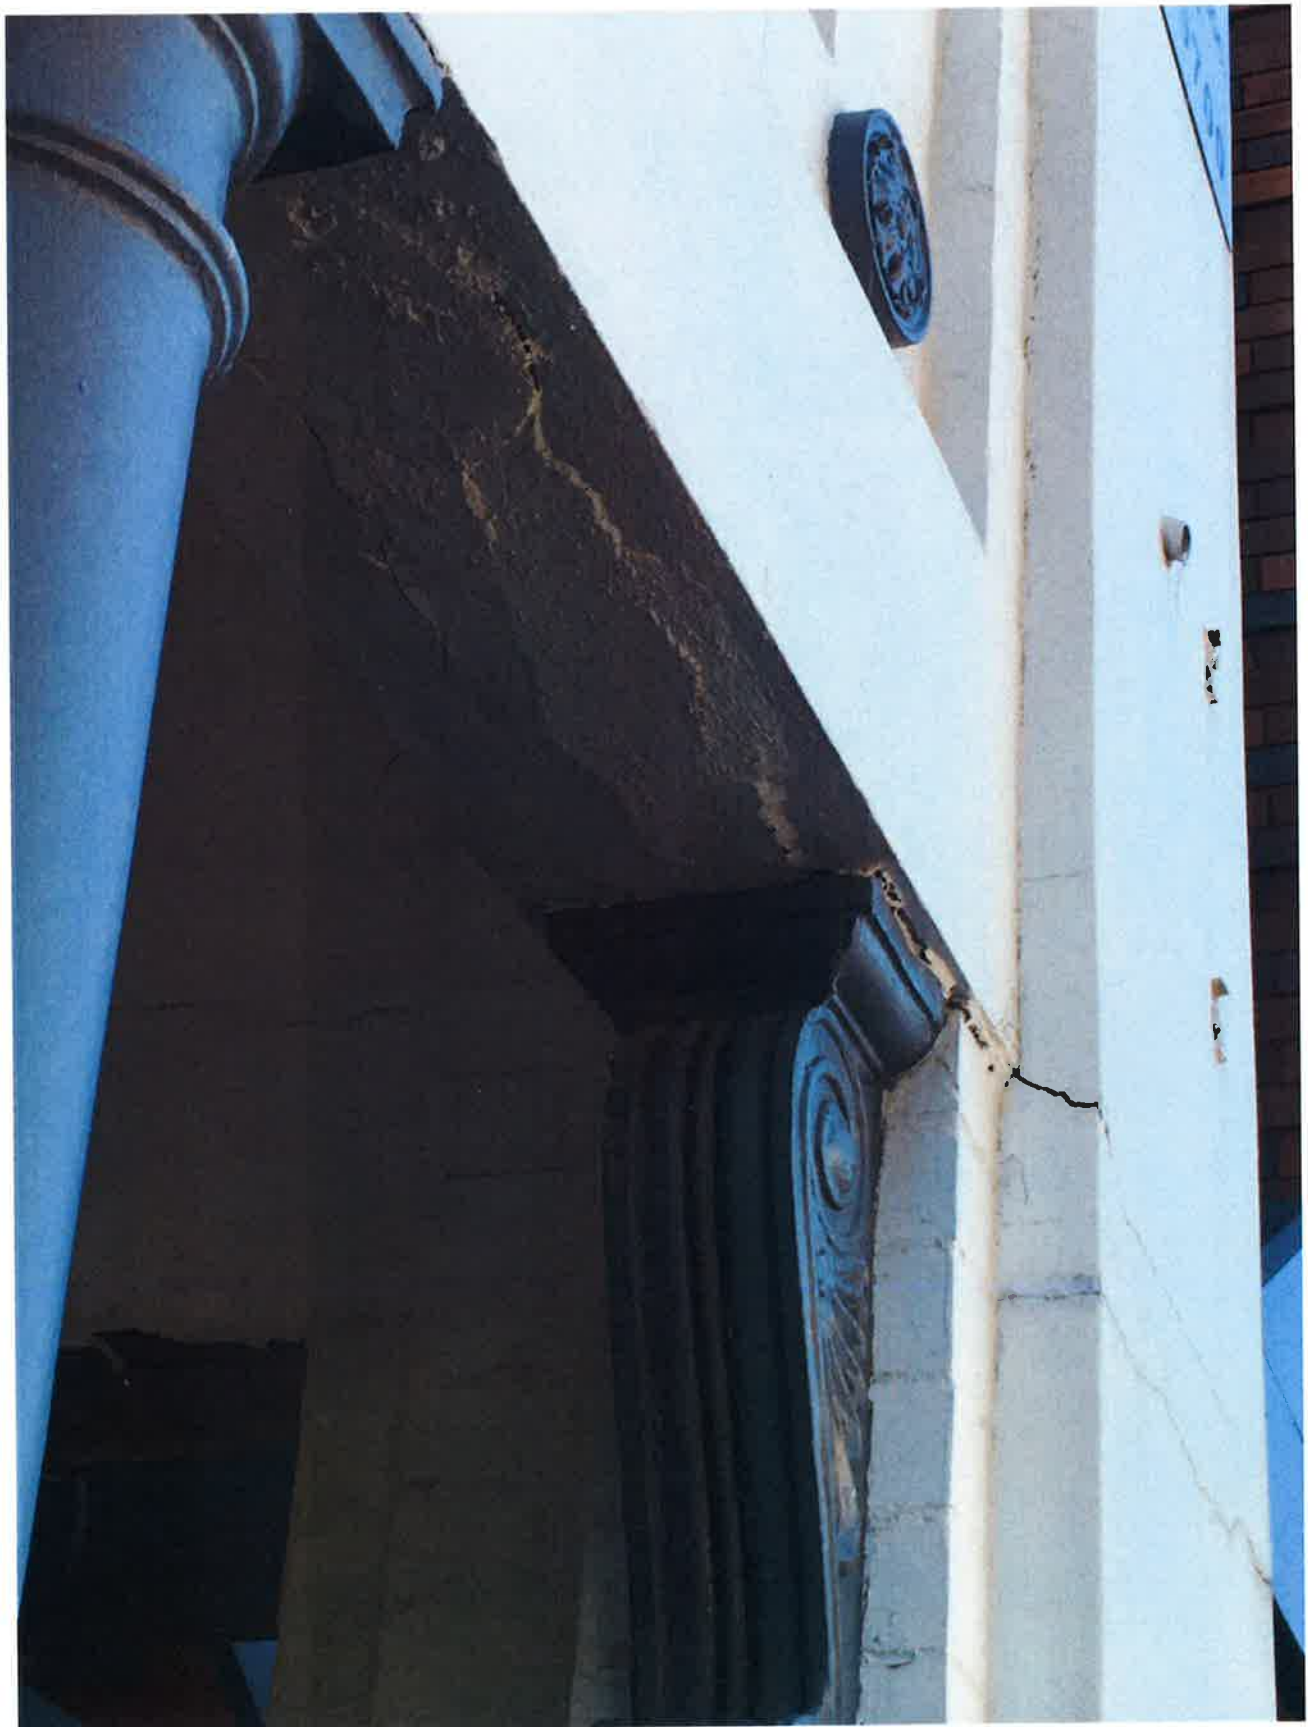
P02 – Separation to brickwork at corbels.

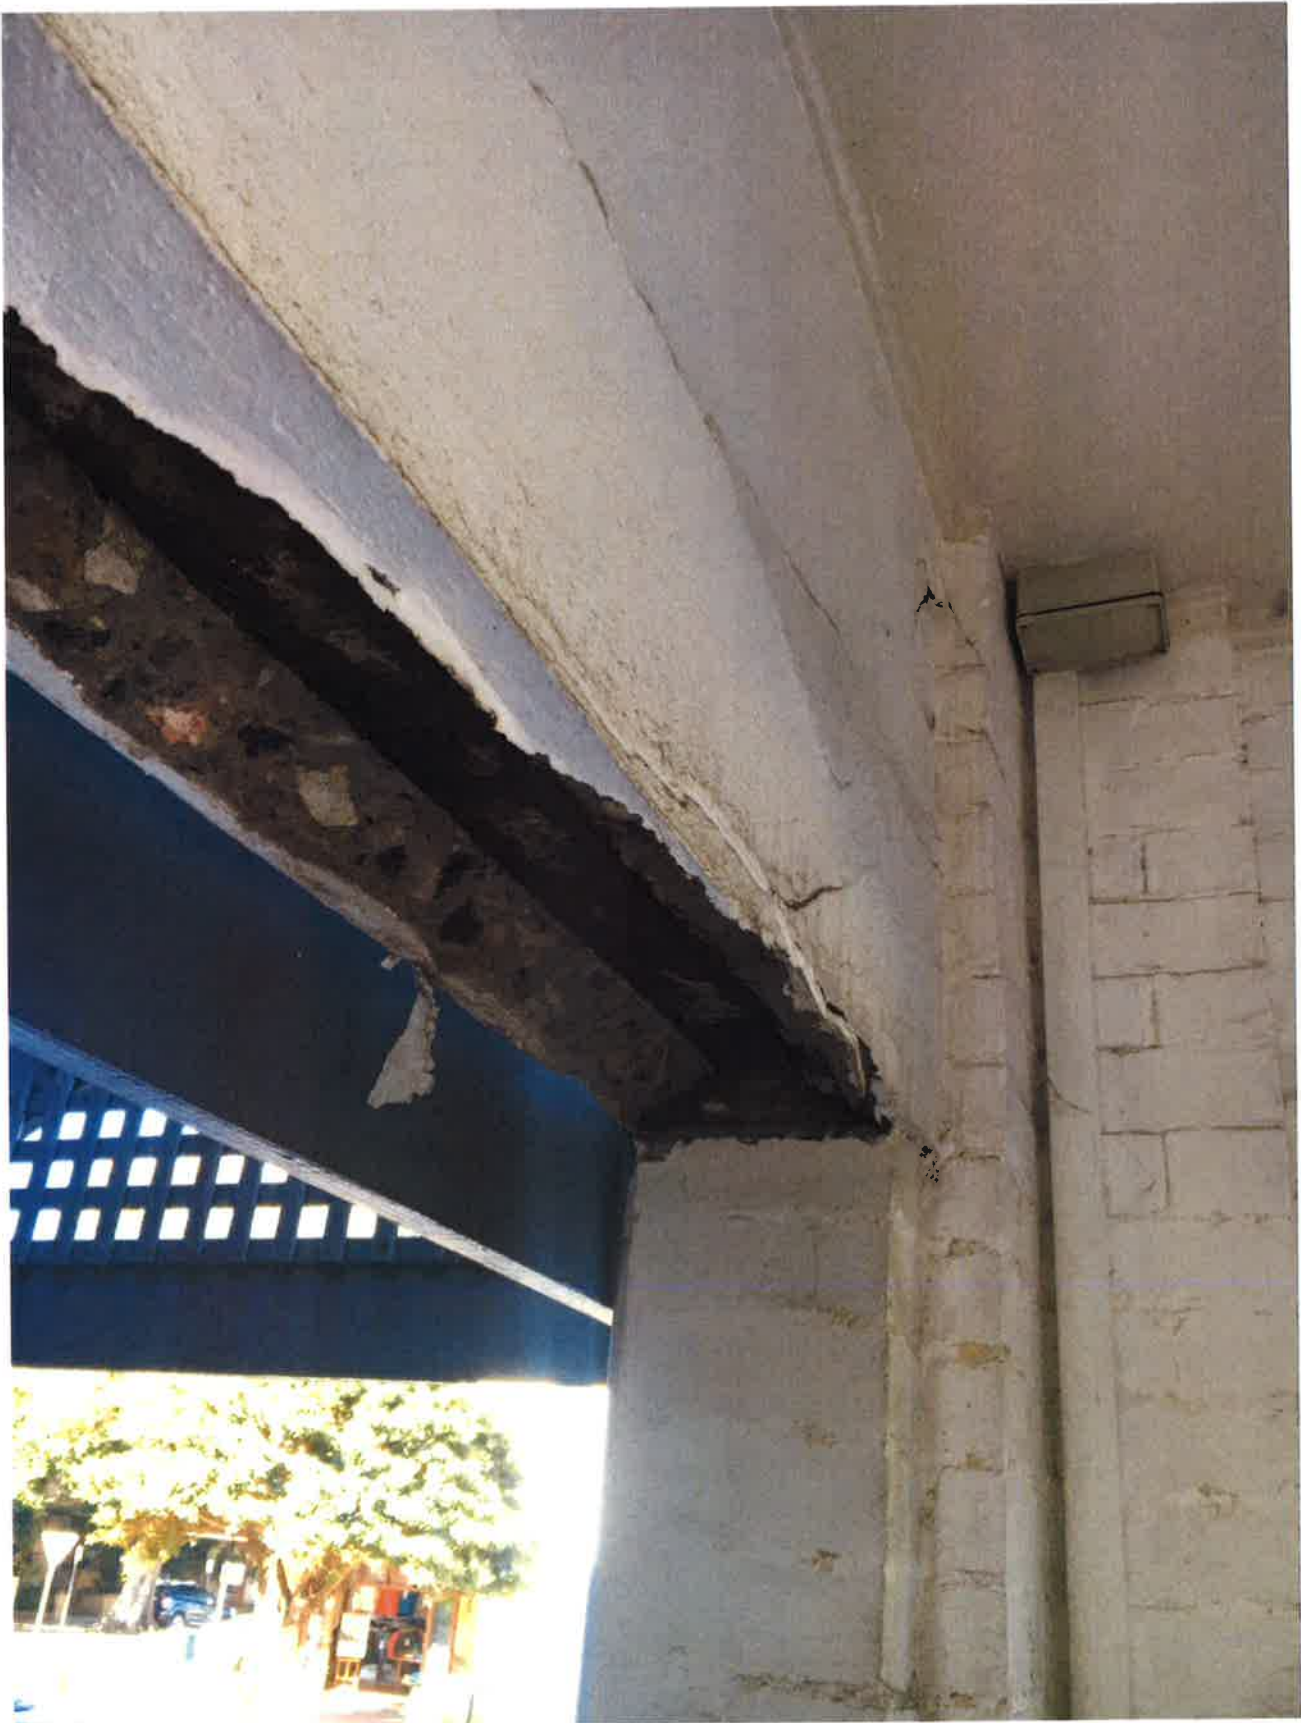
P03 – Spalling to beams and corroded lintel bars.

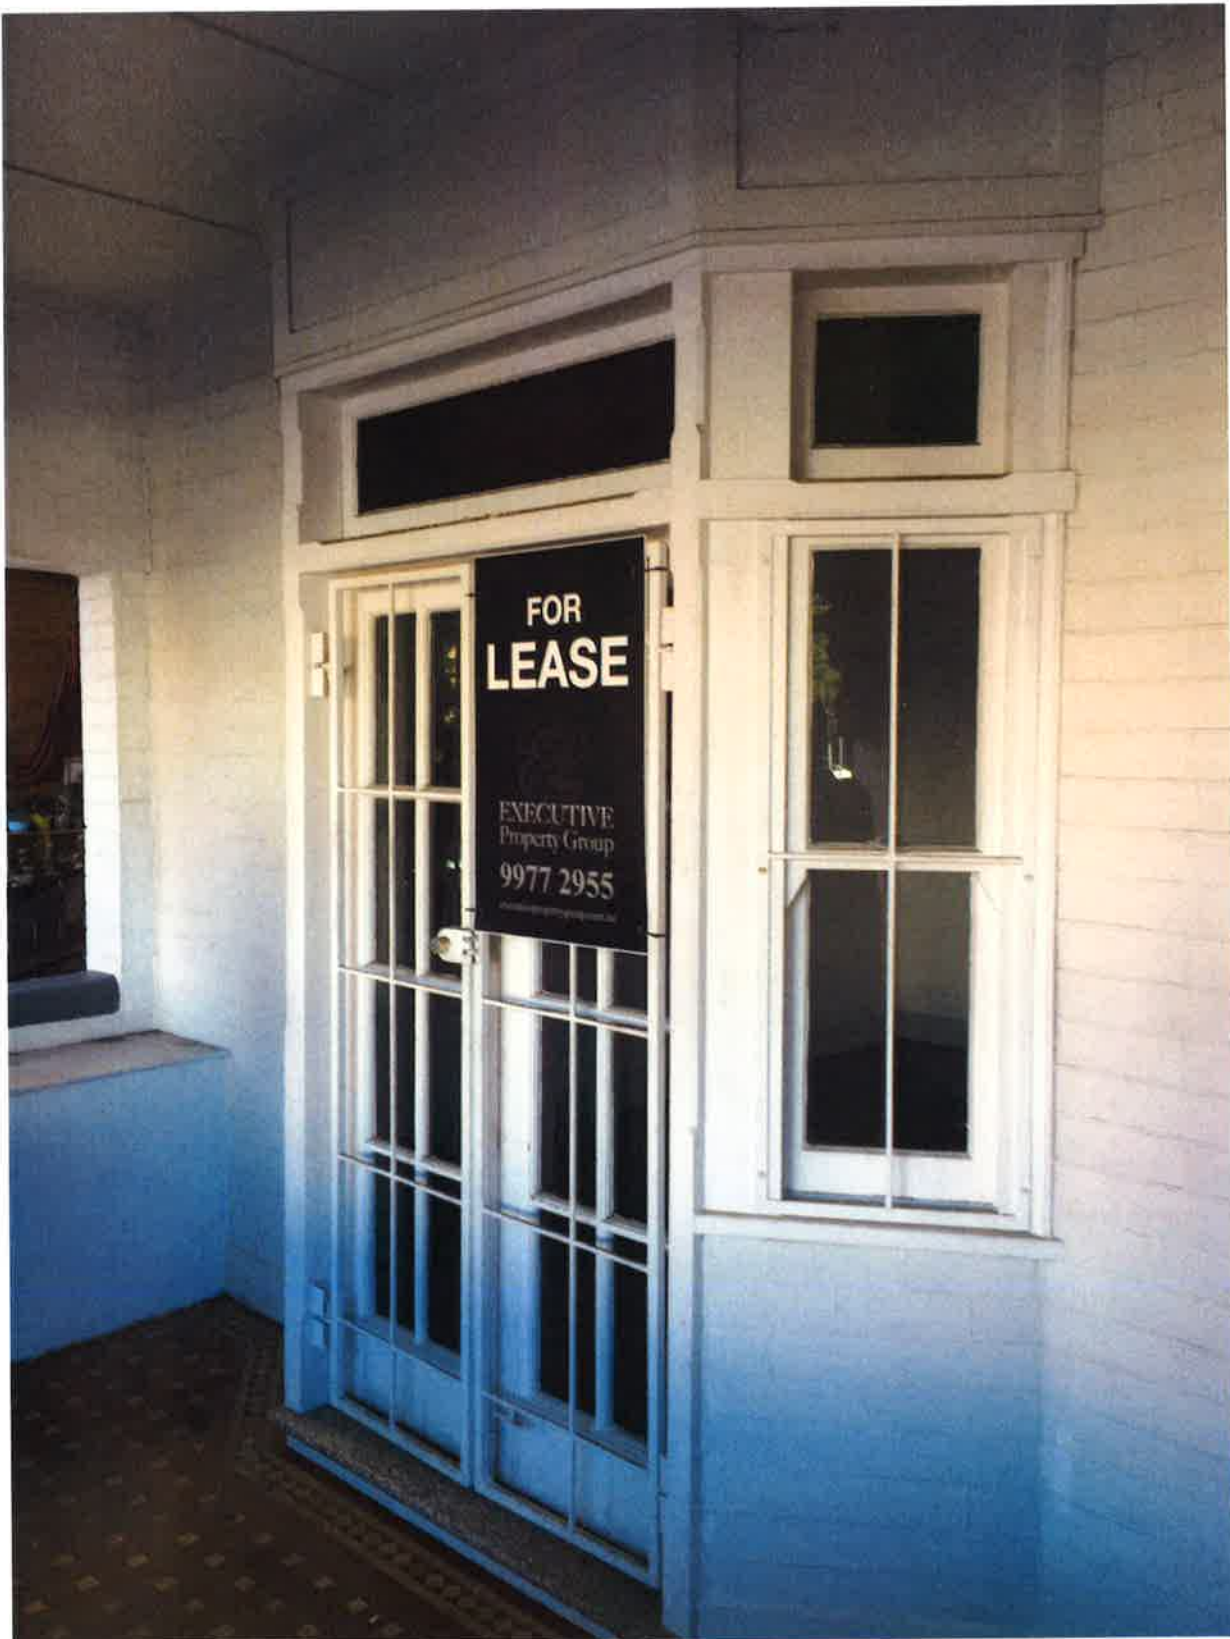
4. The front entry steel screen doors can be salvaged, treated for rust and reinstated to match the original style. The glazing and entry doors to the bay windows could be surface treated and reinstated to match the original style. Refer photograph 4.

P04 – Front entry screen doors and bay window.

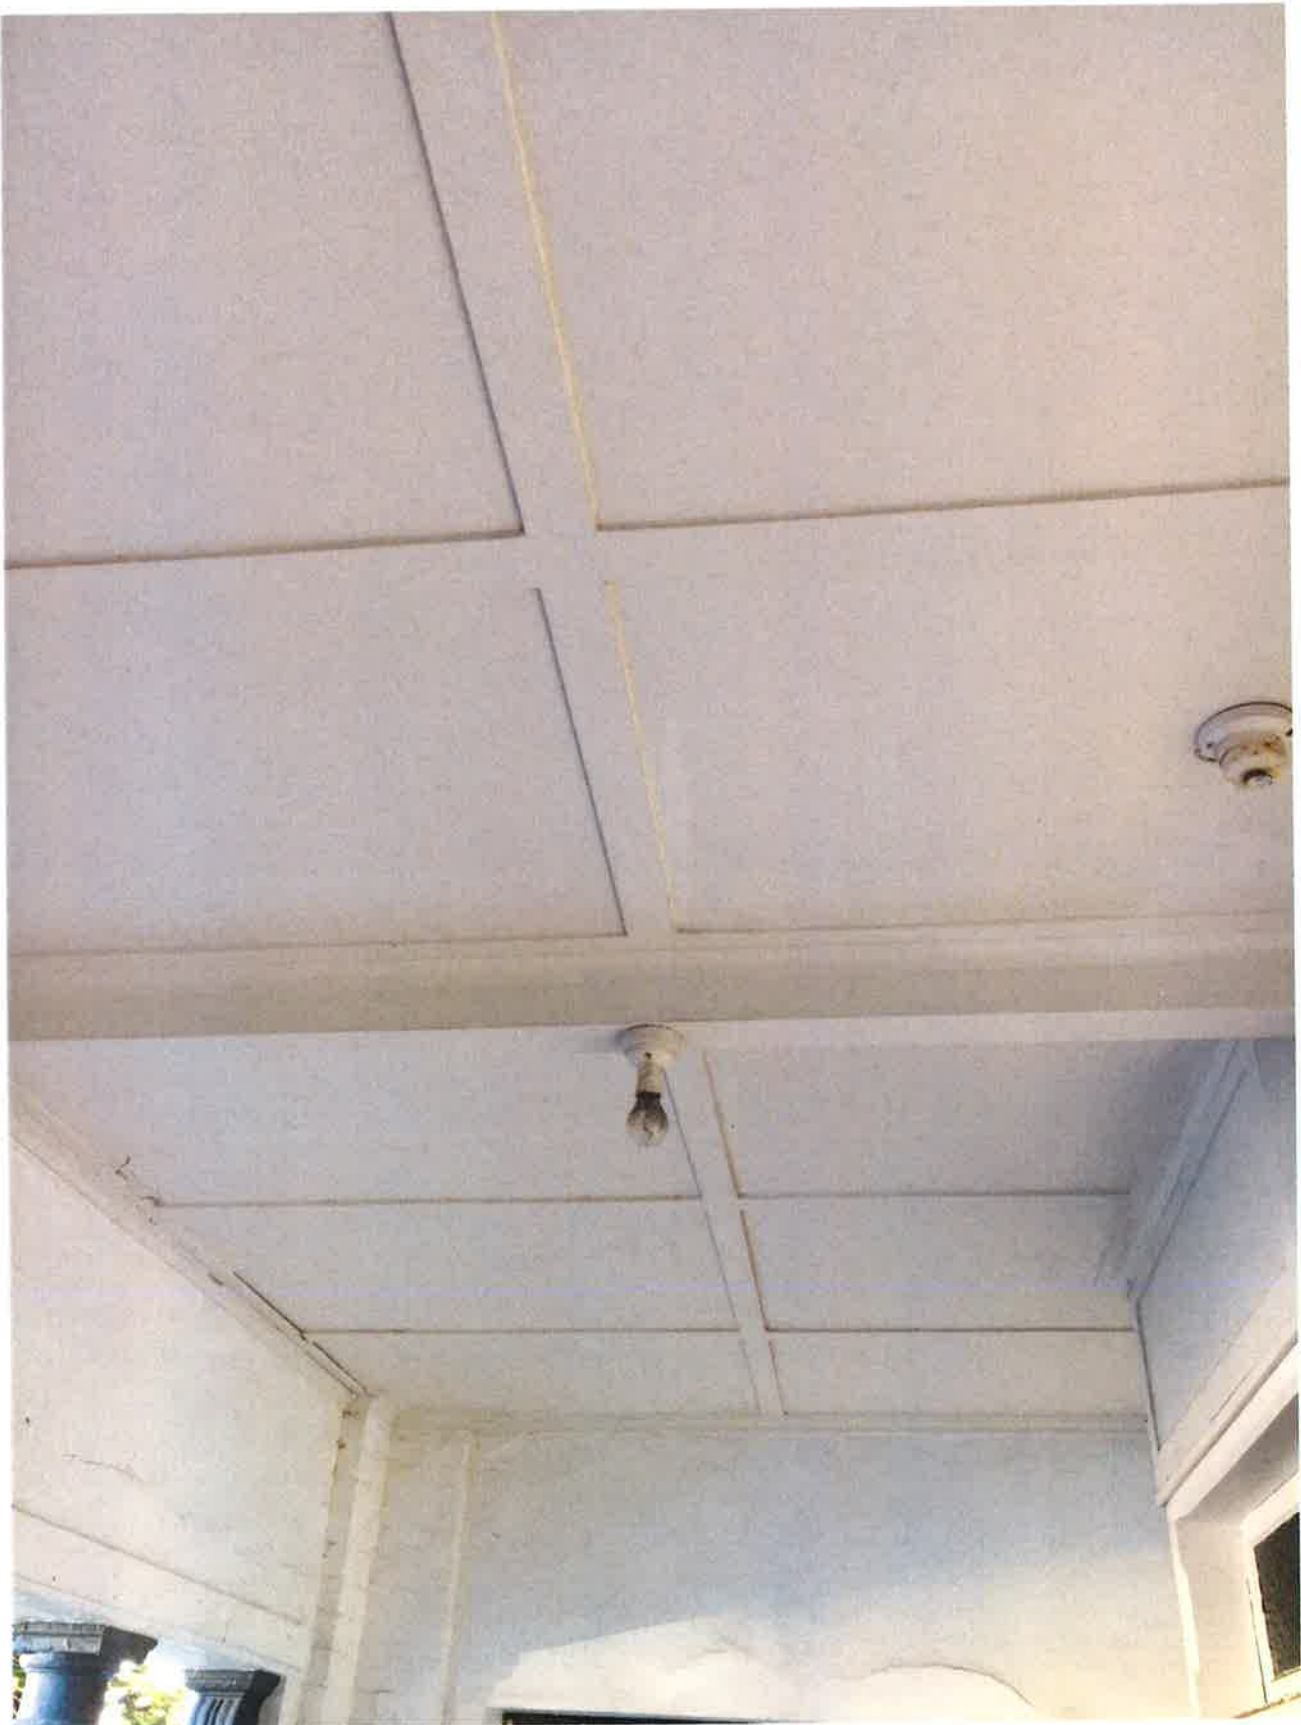
5. Asbestos ceiling lining to the front entry porch is visible and it should be removed. Refer photograph 5.
6. The front entry porch slab is out of level and the slab has settled in the southern corner. Water staining on the tile bed shows ponding occurs at this location. Refer photograph 6. The slab is considered defective due to settlement.

P05 – Asbestos ceiling lining to front entry.

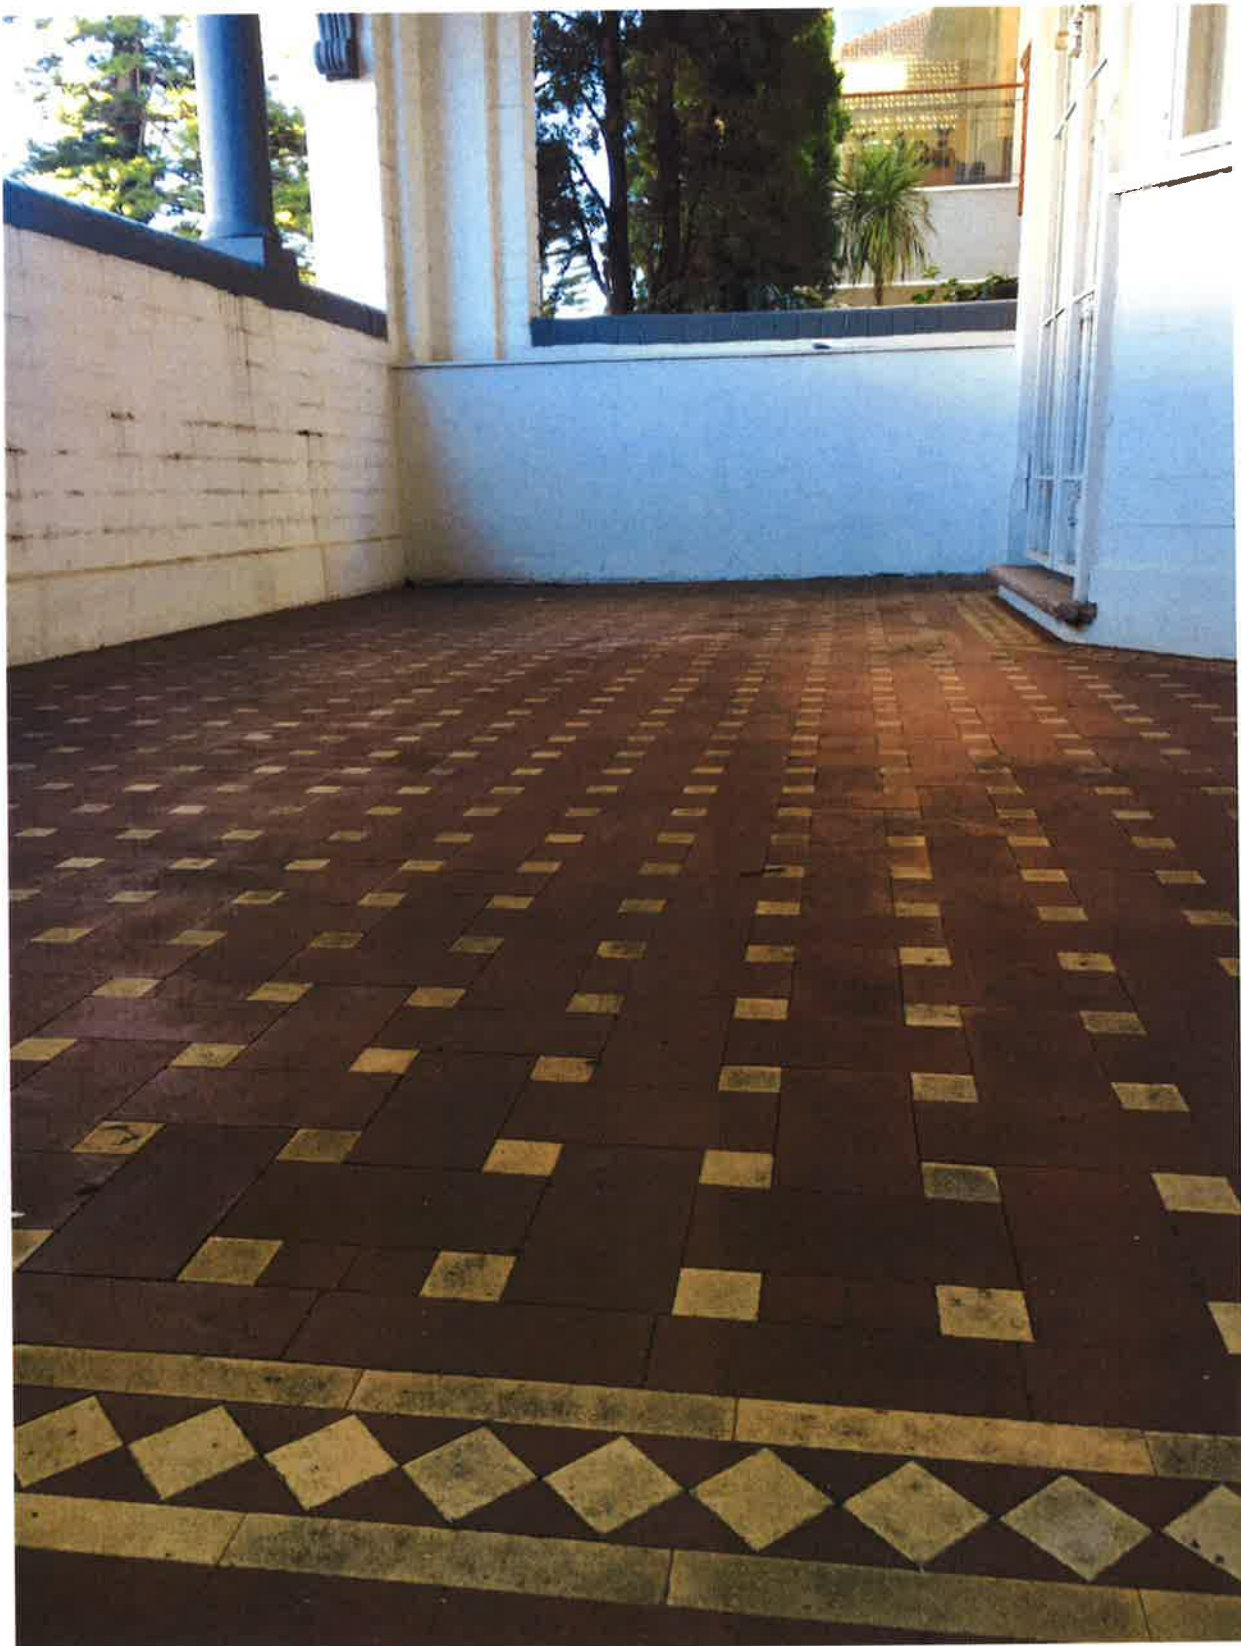
P06 – Front entry porch slab out of level.

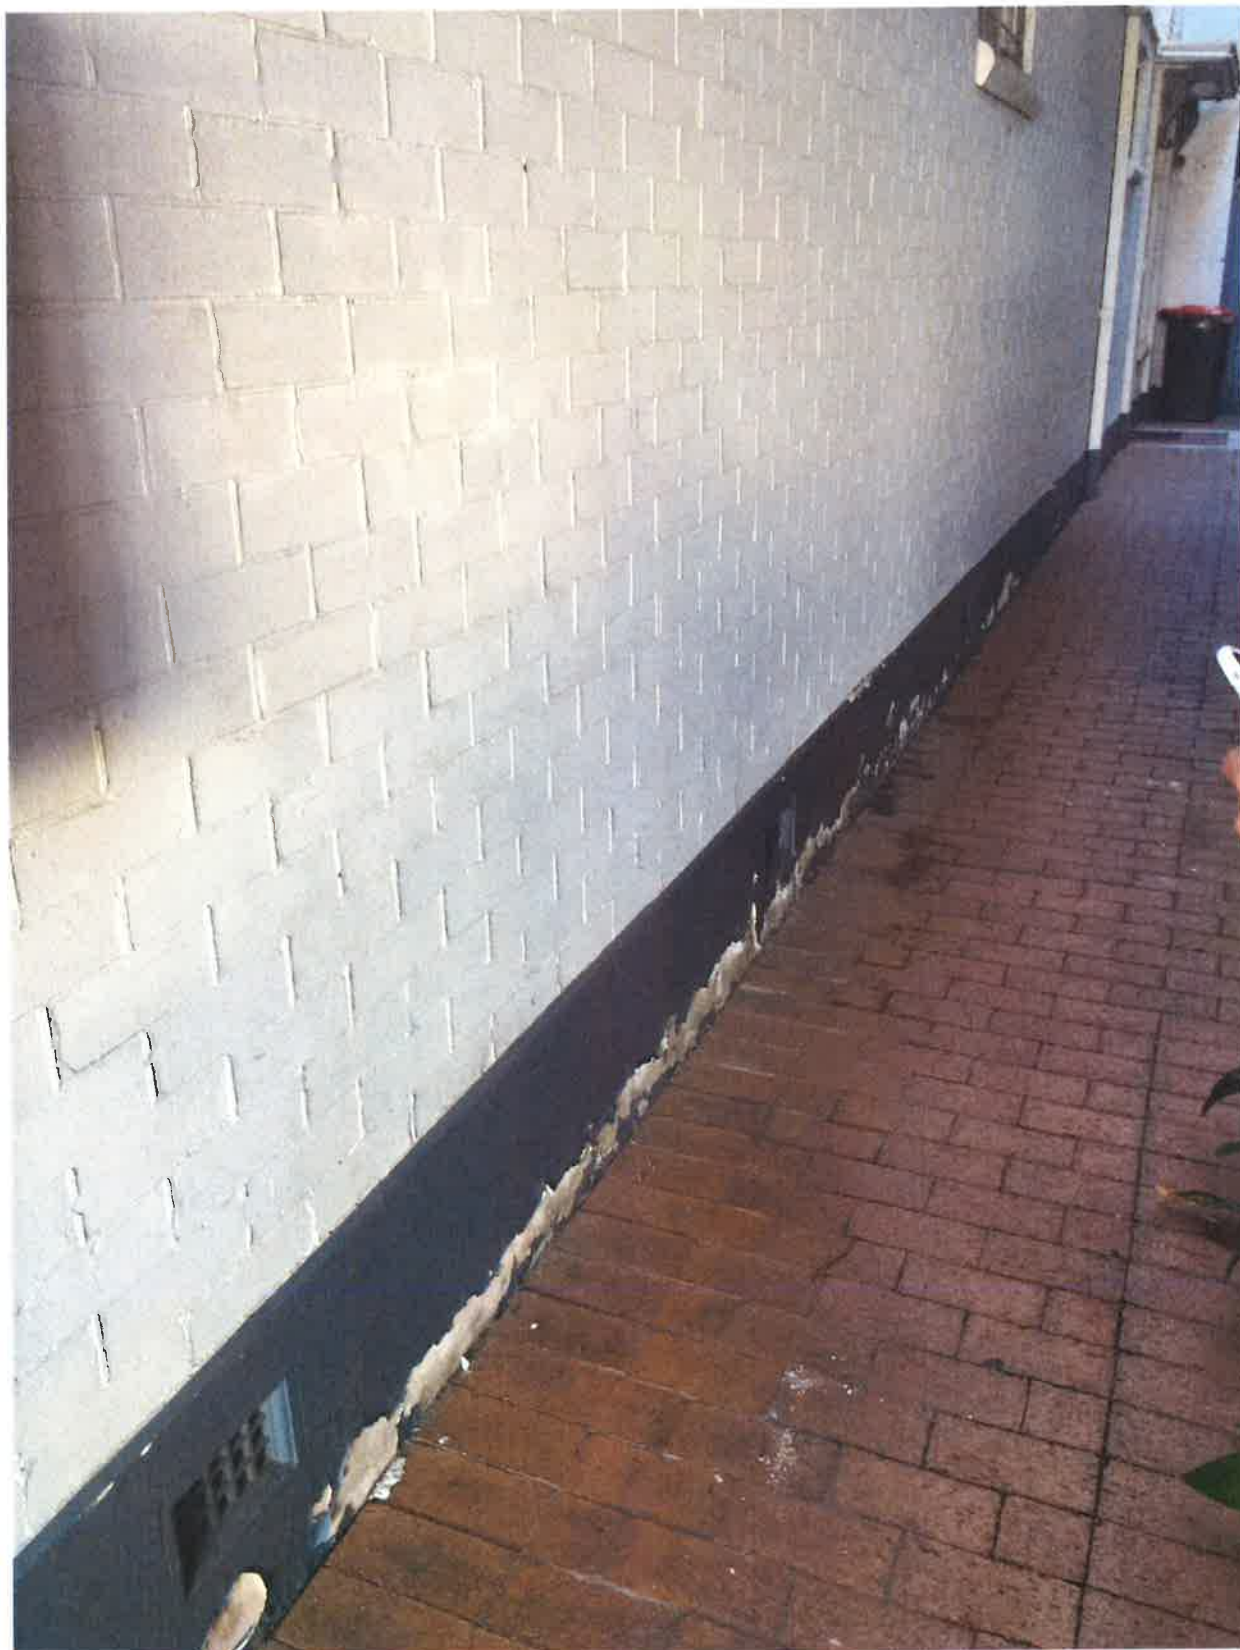
7. The original lime mortar bed joints to the façade brickwork exhibit a 'tuck pointing' style finish. Lime mortar lacks bonding strength as distinct from cement mortar which is bound by cement. Consequentially most of the lime mortar has turned to sand and lost all bearing capacity. The longevity of the brick walls would benefit if it is reconstructed with cement mortar joints then tuck pointed to match the original style. Refer photograph 7.

8. Along the sides of the building rising damp is visible above the footing and the applied render and paint is fretting away. Refer photograph 7. There is no practical long-term remedial solution where rising damp and fretting will continue.

P07 – Tucking pointing to brickwork and rising damp above the footing.

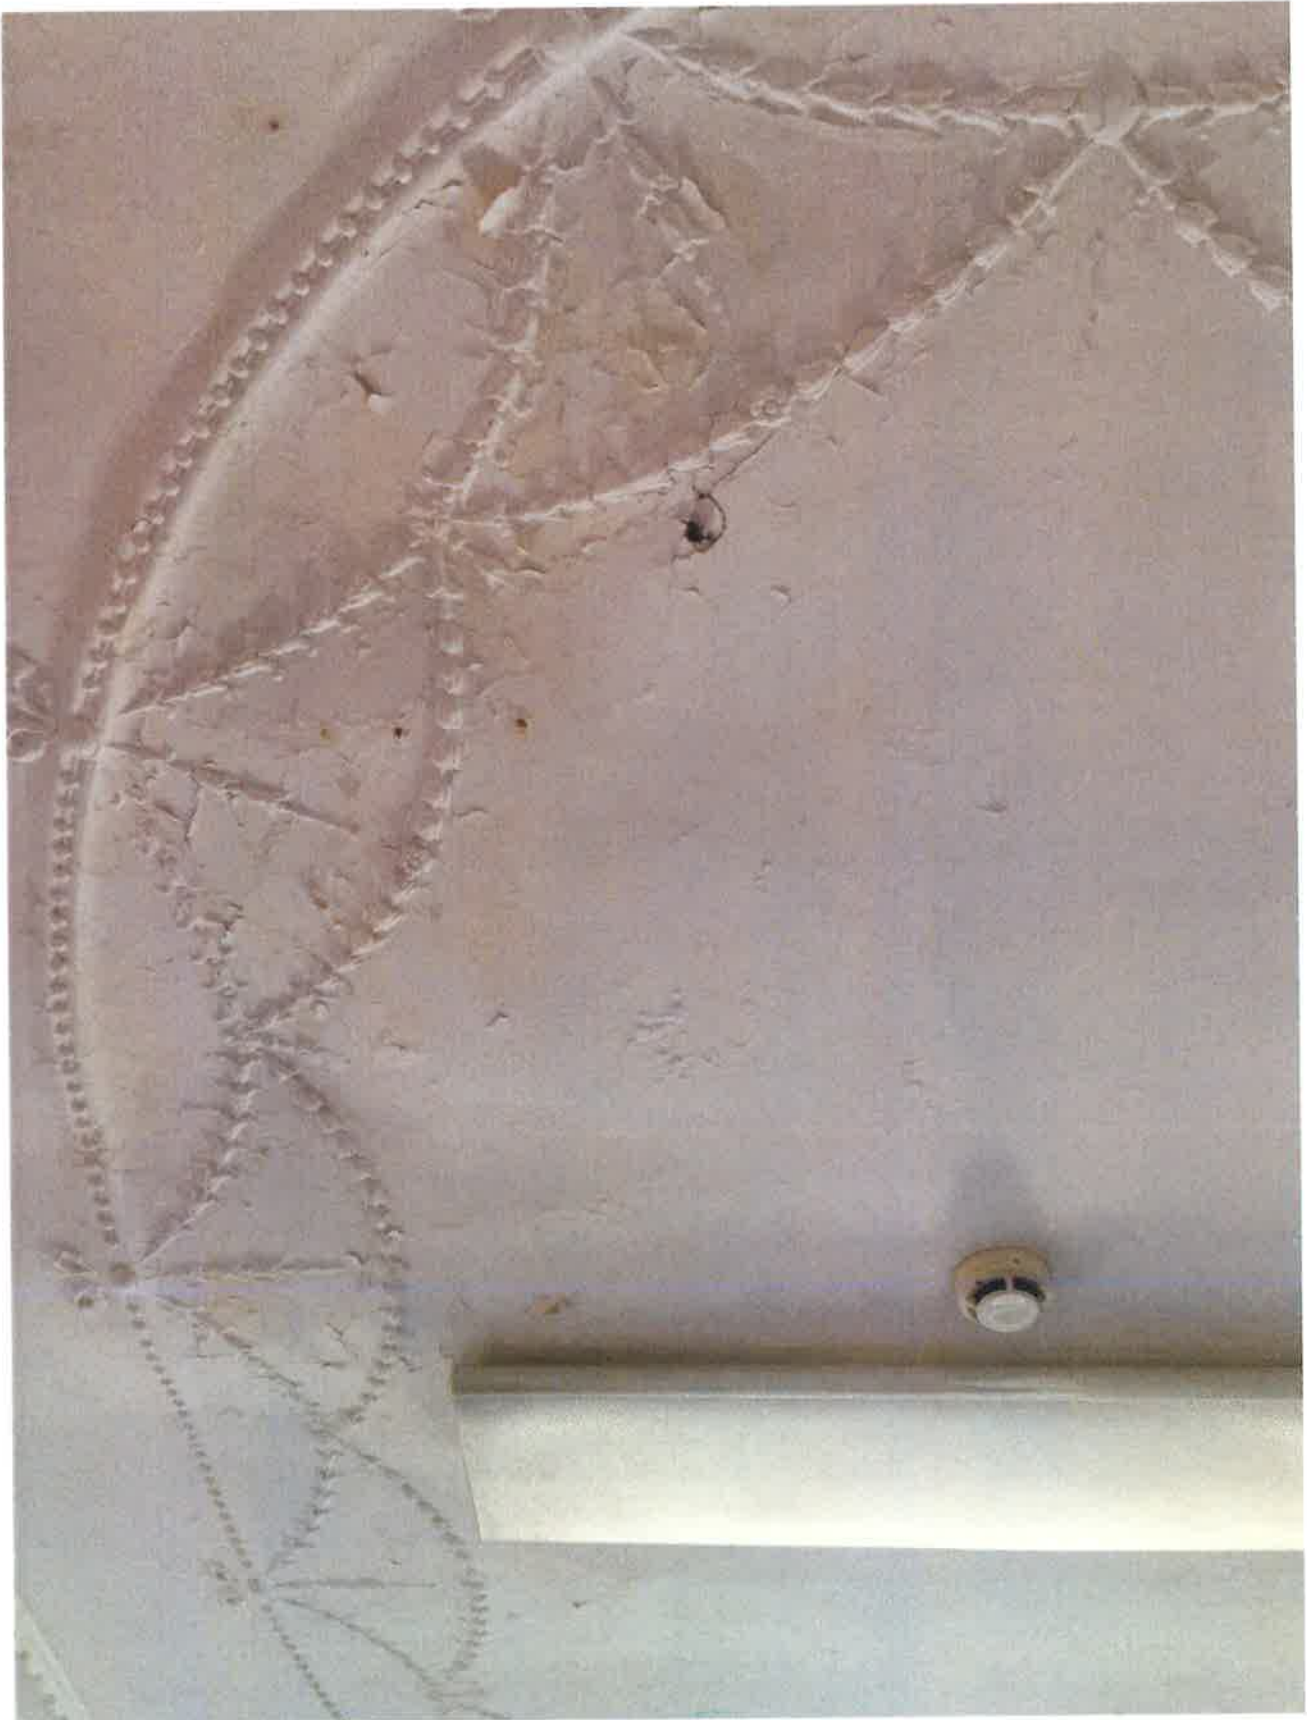
9. In the front room of level 1, ceiling damage and sagging is visible indicating the ceiling has detached from the structure. Refer photograph 8.
10. Asbestos ceiling lining to the front first floor balcony is visible and it should be removed. Refer photograph 9.

P08 – Damage and sagging to the ceiling to the front first floor room.

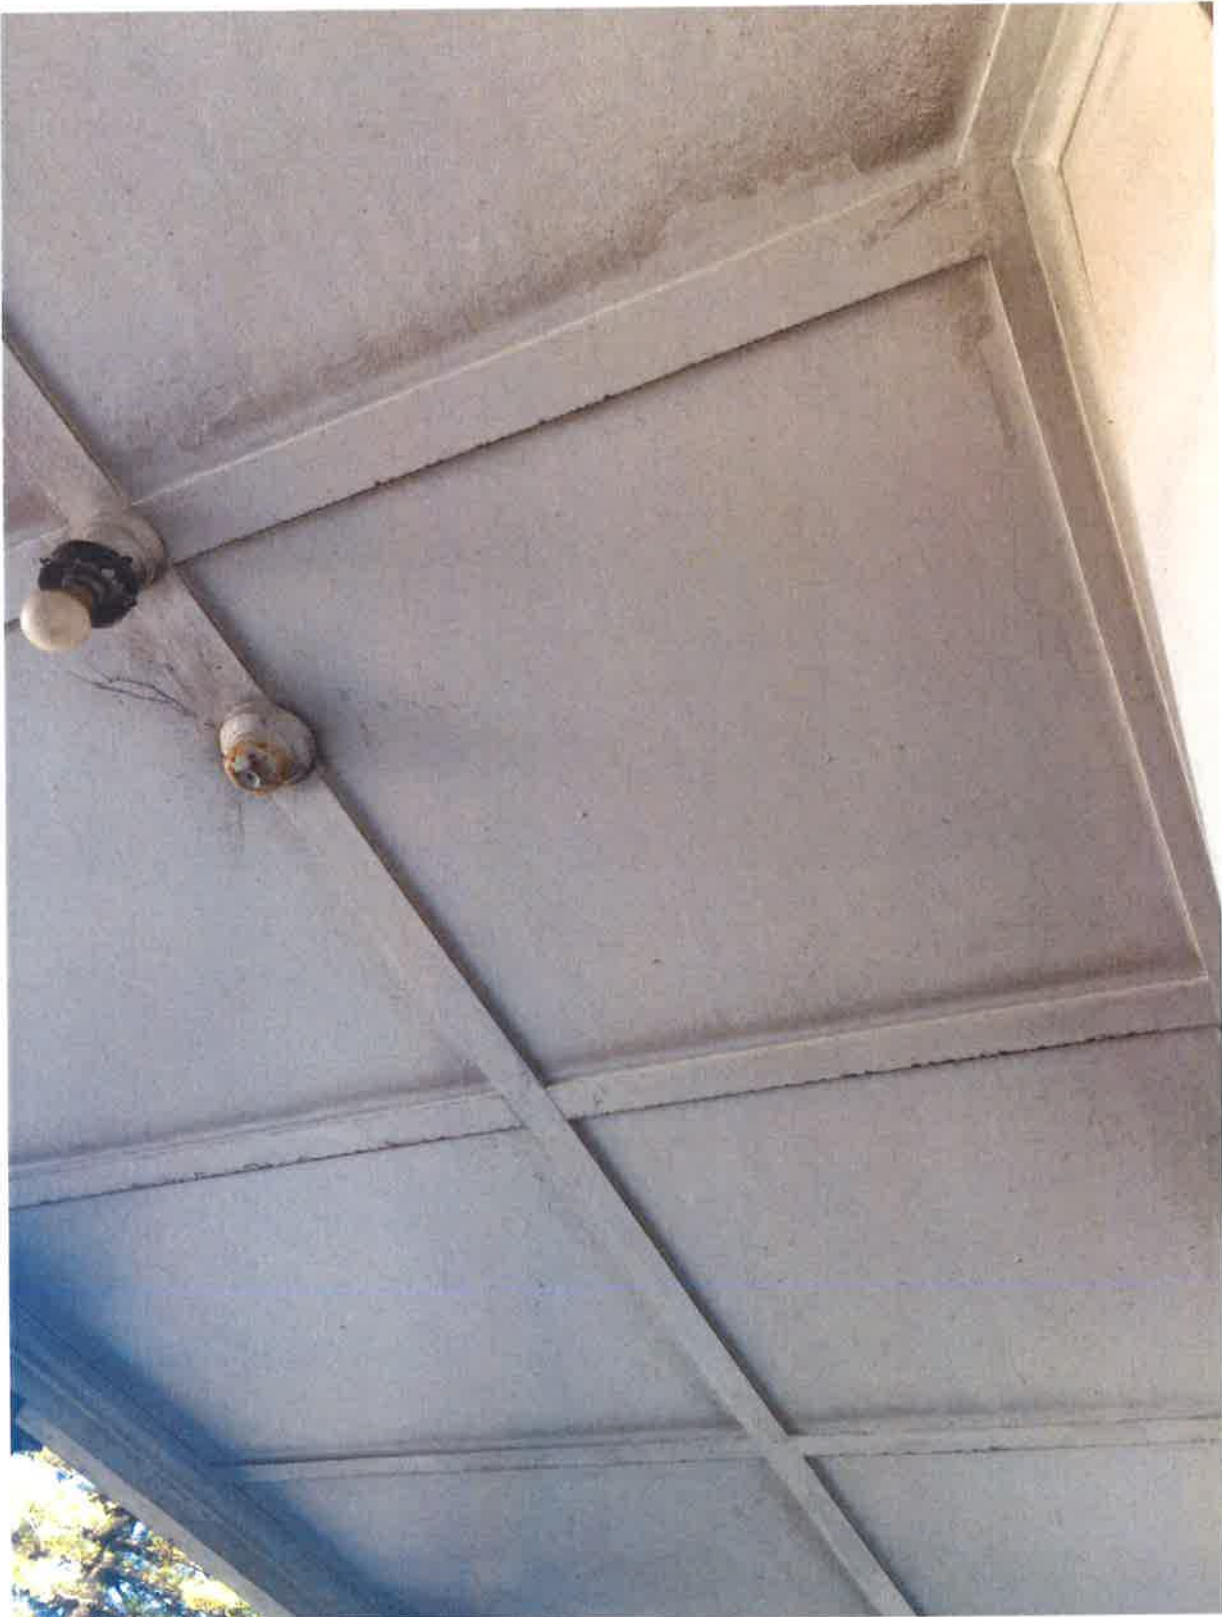
P09 – Asbestos ceiling lining to front first floor balcony.

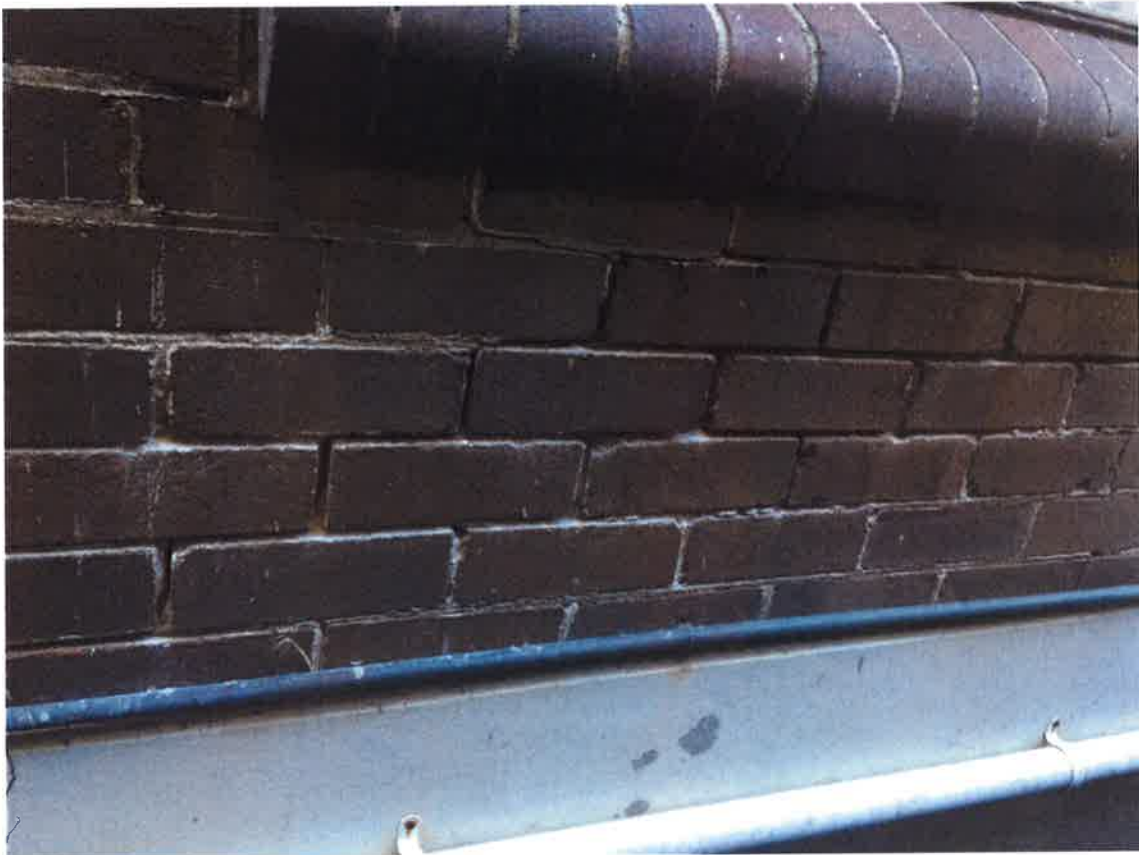
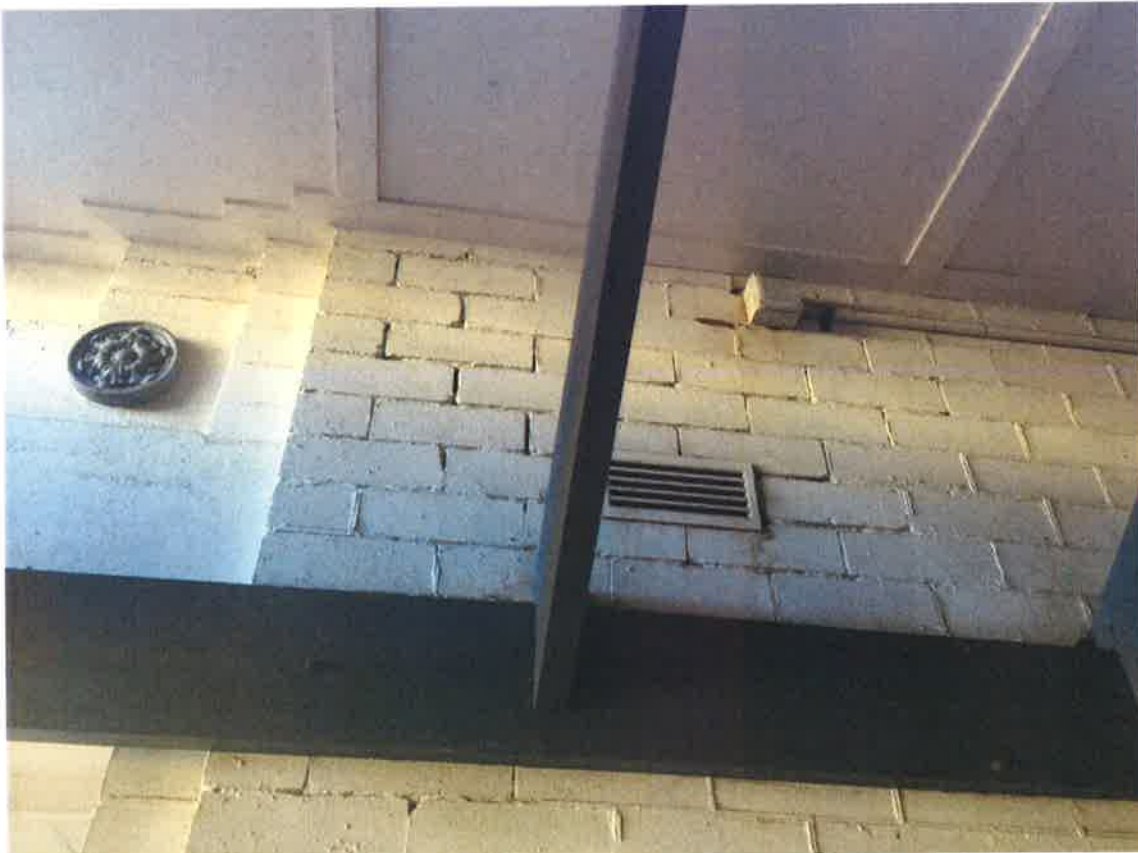
11. Fretting to the facade brickwork on both the sides of the building was observed indicating that salt ingress into the bricks and mortar beds has occurred thereby leading mechanical fretting. Refer photographs 10 and 11. There is no long-term solution due to the original weaker lime mortar bedding.

P10 – Fretting to façade brickwork.

P11 – Fretting to façade brickwork.
