**Re: Inspection and assessment of existing structure  
at 11 VICTORIA PARADE, MANLY  
Job N° 170768**

At the request of Mr Ces Koutsos, Stewart McGeady of Northern Beaches Consulting Engineers inspected the above property in July 2017. The purpose of the visit was to examine and comment on the condition of the existing heritage façade and attached structures in relation to the proposed new development detailed on architectural drawings prepared by Blackmore Design Group dated 15 June 2015.

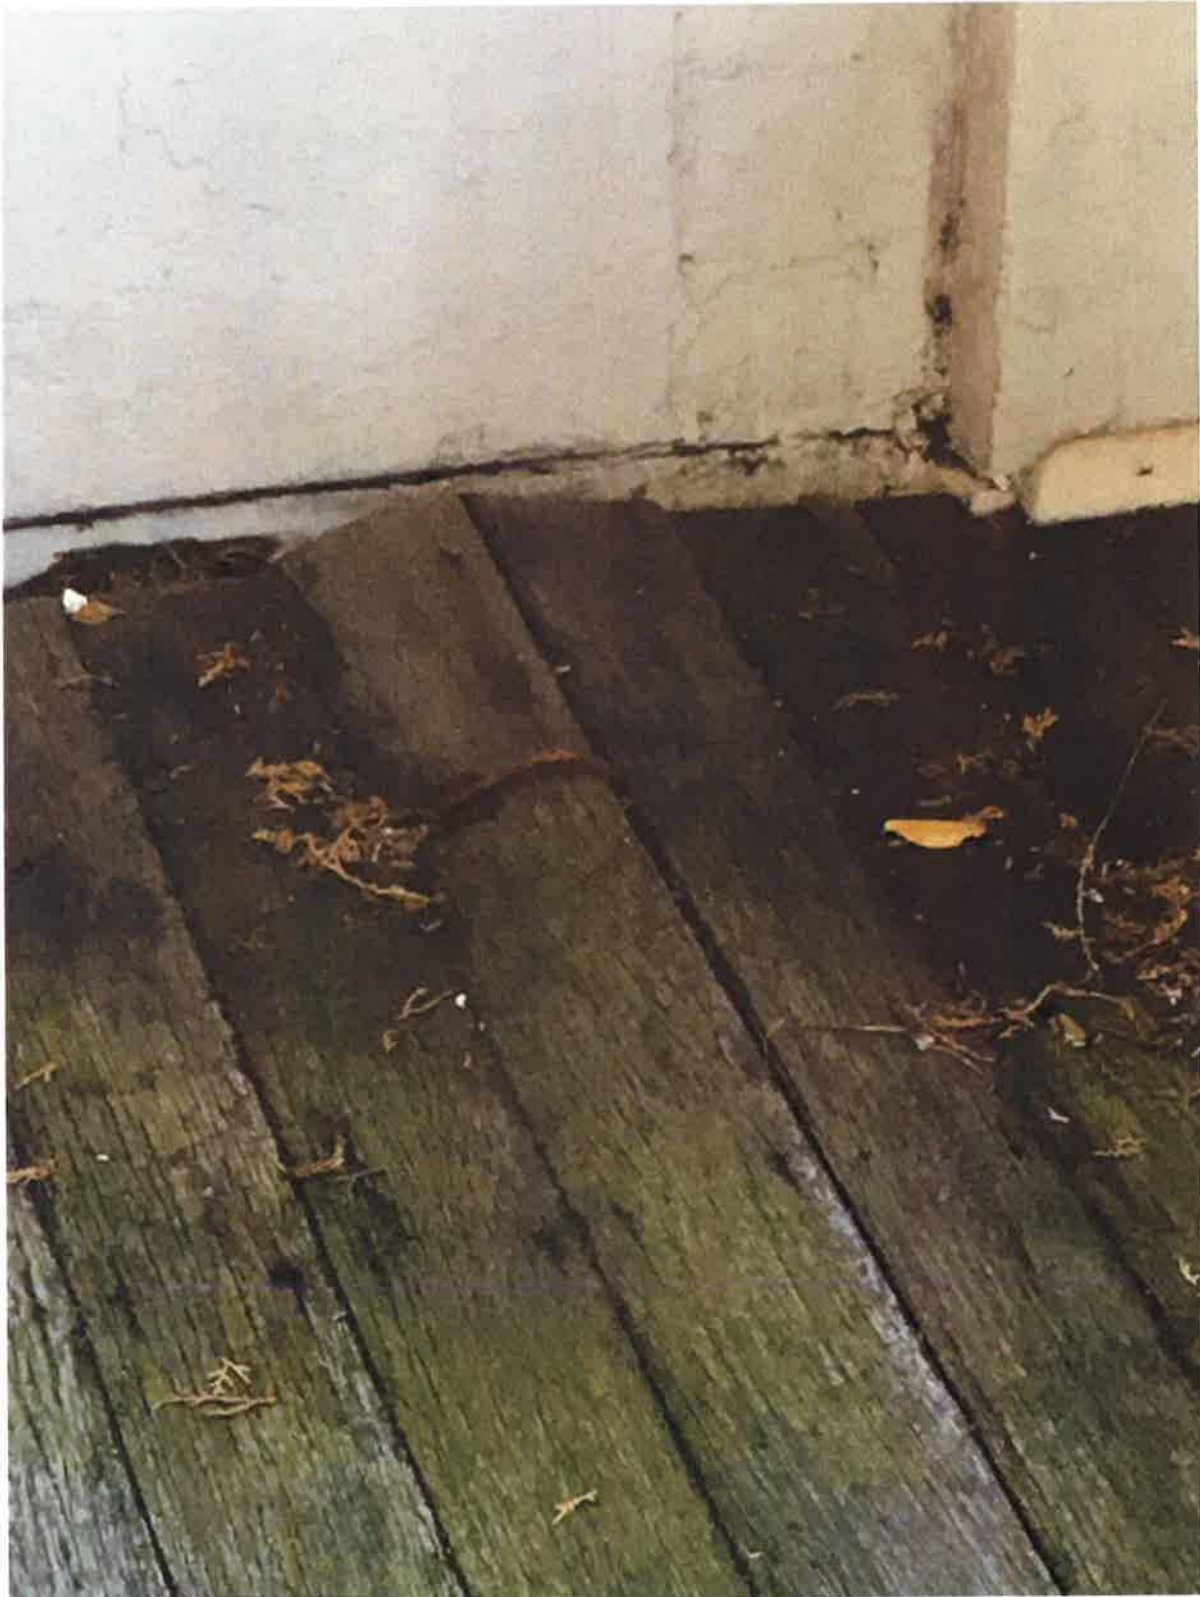
12. The floor boards to the front first floor balcony have buckled vertically from moisture absorption and expansion. Refer photograph 12.
13. No drainage is available for storm water run-off to the balcony thereby leading to water damage to concealed structure beneath.

P12 – Buckling to first floor balcony floor boards.

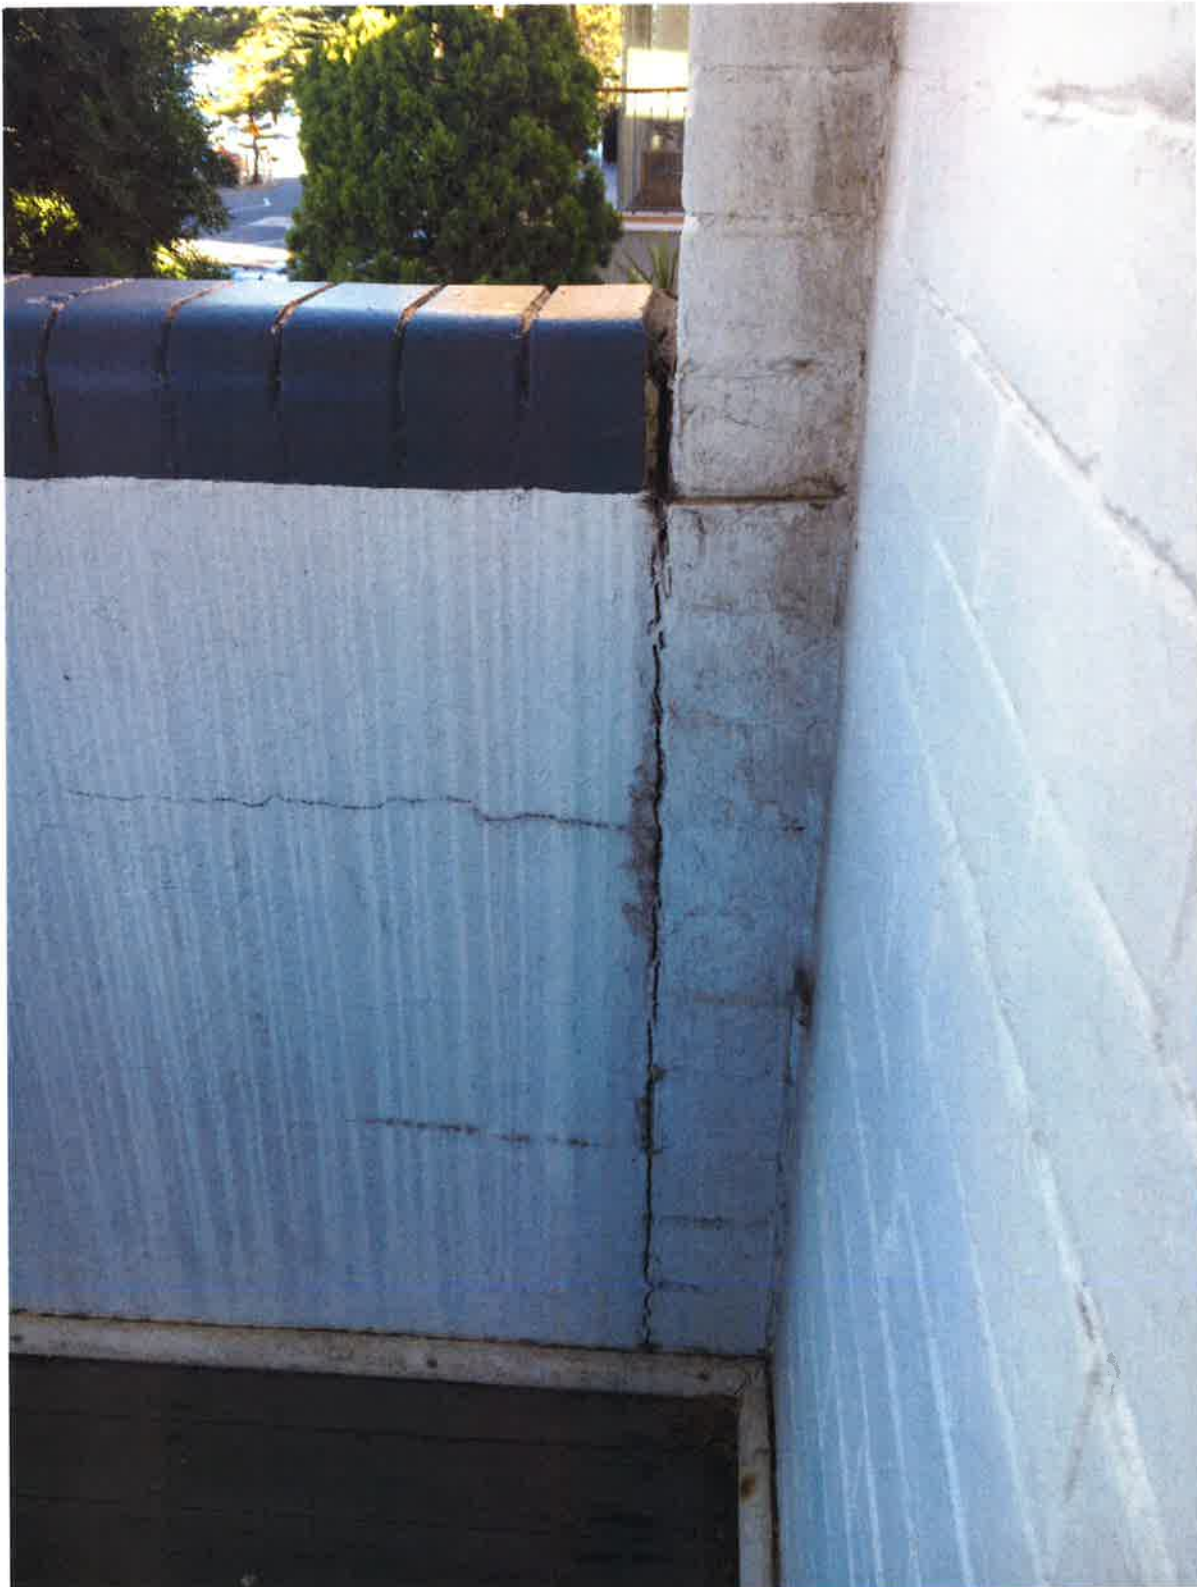
14. The brickwork balustrade to the balcony has separated from the façade and lacks the lateral restraint required to comply with Australian Standards. Refer photograph 13.

P13 – Separation of first floor balcony balustrade from façade brickwork.

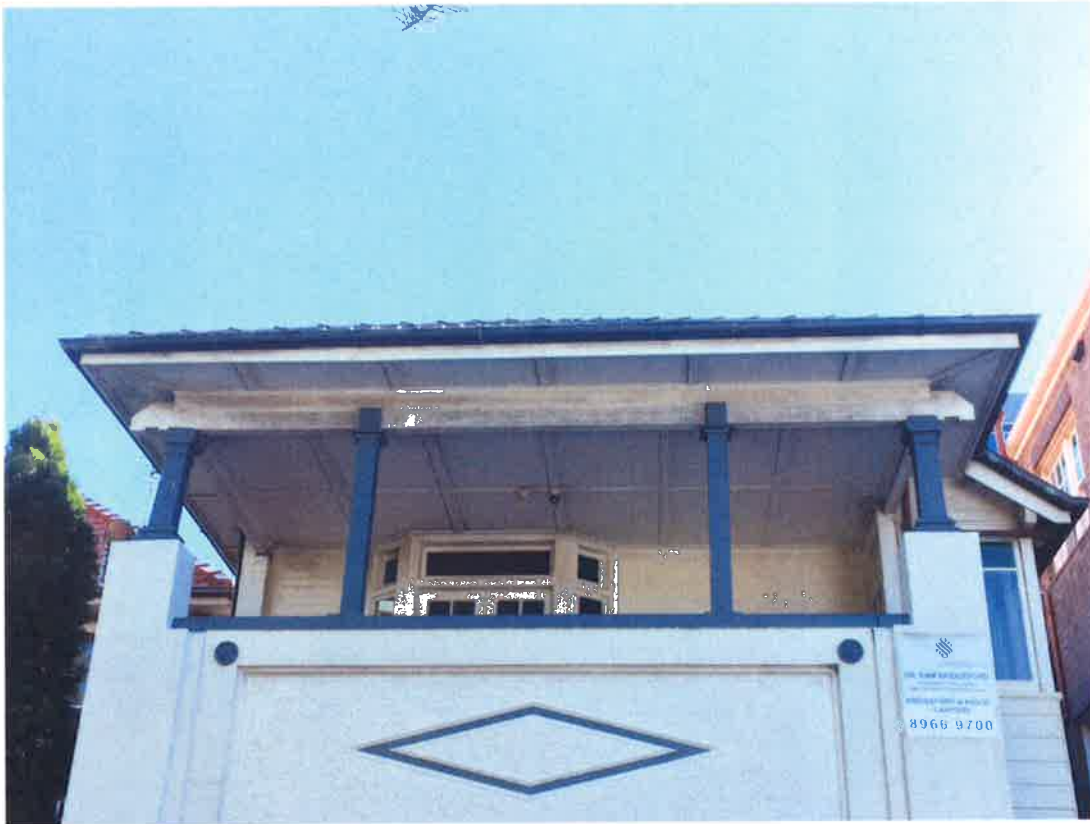
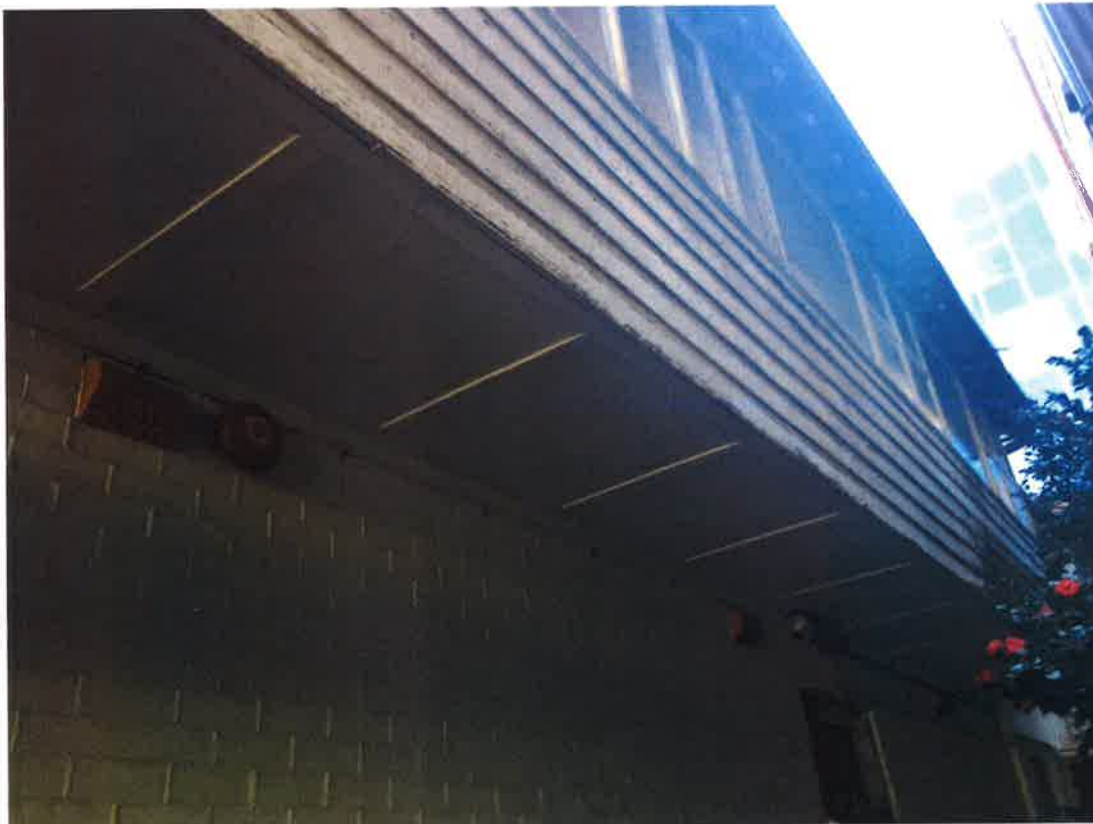
15. The bay window fenestration to the masonry built part of the building can be salvaged, surface treated and reinstated to keep the original style. The entire north-eastern overhanging timber framed section to the first floor is rotten beyond repair however the frosted glass windows could be salvaged and reinstated. Refer photographs 14 and 15.

P14 – Bay window fenestration to brickwork constructed part of building.

P15 - North-eastern overhanging section to the first floor.

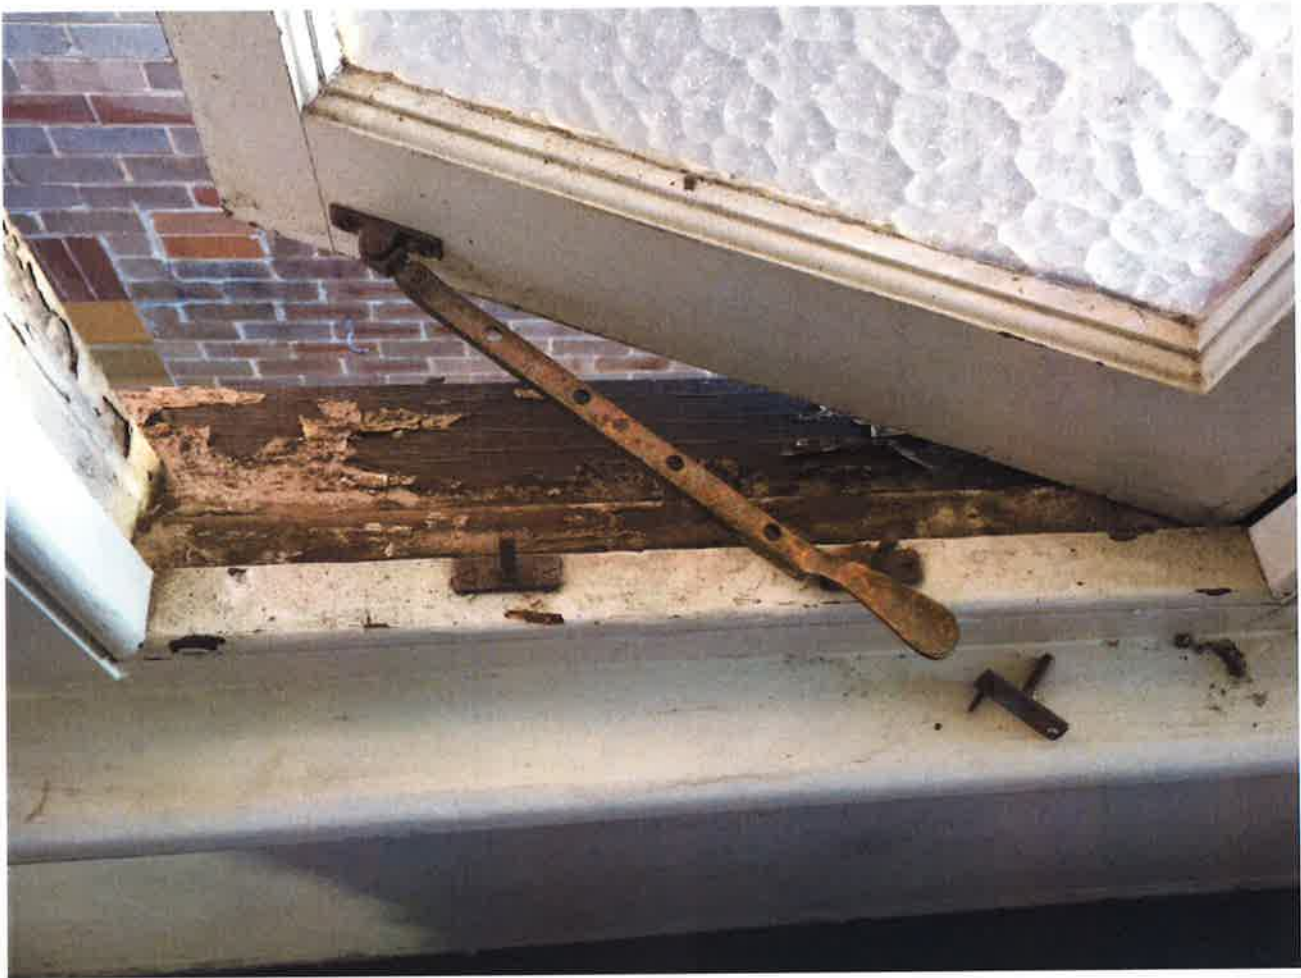
16. There is a moderate degree of timber rot due to weathering to the north-eastern external window frames and they are considered beyond the limit of practical repair. Refer photograph 16.

P16 – Weathering and rot to the north-eastern external window frames.

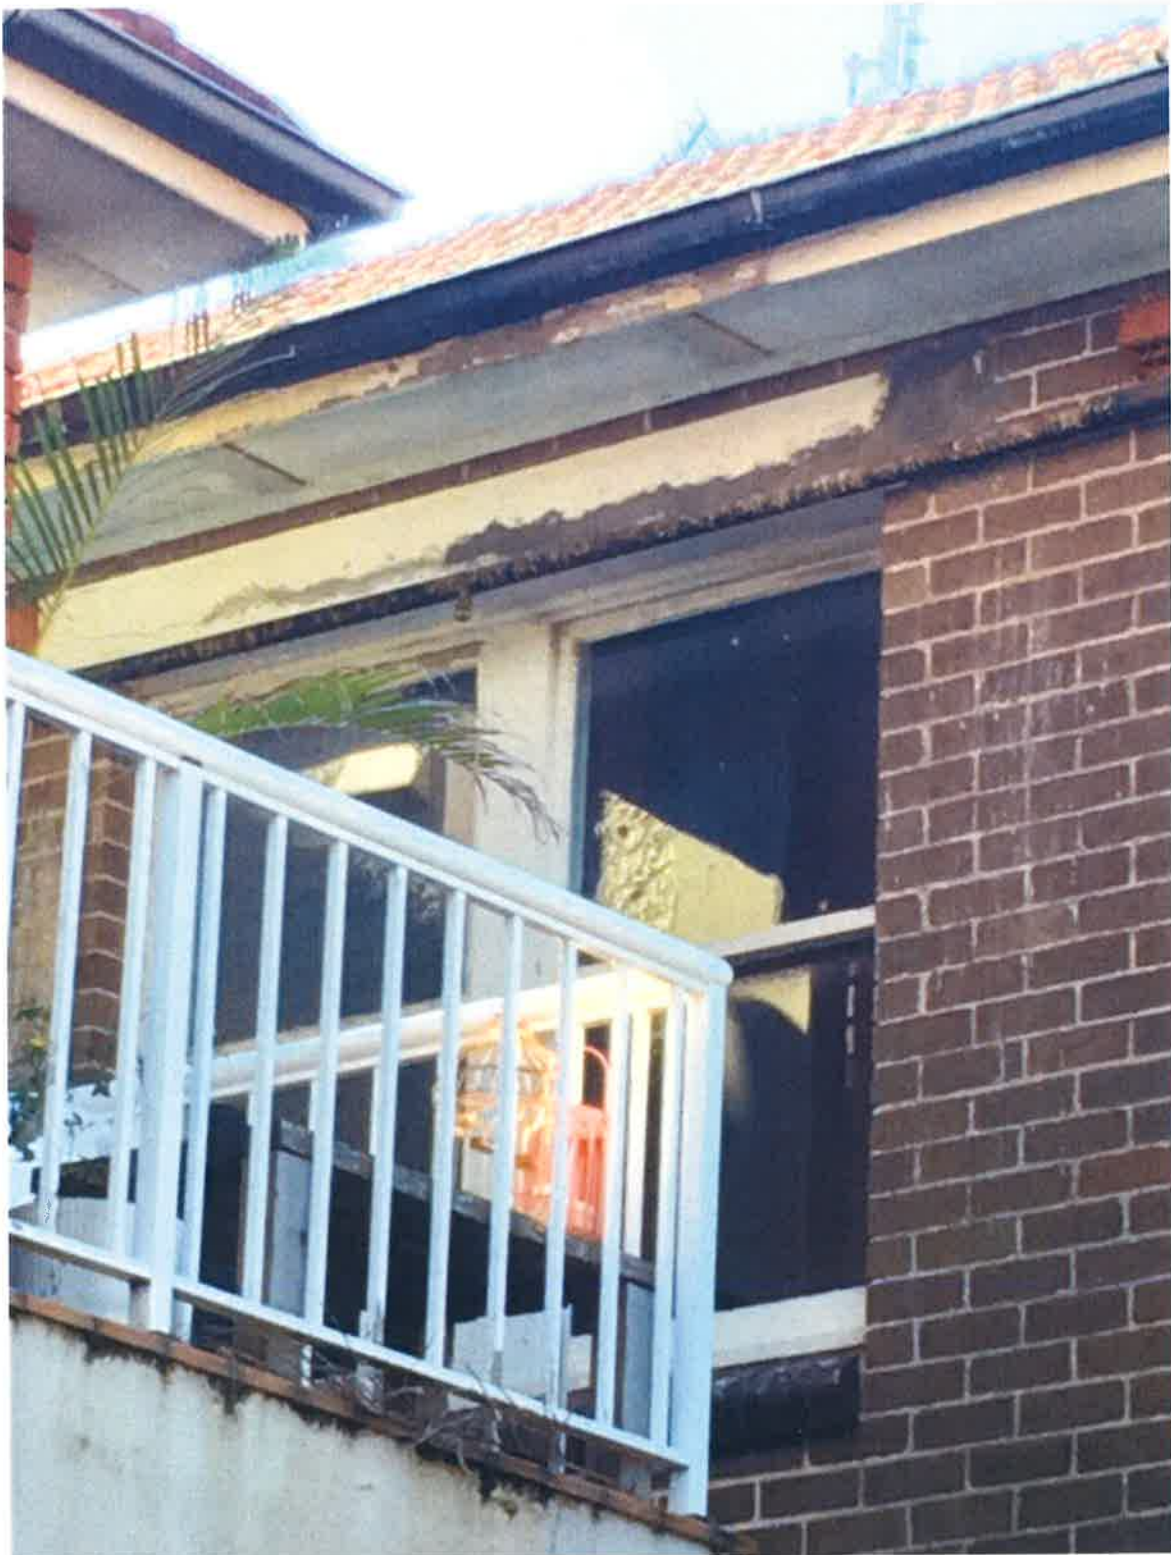
17. Lintels on the south-western façade have corroded and show signs of previous patch repair work. Ongoing spalling and deterioration is evident. Refer photograph 17.

P17 - Corroded lintels with patch repair on the south-western façade.

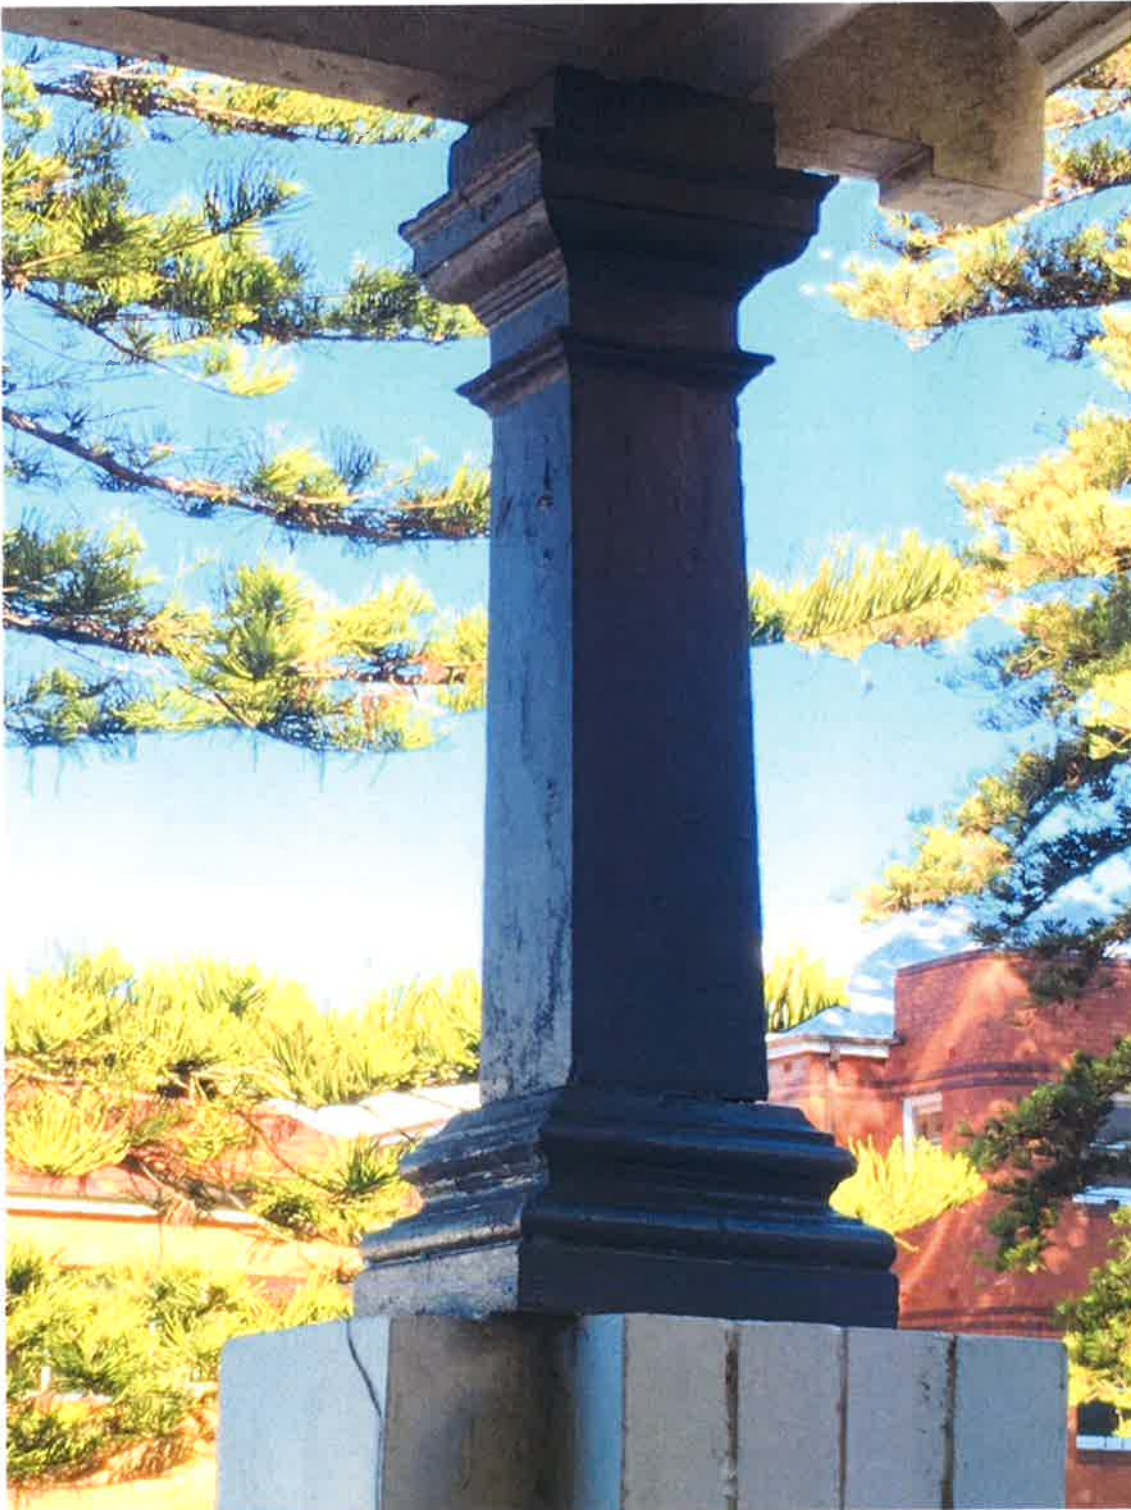
18. A timber post which supports the balcony roof framing exhibits rot which has caused it to swell and distort and requires replacement. Refer photograph 18.

P18 - Timber post supporting the balcony roof exhibiting rot and is distorted.

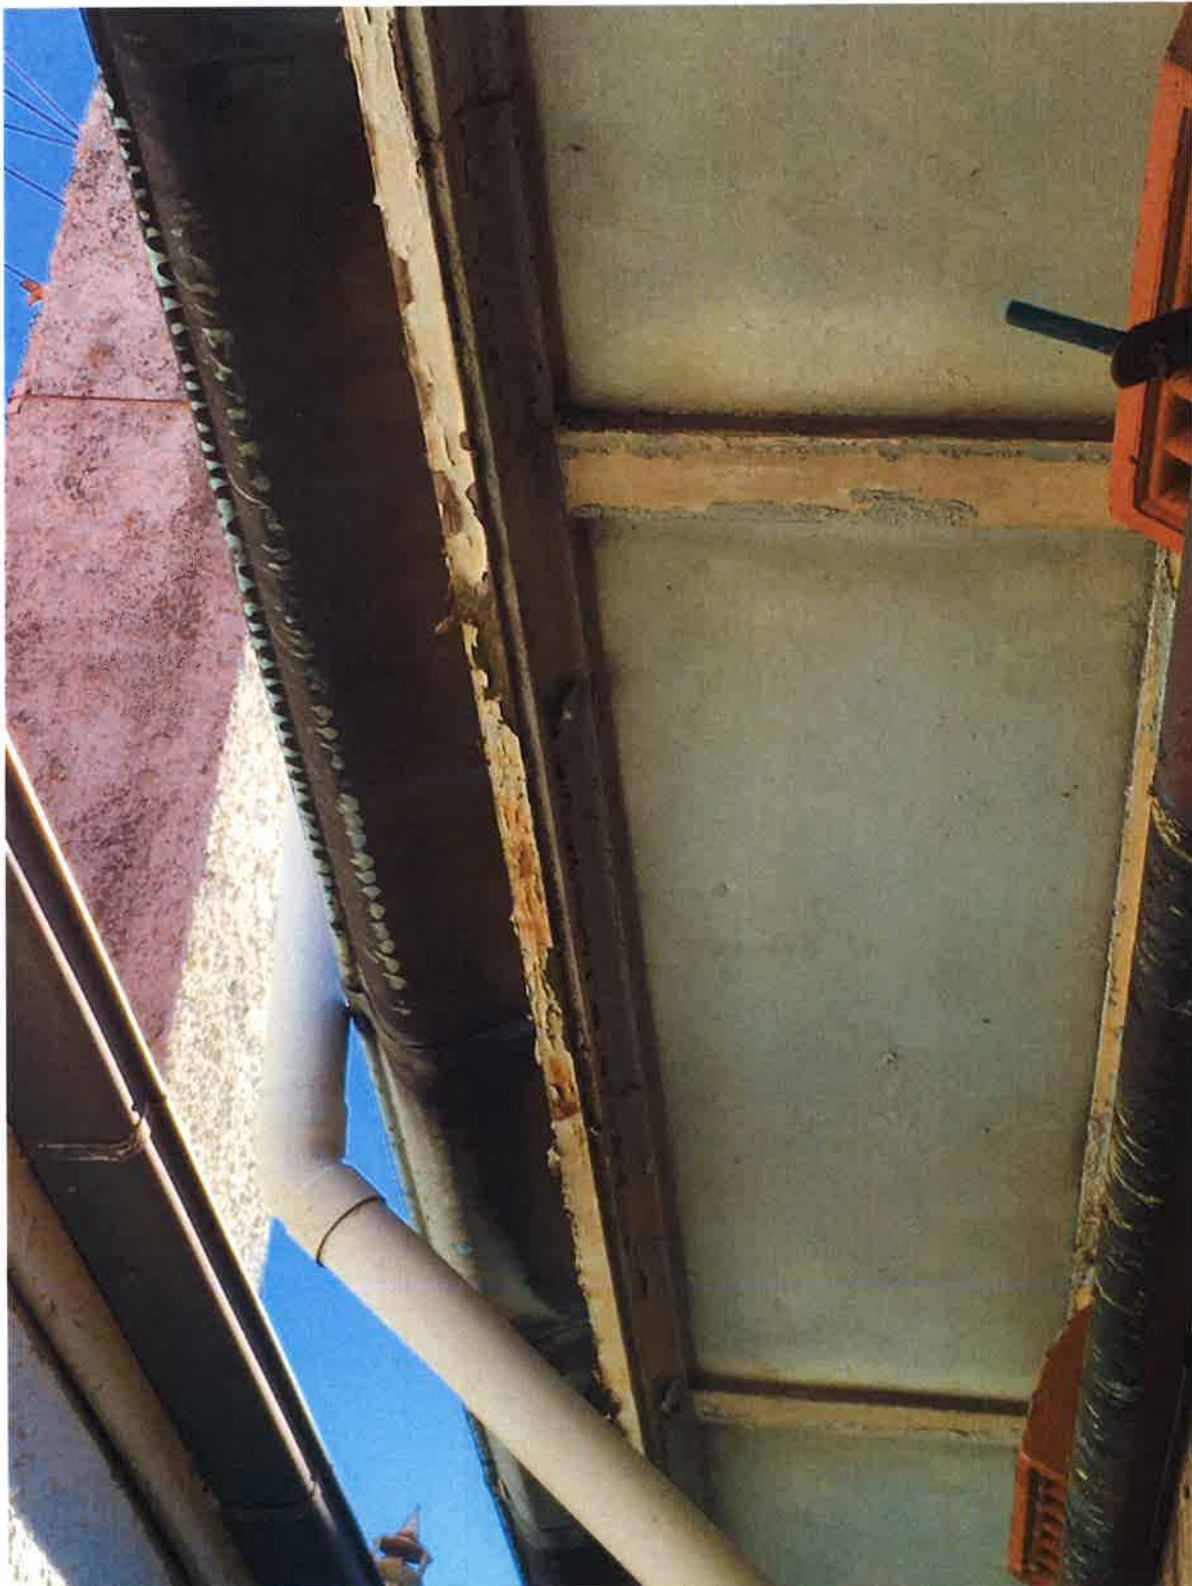
19. The eaves gutter along the south-western side of the building has detached from the roof and the eaves are lined with asbestos that must be removed. Refer photograph 19. The eaves gutters have detached and need to be replaced.

P19 – Detached eaves gutter to south-western side of building and asbestos eaves lining.

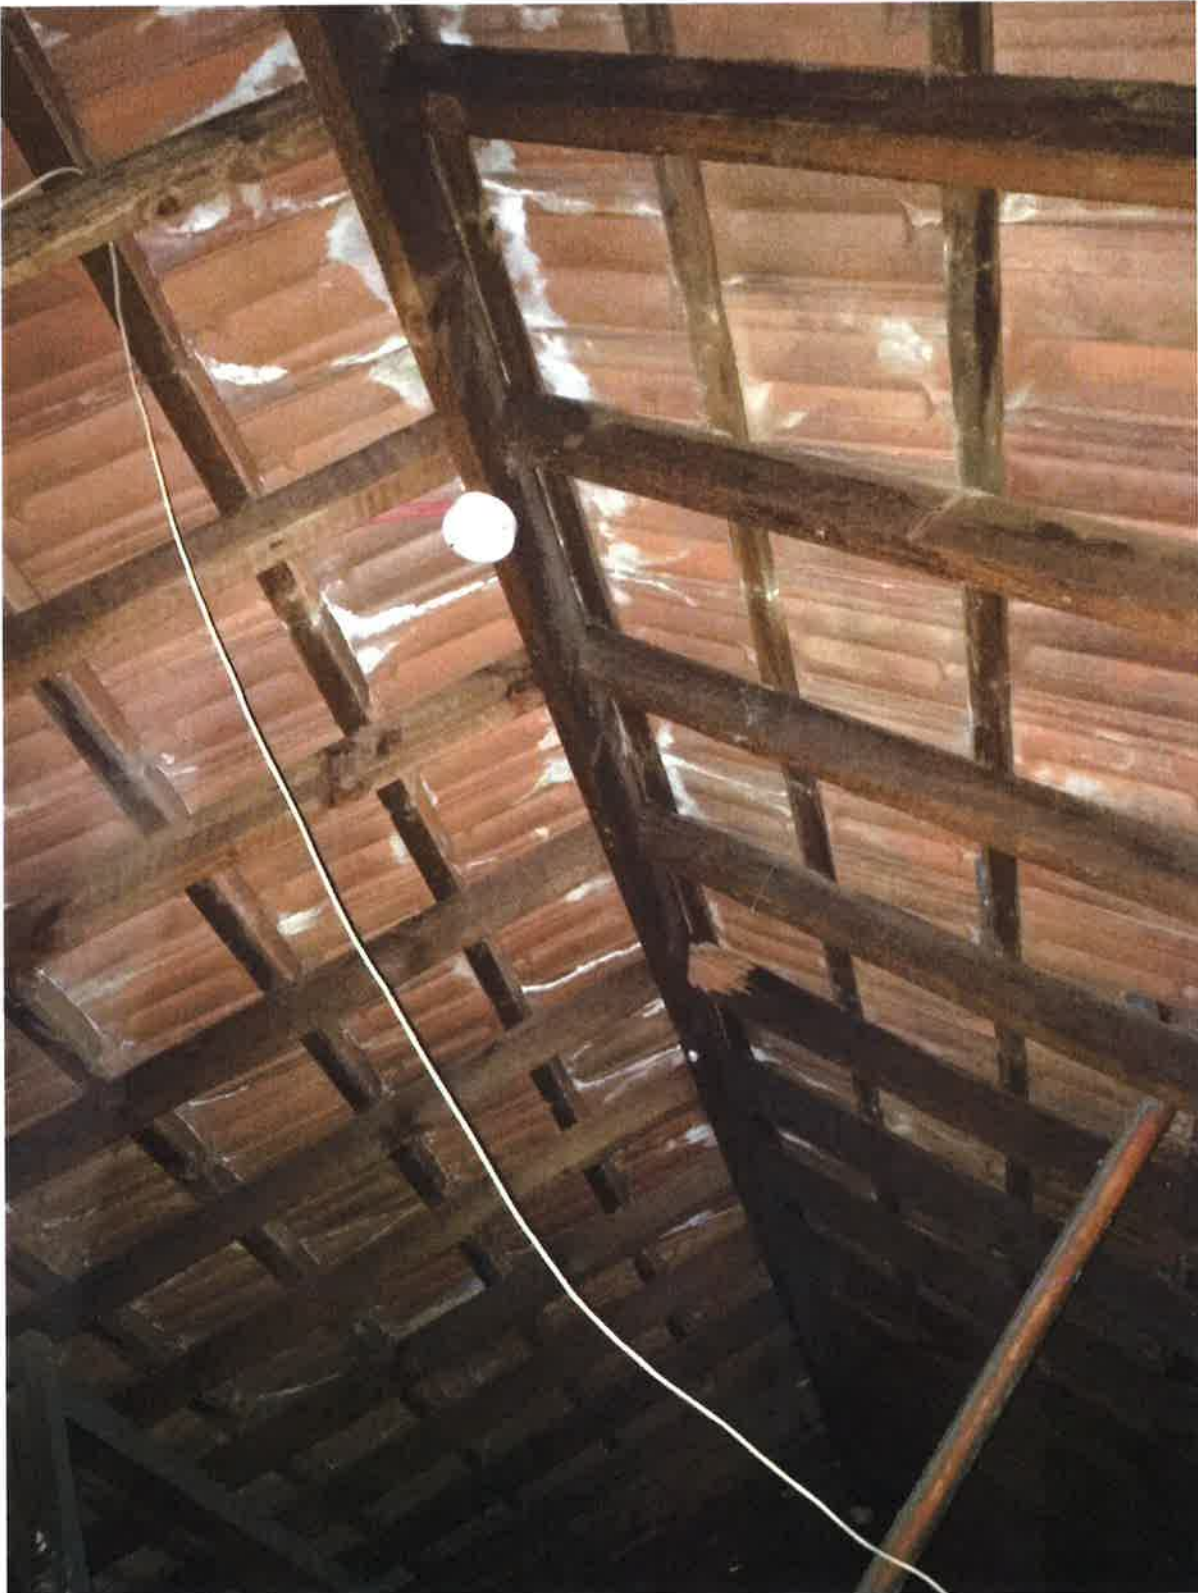
20. The underside of the roof tiles exhibit efflorescence from salt ingress as there is no glazing to the underside of the tile. The outer glaze has also deteriorated thereby allowing water ingress and efflorescence observed. This consequentially causes an inability to resist salt ingress and disintegration of the tiles. Refer photograph 20. The roof tiles will begin to fret and break away.

P20 - Efflorescence to underside of roof tiles.
