## **36 Lindley Avenue, Narrabeen**

### Geotechnical Comments for Section 4.55.

## **GEOTECHNICAL INVESTIGATION:**

Alterations & Additions at **36 Lindley Avenue, Narrabeen**

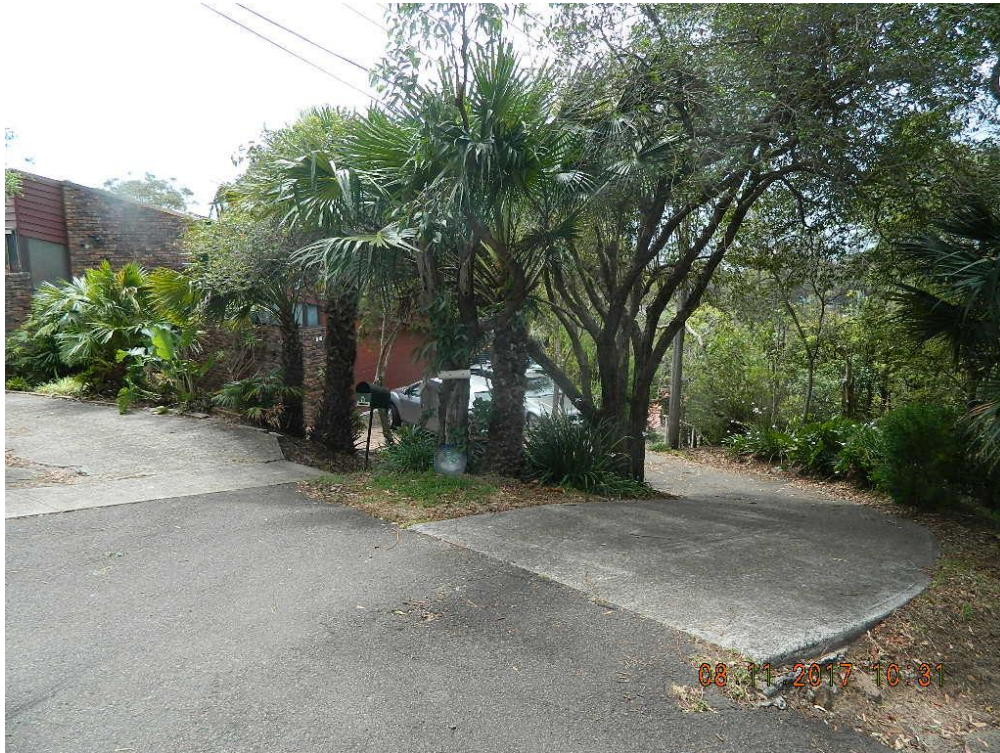
Photo 1

- 2.3** From the road frontage a concrete driveway runs to a brick paved parking area and garage attached to the uphill side of the house (Photos 1 & 2). Another shared driveway lines the W boundary of the property and runs to the downhill neighbouring properties (Photo 3). Filling has been placed for the parking area. It is supported by a concrete block retaining wall that is partly obscured by thick vegetation (Photo 4). From what could be seen of the wall it appears stable. The two storey brick house displays no significant signs of movement in the external supporting walls that could be associated

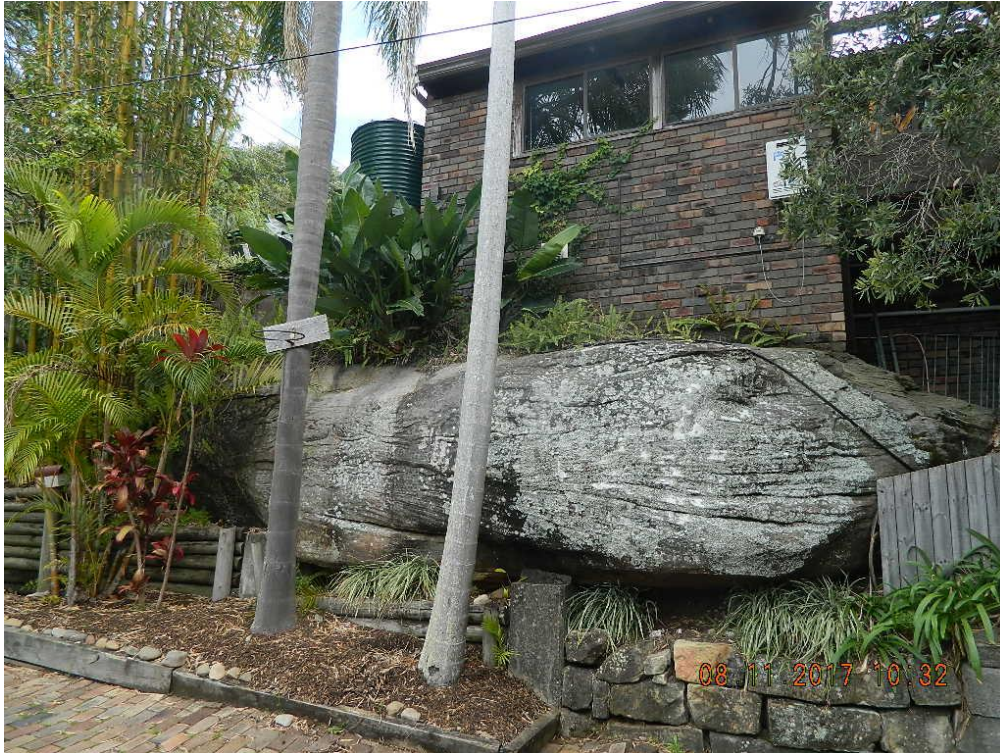
Photo 5

with slope instability. The E side of the house is partly supported on an exposed, large medium strength sandstone joint block (Photo 5). The block is mostly embedded in the slope and displays no visible signs of movement. Beside the lower E side of the house ~1.4m of filling has been placed for a brick paved area (Photos 6 & 7). It is supported by a brick retaining wall that appears stable. There was minor settlement of the surface pavers and underlying fill beside the house (Photo 7). The movement is expected to be due to inadequate compaction of the fill and it is not considered a significant risk to life or property. On the lower NE corner of the block an excavation has been made into the slope for a concrete slab and awning (Photo 8). The cut is supported by an old rough stack rock retaining wall. The proposed retaining wall will be constructed below and beside the existing retaining wall and the void backfilled between the old and new walls.

It should be noted that bands of medium to high strength sandstone were exposed to the S of the proposed works (Photo 5) and on the neighbouring property to the W (Photo 10). The ground tests did not exceed a depth of 1.8m below the current surface and did not encountered sandstone. The rock strength below the tests is unknown but is expected to gradually increase with depth.

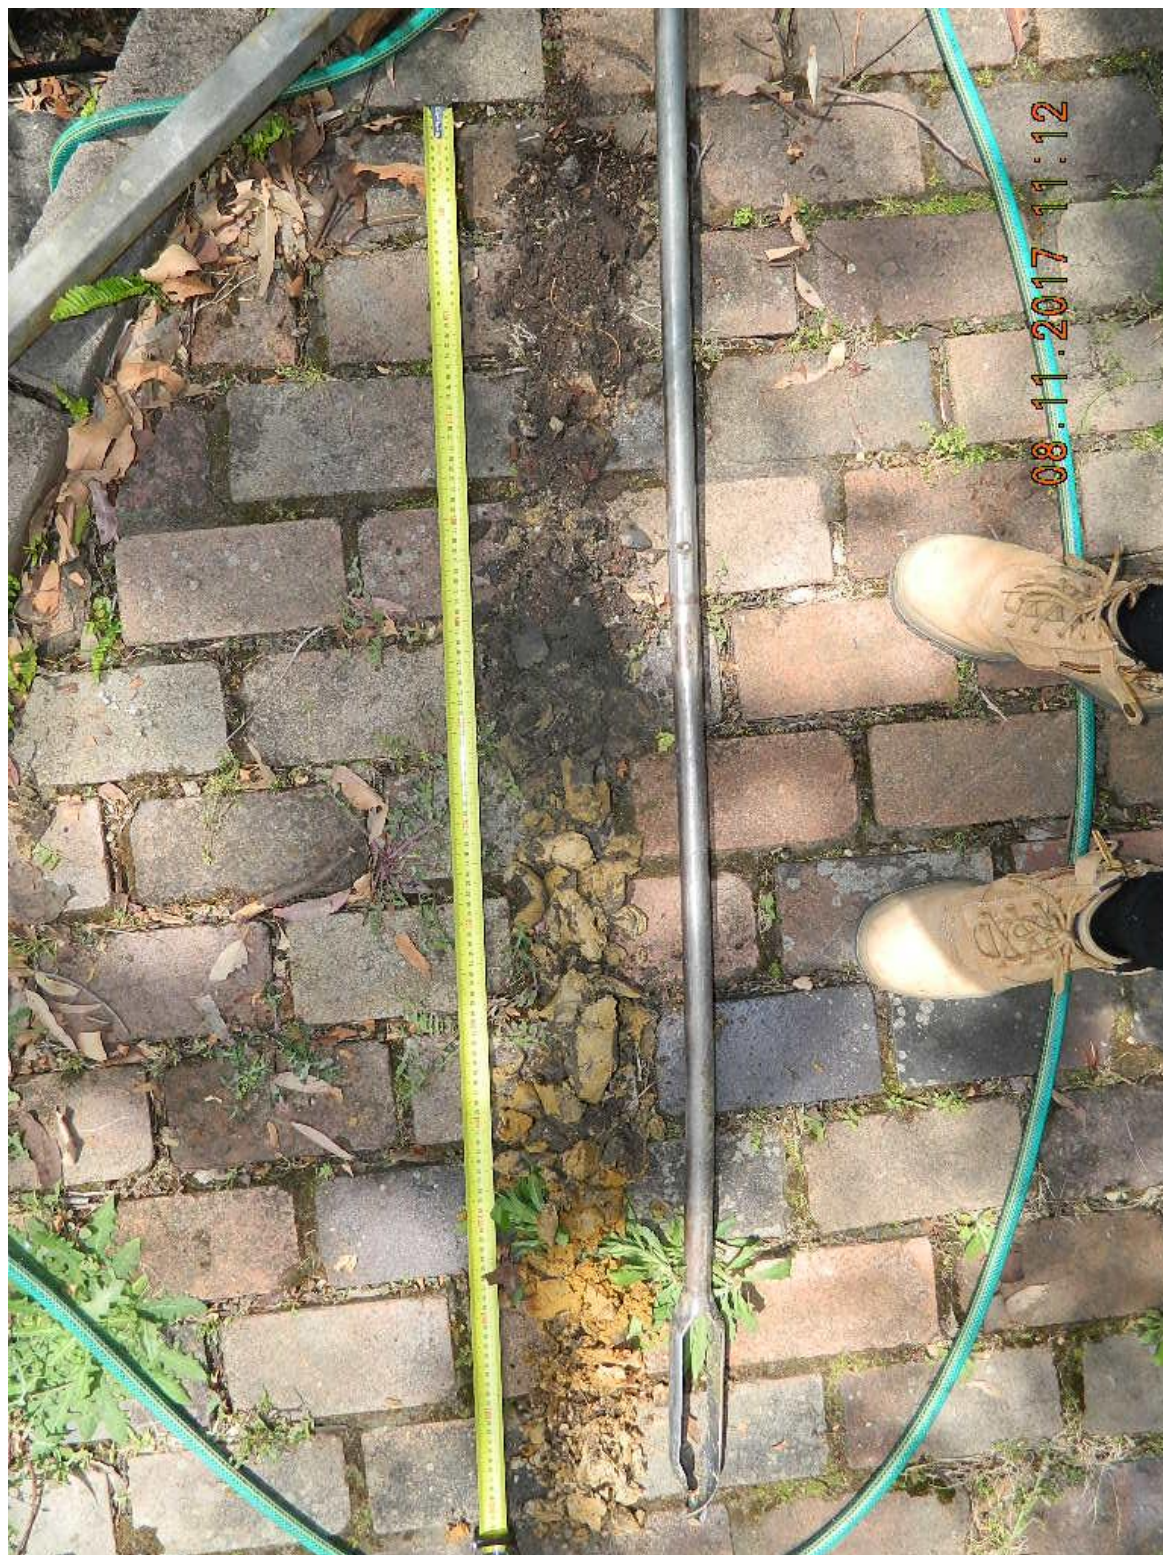
## AUGER HOLE 1 (~RL 20.5) – AH1 (Photo 9)

End of hole @ 1.4m. Auger still very slowly penetrating clay like weathered rock.  
No watertable encountered.

*Photo 9 – Base of the auger is at the bottom of the photo*

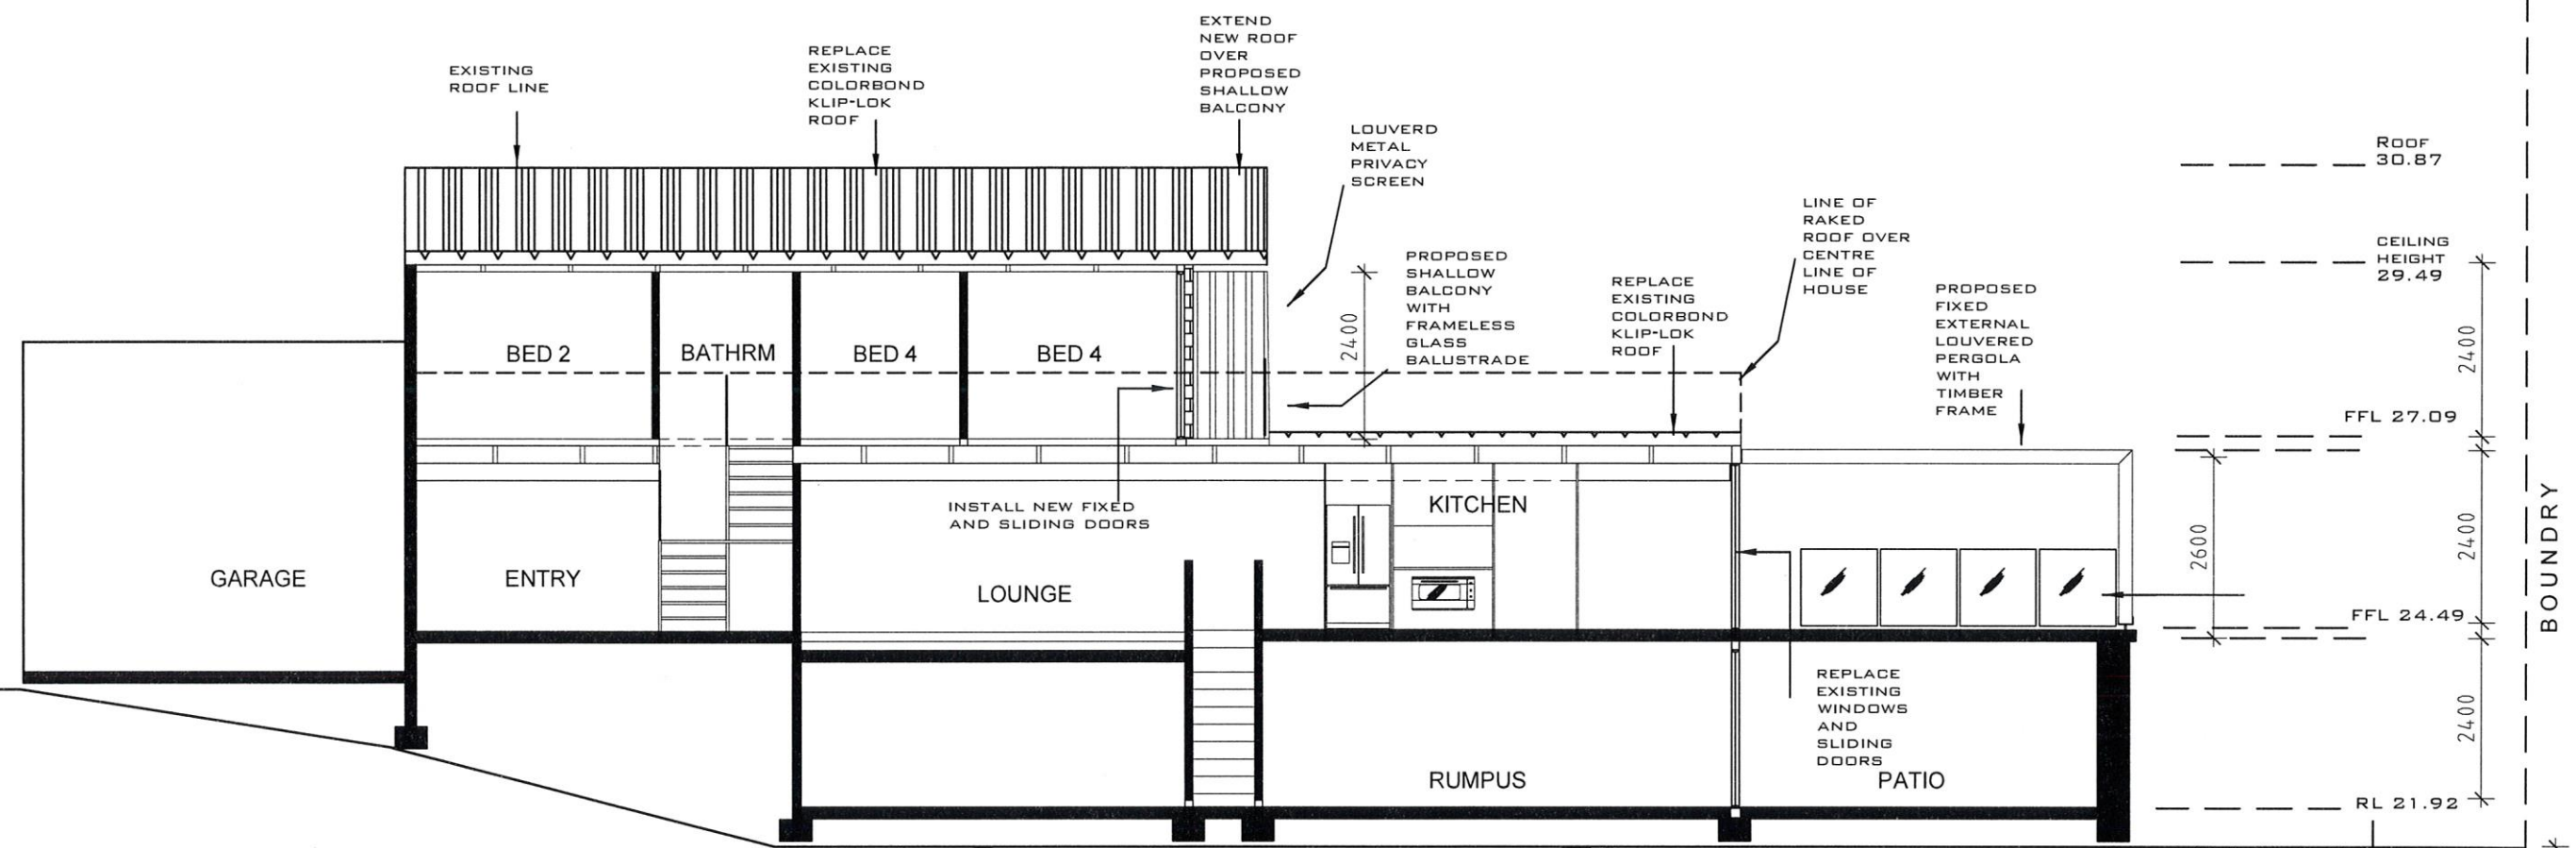
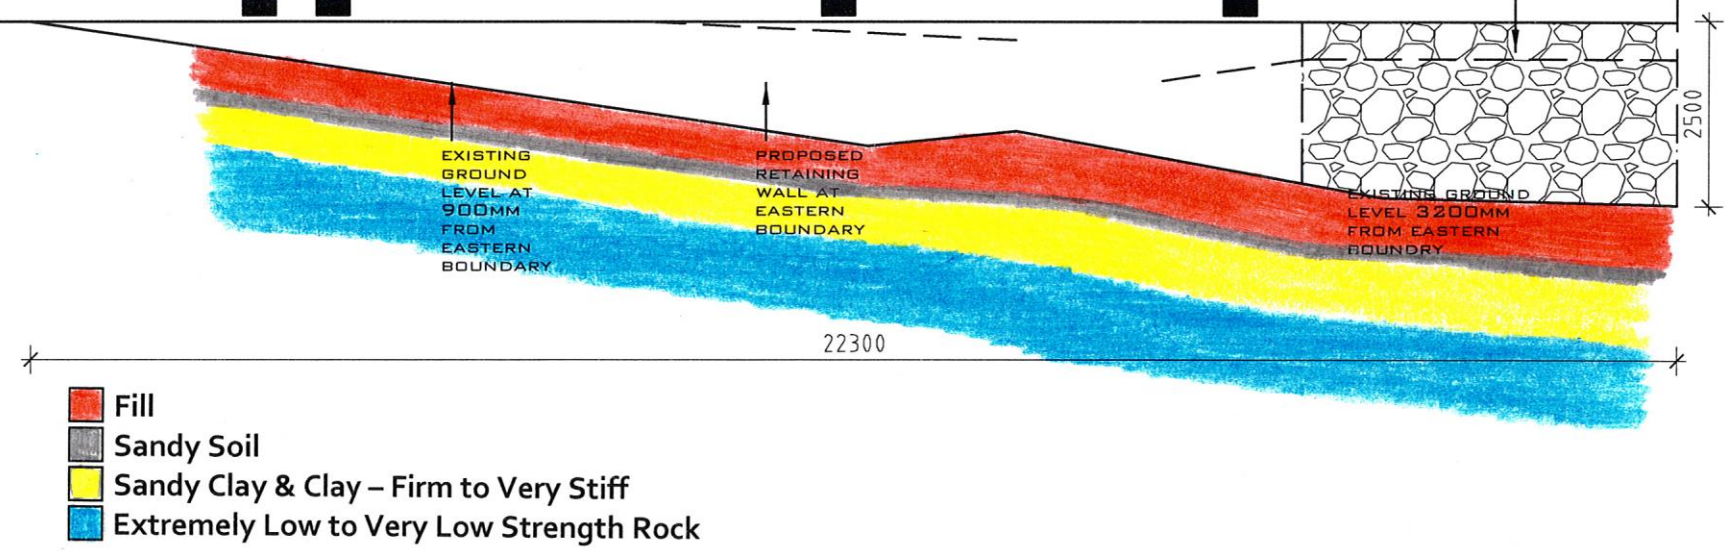
## SECTION 1-1 (WD01)

See Type Section attached for a diagrammatical representation of the expected ground materials.
