## **21 Moore Street, Clontarf**

### Comments on Updates to Plans

## **GEOTECHNICAL INVESTIGATION:**

### **Alterations and Additions and New Pool at 21 Moore Street, Clontarf**

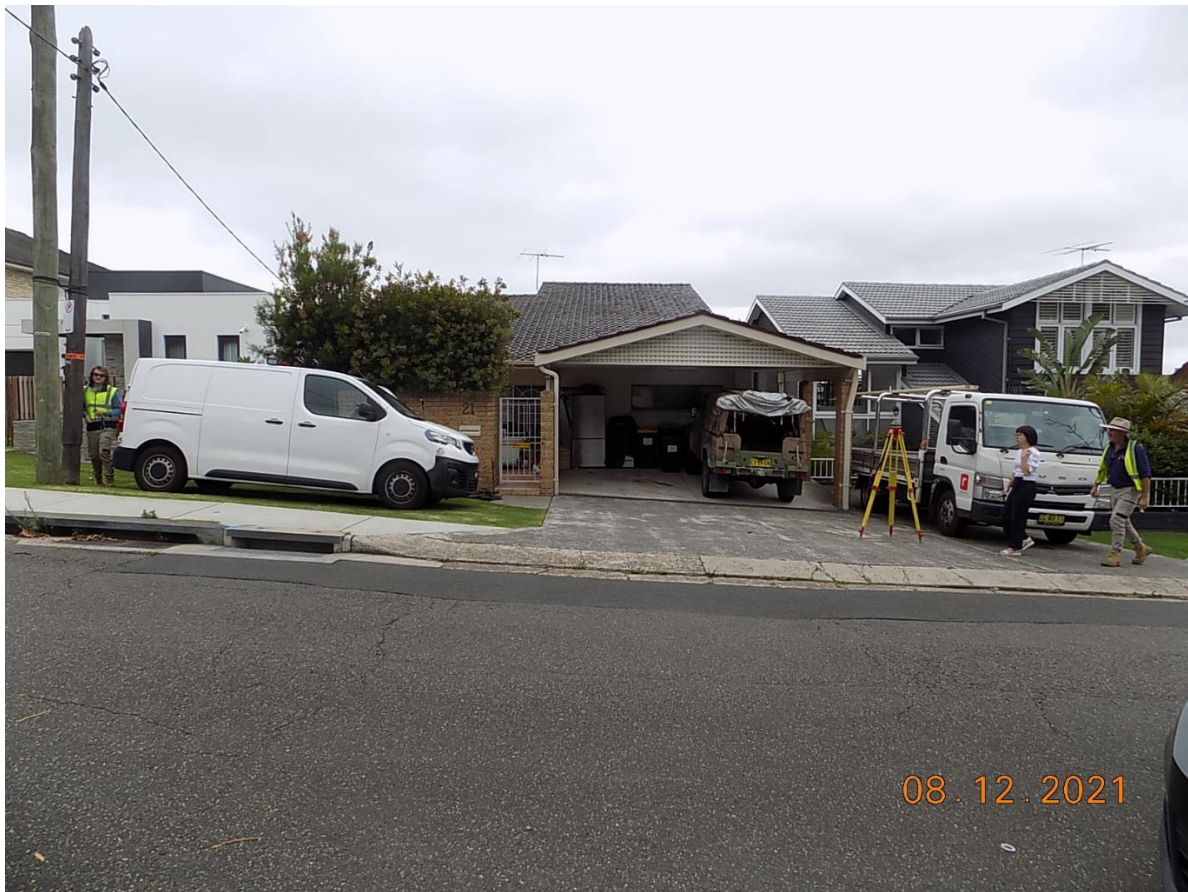
Photo 1

- 2.3** At the road frontage, a concrete driveway runs to a stable carport attached to the uphill side of the house (Photo 1). Between the road frontage and the house is a gently sloping tile-paved patio (Photo 2). The part three-storey brick house is supported on brick walls (Photo 3). No significant signs of movement were observed in the supporting brick walls. A level terrace extends off the downhill side of the house that will be demolished as part of the proposed works (Photo 4). A void was observed under the W end of the terrace. A pool has been cut into the slope below the terrace

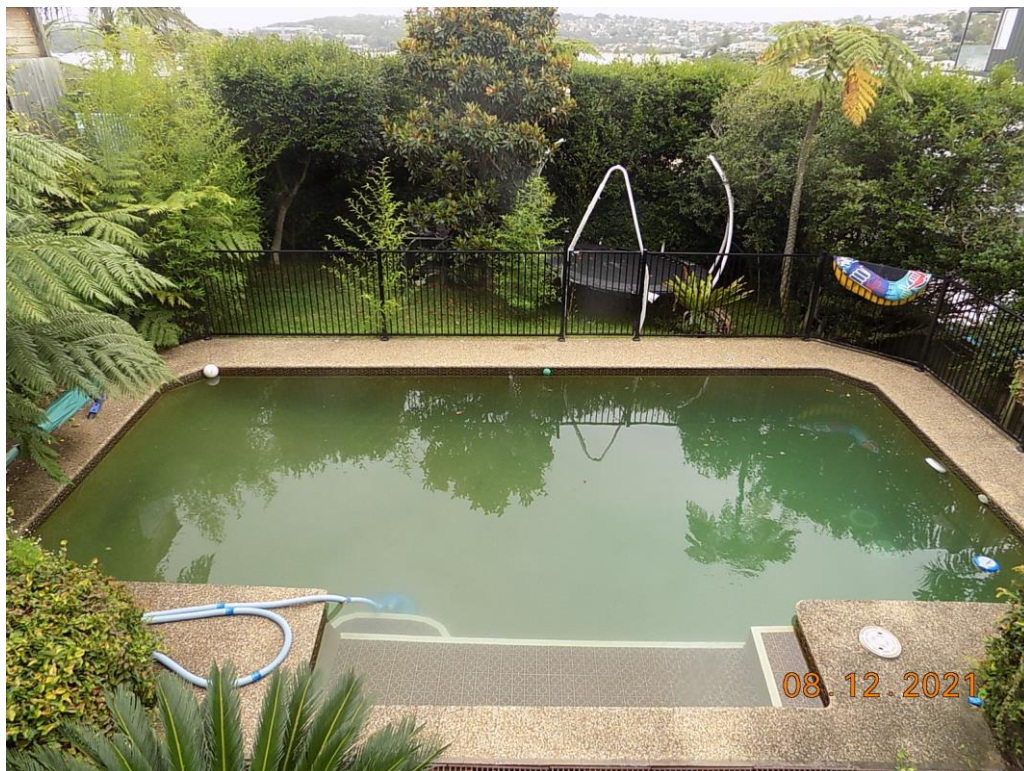
Photo 5

(Photo 5). The pool will also be demolished as part of the proposed works. A gently sloping lawn-covered fill extends off the downhill side of the pool to a garden area near the lower common boundary (Photo 6). The fill is battered to stable angles and will be removed as part of the proposed works.

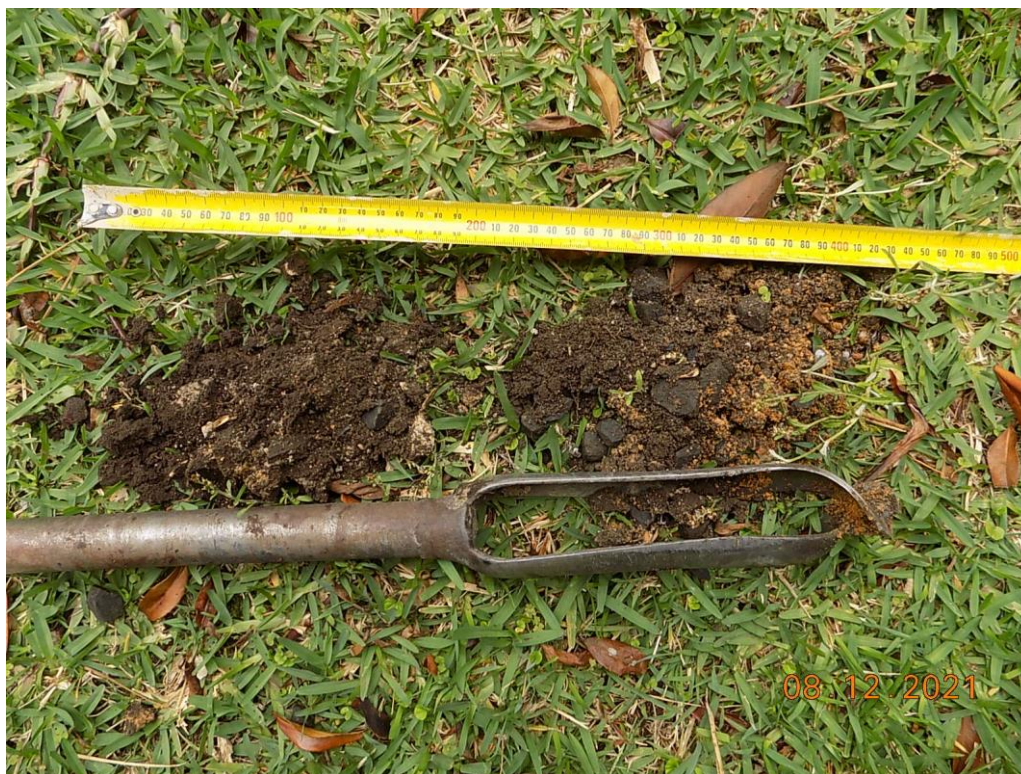
#### AUGER HOLE 1 (~RL43.8) – AH1 (Photo 7)

| Depth (m) | Material Encountered |
|---|---|
| 0.0 to 0.4 | <b>FILL</b> , disturbed gravelly soil, dark brown, medium dense to dense, dry, fine to coarse grained with fine trace organic matter. |

Refusal @ 0.4m on obstruction within fill. No water table encountered.

Photo 7: AH1 – Downhole is from left to right
