## ARBORICULTURAL IMPACT ASSESSMENT REPORT

Site Address: 52 Woodbine Street,  
NORTH BALGOWLAH, NSW, 2093

Inspection Dates: 1<sup>st</sup> November 2022  
Report Date: 8<sup>th</sup> November 2022  
Amended Date: 3<sup>rd</sup> February 2023 (Version 3)

Prepared by Gordon Blues  
Diploma (Arboriculture) AQF5  
0439 991122  
[GORDON@BLUESBROS.COM.AU](mailto:GORDON@BLUESBROS.COM.AU)

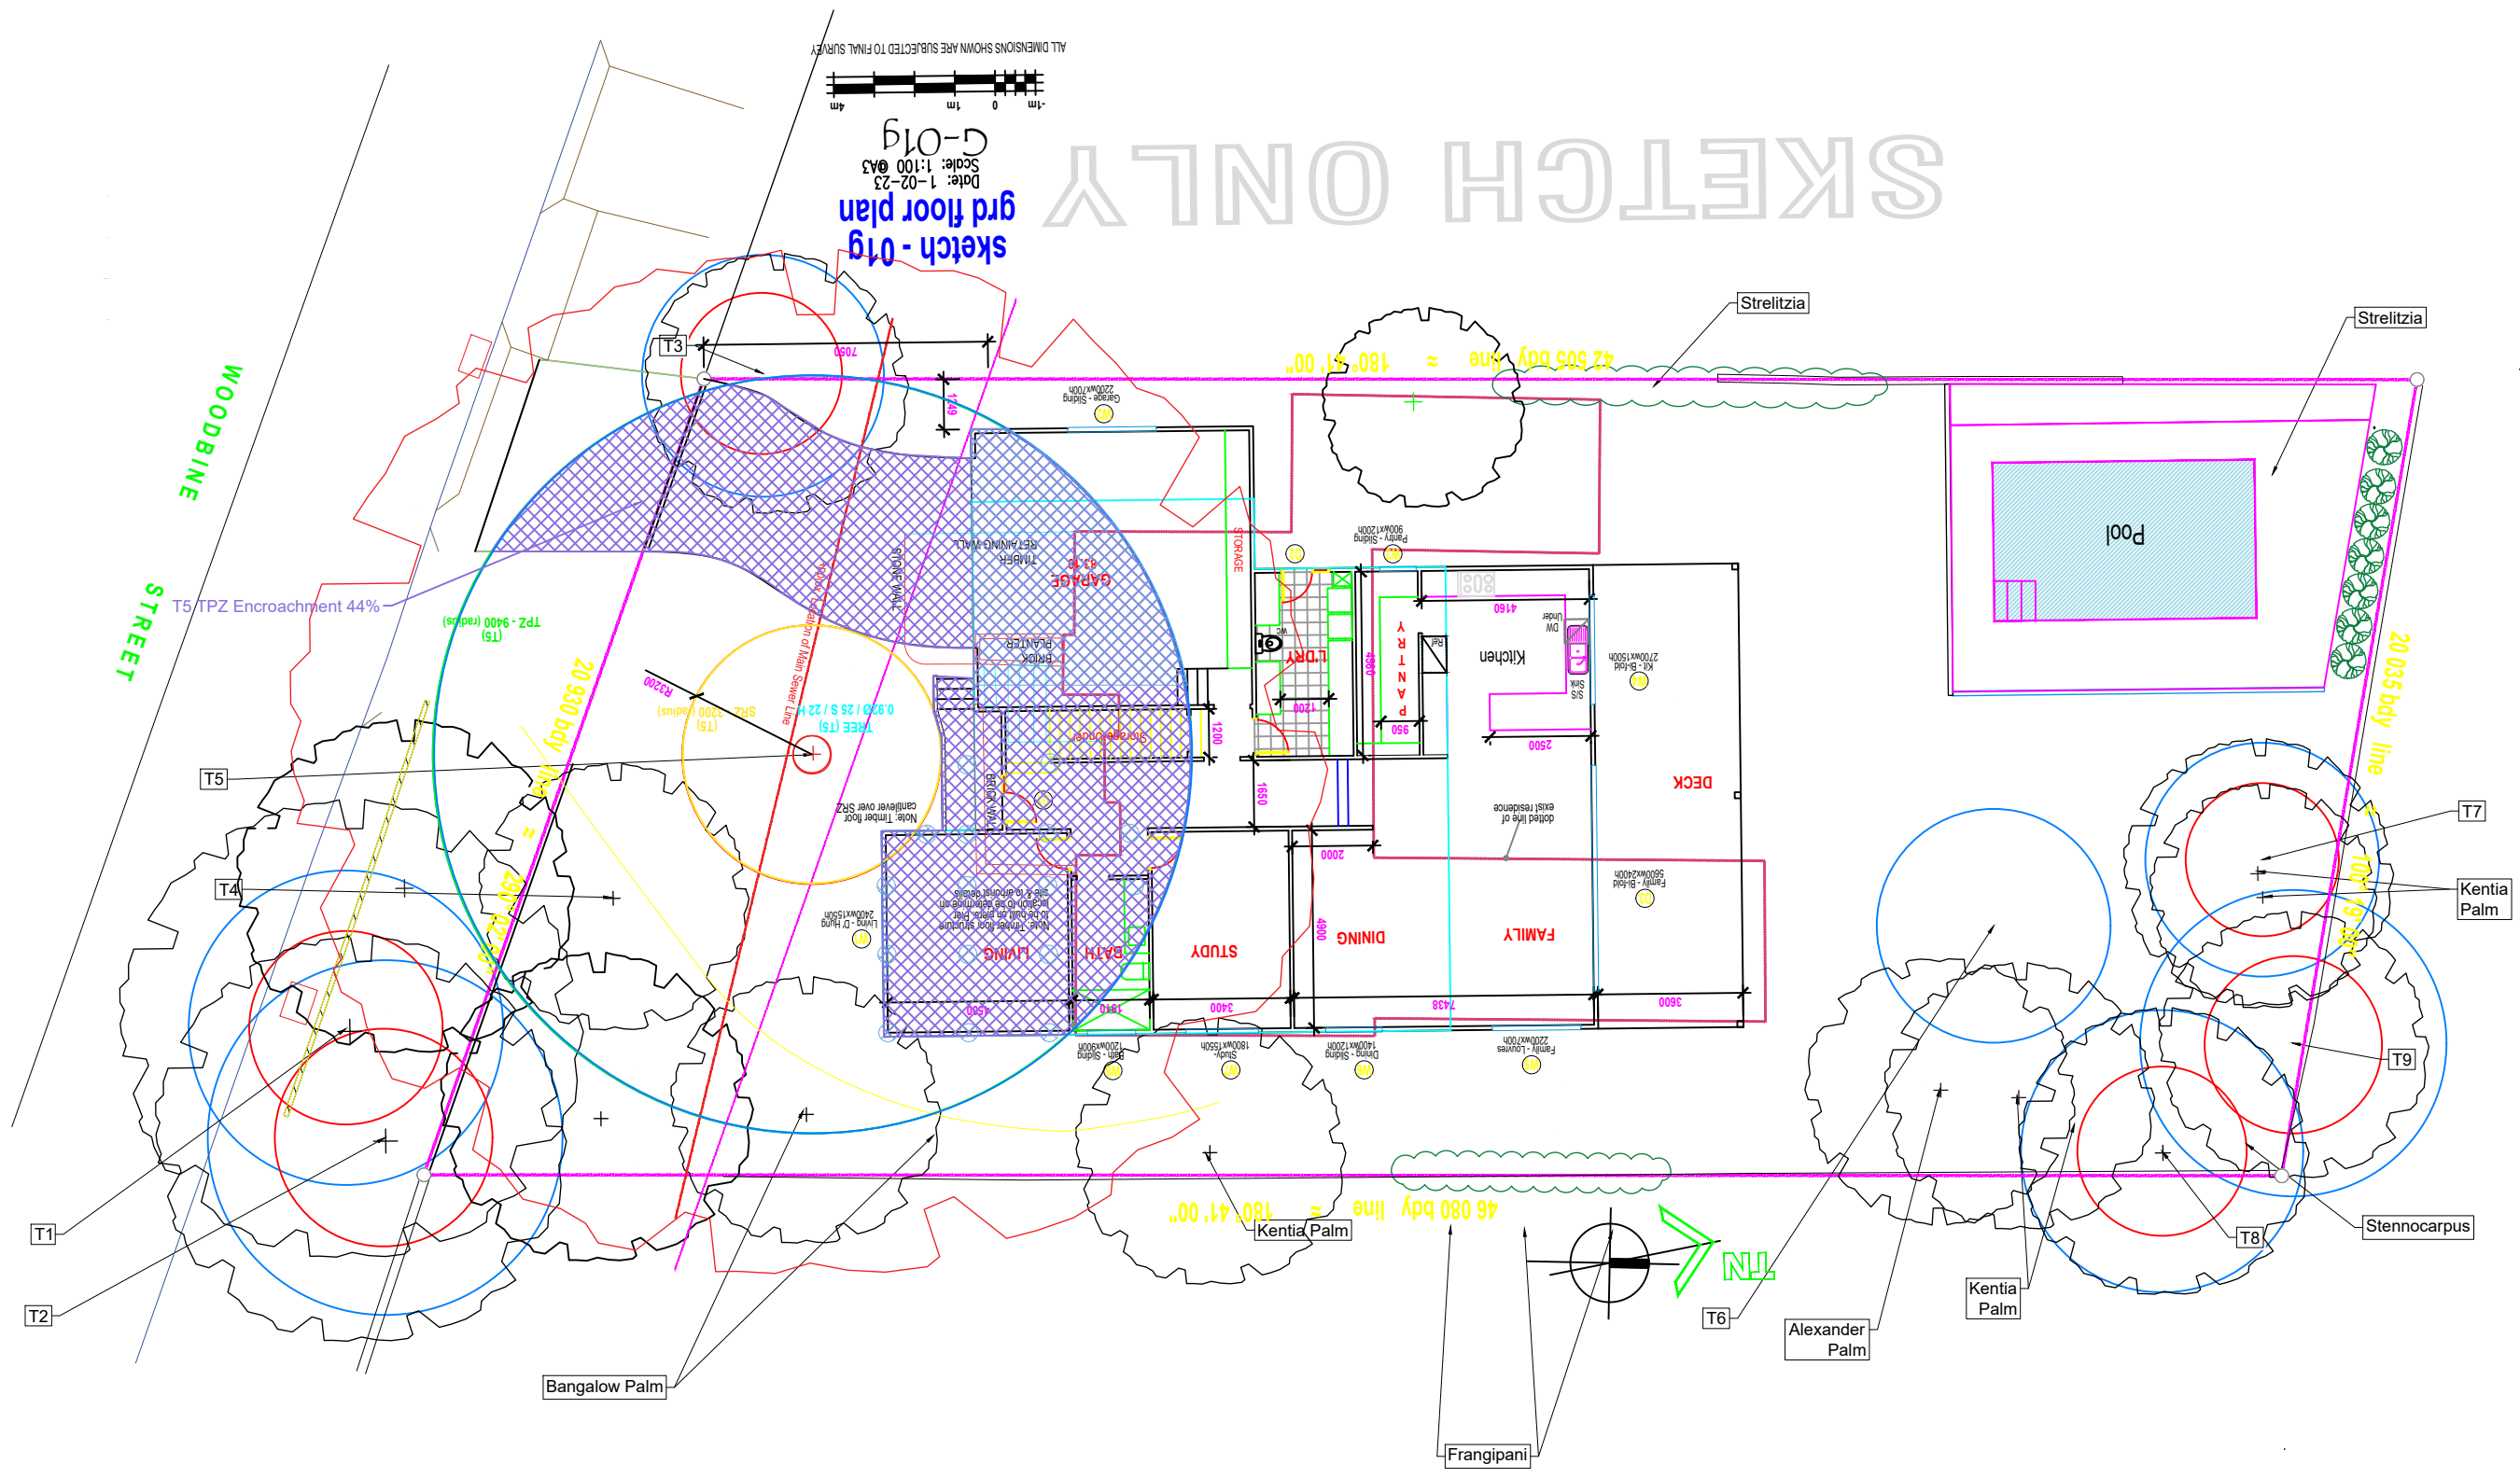
Title:  
Encroachment Potentials

3.5.3 *Major* encroachment of Tree 5's TPZ & SRZ will occur due to the proposed dwelling & driveway. Calculations of encroachment indicate the encroachment will interact with 44% of the TPZ area.

The arborist notes that due to the size and location of the tree, its respective TPZ spans almost entirely across the width of the site.

- 5.2.1 Tree 5 is recommended for retention under the proposed development with the following recommendations:
- It is recommended that the building be located on isolated piers. Engineering tolerances must permit minor translation of pier location should significant tree roots be found.
  - Piers may be excavated by mechanical means, provided excavation equipment used is no larger than 3 tonnes in size. (A larger machine is more powerful & may cause root severance).
  - It is recommended that an AQF 5 Arborist is engaged to supervise the excavation of footings for the proposed garage.
  - See below for recommendations pertaining to driveway surface.

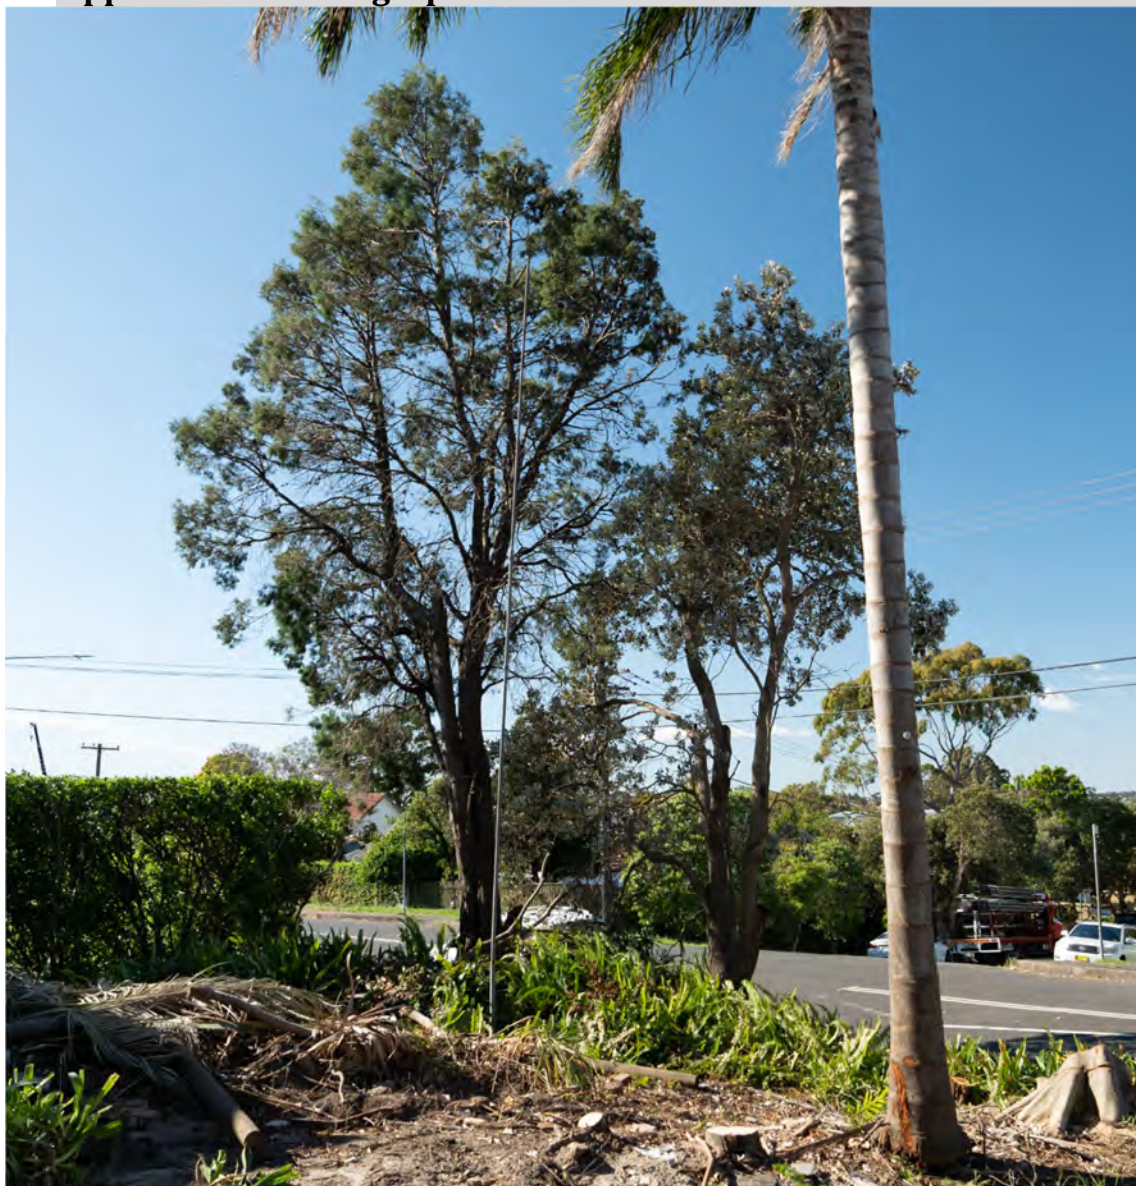
#### 3.4.3 Street trees, T1 & T2, were located atop a raised area of the verge. Both trees presented in good condition. Pruning of lower limbs had occurred for the trees which scored moderate scores of landscape significance.

*Image 2: Street trees T1 & T2, and the exempt Cocos Palm T4 [right].*

- 5.1.1 Tree 4 (Cocos Palm) is listed as an exempt species on Council's DCP. The removal of this tree is recommended due to the proximity of proposed excavation & retaining wall construction within its vicinity.

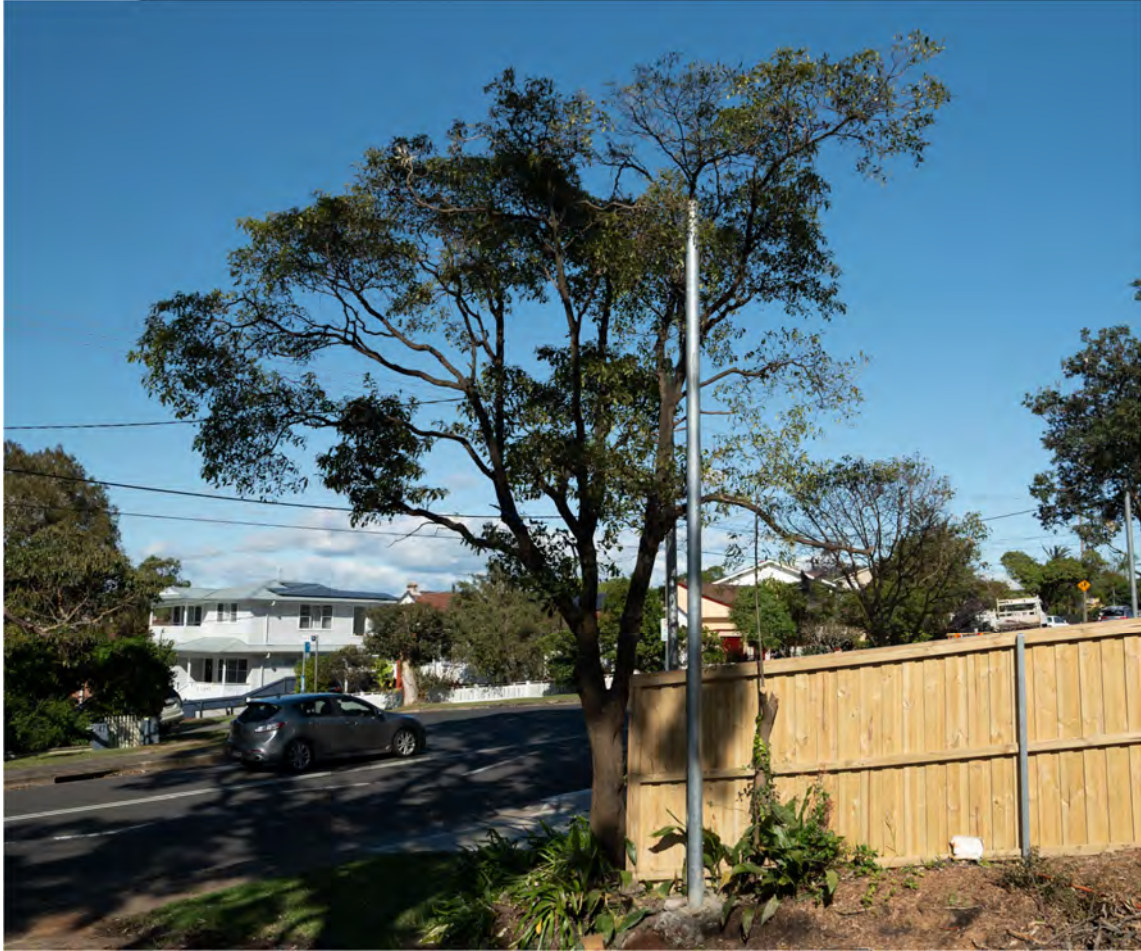
\* Tree 3 was located on adjoining land and must be protected throughout the development.

3.5.2 *Major* encroachment of Tree 3's (Pittosporum) TPZ & SRZ will occur due to the proposed driveway within the TPZ & SRZ areas.

*Image 3: Tree 3 as seen.*

- 5.3.1 It is recommended that the driveway be constructed at a level above existing grade. Construction of this surface which does not require excavation will significantly reduce possible impacts to Trees 3 & 5.

| Tree ID | Fencing Required | Trunk Armouring Required | Ground Protection Required | Signage Required |
|---|---|---|---|---|
| 3 | Site perimeter fencing. | No | No | No |

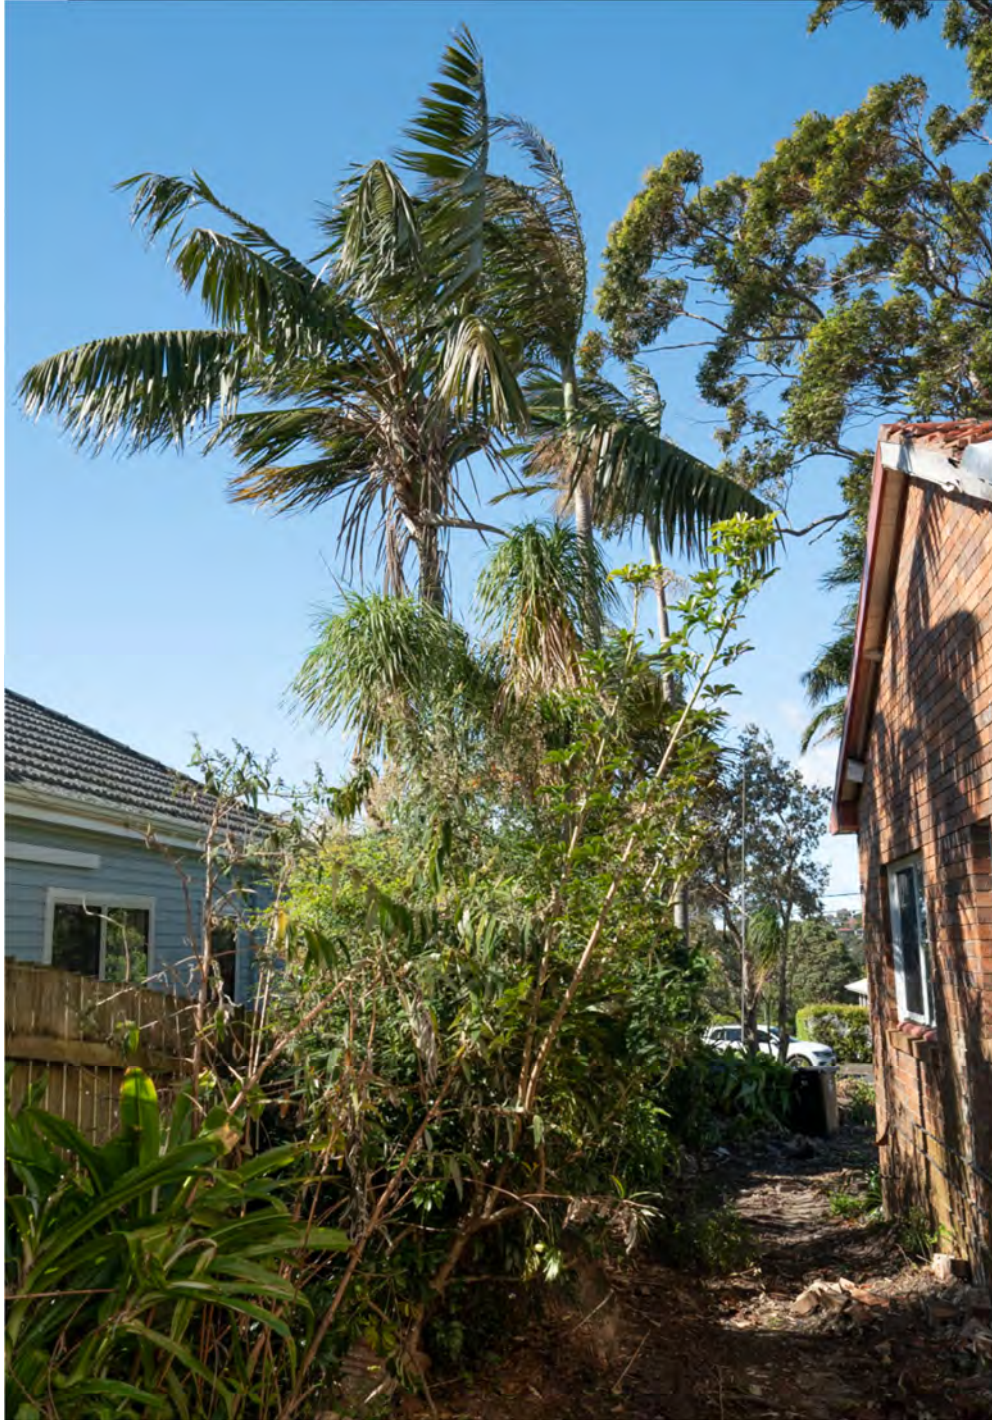
*Image 4: Vegetation along the Eastern boundary of the site.*

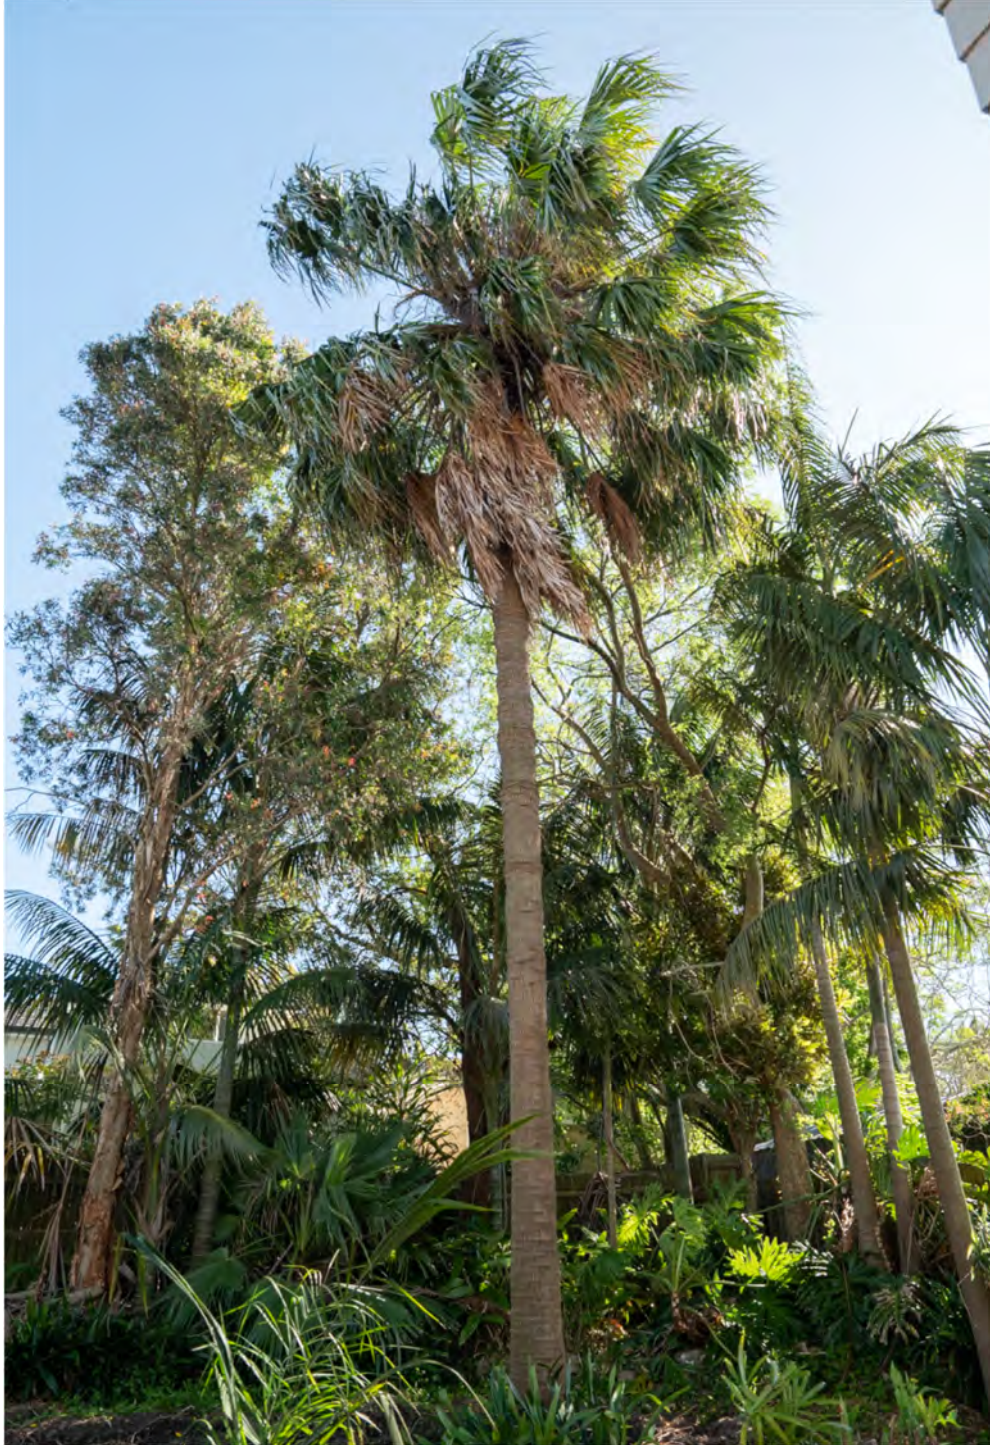
#### 3.4.5 A Cabbage Tree Palm, T6, was located at the rear of the site. Scoring a moderate landscape significance, the palm stood in a healthy condition despite evidence of plant tracking adjacent to the base of the tree.

#### 3.4.6 A dense stand of vegetation containing Trees T7-T9 in the north-eastern corner of the site was collectively seen with trees of low and moderate landscape significance. Smaller Kentia Palm species and other shrubs were interspersed among the trees.

*Image 5: Tree 6 [centre] and vegetation in the North-eastern corner of the site [rear].*

| Tree ID | Fencing Required | Trunk Armouring Required | Ground Protection Required | Signage Required |
|---|---|---|---|---|
| 6 | Yes, 1x1 panel | If not fenced (Fencing Preferred) | No | No |
| 7-9 | Yes, see part 6.1.3 below | | | |

6.1.3 Fencing shall consist of a contiguous exclusion zone around all vegetation with an offset of the TPZ area. Fencing shall form the site perimeter fencing, or integrate with existing fencing.

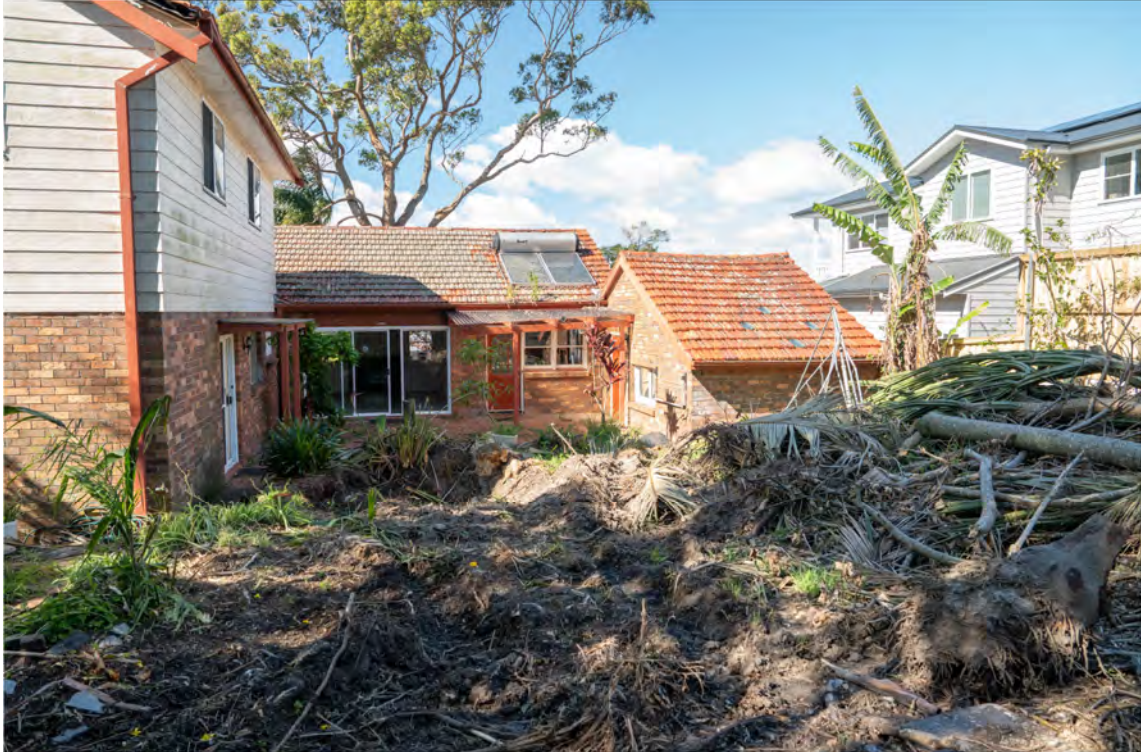
- 3.2.1 Located in central North Balgowlah, the previously developed site presented with a southerly aspect.
- 3.2.2 The sole existing structure on the site was a single storey brick dwelling located centrally to the land parcel.
- 3.2.3 Recent clearing of vegetation had occurred on the site. Several freshly cut stumps and cuttings were sighted during site attendance. Machinery tracks were also noted within the vicinity of remaining trees.
- 3.2.4 Numerous trees shown on the supplied survey had been removed prior to the site visit. Information pertaining to removed vegetation is annotated on the annexed markups within Appendix 2 - Tree identification and incursion potentials.
- 3.2.5 Remaining vegetation generally appeared in good health and condition despite evidence of the site being previously heavily overgrown.

*Image 6: The rear of the site had been extensively cleared.*

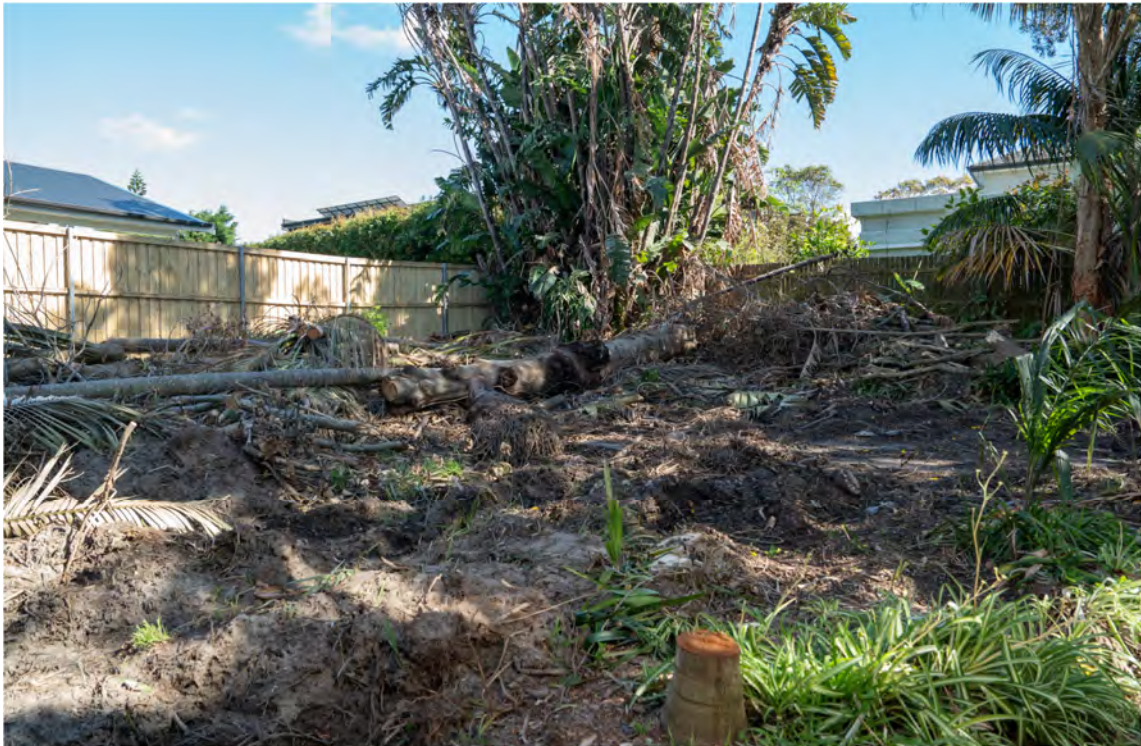
*Image 7: The rear of the site had been extensively cleared.*
