J5149. 29th September, 2023. Page 1.

GEOTECHNICAL INVESTIGATION:

New House and Pool at 1 Harewood Place, Warriewood

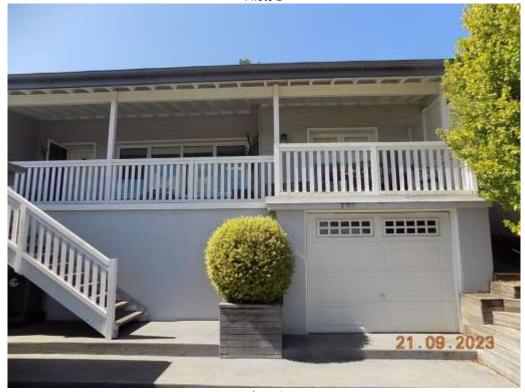
Photo 3

walls. The exterior brick walls appear to be in good condition (Photo 3). The house and

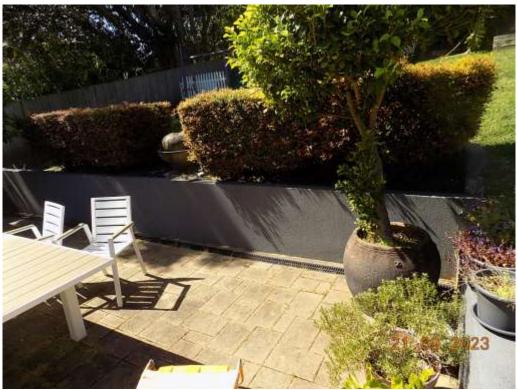
extends off the uphill side of the house is supported by a stable ~0.8m high rendered

masonry retaining wall (Photo 4). This wall is to be demolished as part of the proposed

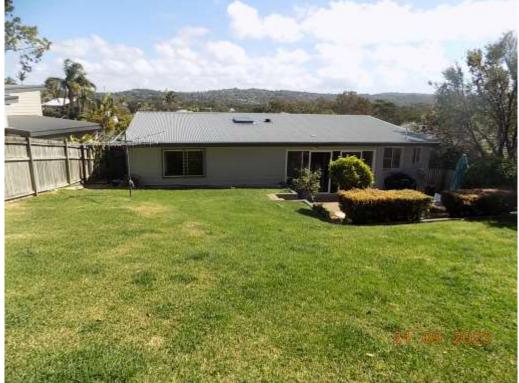
Photo 5

works. A gently sloping lawn extends above this wall to the upper common boundary

(Photo 5).

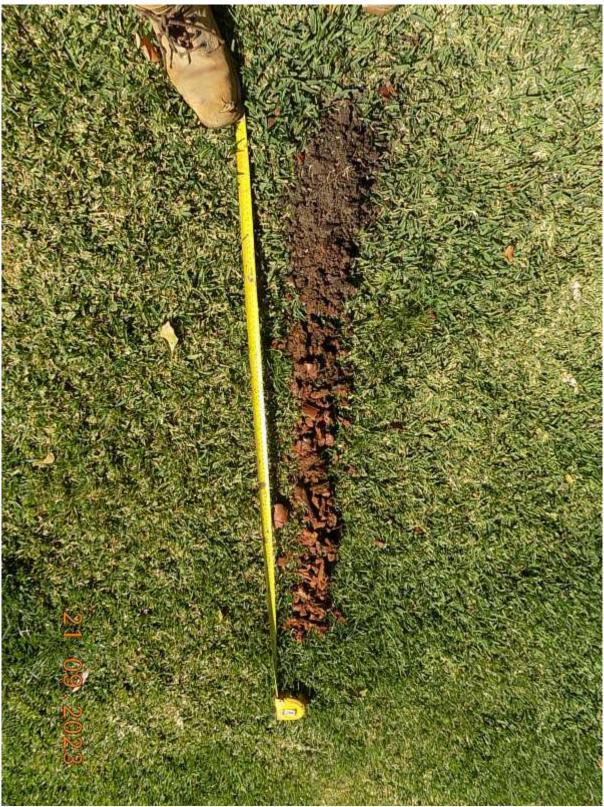
Photo 6 (Top to Bottom)

AUGER HOLE 1 (~RL19.0) - AH1 (Photo 6)

Depth (m)	Material Encountered
0.0 to 0.3	TOPSOIL, dark brown clayey soil, medium grained, loose, fine trace of
	organic matter, dry.
0.3 to 1.2	CLAY, orange, fine grained, hard, dry.

End of test @ 1.2m. No water table encountered.
