J4349. 2<sup>nd</sup> November, 2022. Page 1.

### **GEOTECHNICAL INVESTIGATION:**

Alterations and Additions and balcony at 518 Barrenjoey Road, Avalon Beach

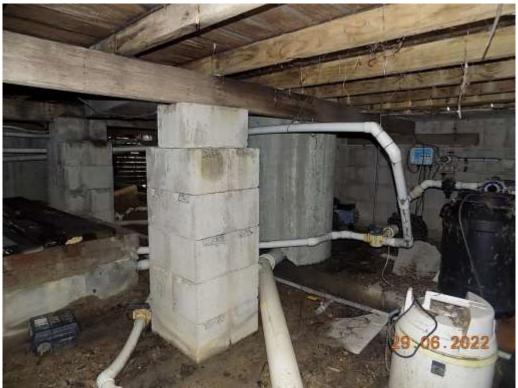
Photo 3

block walls and concrete block piers (Photo 3). The concrete block walls show no significant signs of movement and the visible concrete piers stand vertical. A level lawn area extends from the E side of the property to the E boundary (Photo 4). A ~1.5m high timber crib wall that encompasses the N common boundary and the E boundary supports the fill for this lawn area (Photo 5). The crib wall is almost entirely obscured by dense vegetation and could not be adequately assessed. A gentle to moderately sloping lawn extends shortly beyond the E boundary before dropping ~37m at vertical angles to a rock platform below (Photo 6). The cliff line is obscured by thick vegetation. From below it can be seen to be made up of thinly bedded shale and thicker bedded sandstone (Photo 7). The base of the cliff is armoured from the undercutting action of the waves by the rock platform and a build-up of slope debris (Photo 8). The cliff face to the north of the property has been undercut to ~2.0m across its base but adjacent to the subject property the cliff face has no significant defects (Photo 9). In the unlikely event of a failure the undercut will not impact the subject property. The weathering process of the cliff face occurs when the harder beds are undercut by the softer beds. Because the beds are relatively thin and jointed the resulting failures are small in scale. This weathering process is extremely slow, measured from the geological record to be in the order of 7 to 12 mm/year. The proposed works will be at least 8m from the uphill edge of the cliff. The estimated wave run-up height will reach 6.9AHD; ignoring any cliff face roughness. This is well below the site of the proposed works and only very minor spray would affect the site, as per the coastal report referenced above.

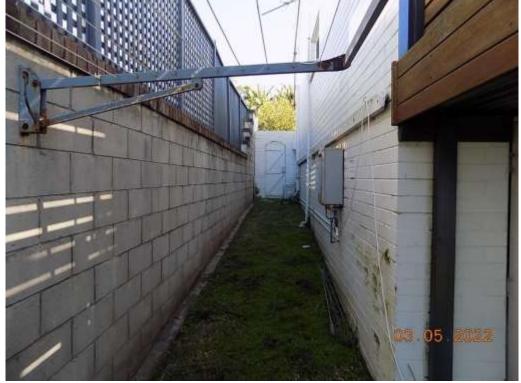
Photo 10

property is a potential hazard (Hazard Two). The additional surcharge loads from the

proposed extension acting on the existing N boundary wall is a potential hazard (Photo 10)

(Hazard Three).

HAZARDS	Hazard One	Hazard Two	Hazard Three
TYPE	The gentle slope that rises and falls across the property and continues below failing and impacting on the proposed works.	A large failure occurring in the sea cliff that impacts proposed works.	The additional surcharge loads from the extension transferring onto the existing concrete block retaining wall causing damage and instability (Photo 10).
LIKELIHOOD	'Unlikely' (10 <sup>-4</sup> )	'Rare' (10 <sup>-5</sup> )	'Possible' (10 <sup>-3</sup> )
CONSEQUENCES TO PROPERTY	'Minor' (5%)	'Major' (60%)	'Medium' (35%)
RISK TO PROPERTY	'Low' (2 x 10 <sup>-5</sup> )	'Low' (6 x 10 <sup>-5</sup> )	'Moderate' (2 x 10 <sup>-4</sup> )
RISK TO LIFE	5.5 x 10 <sup>-7</sup> /annum	8.3 x 10 <sup>-8</sup> /annum	5.6 x 10 <sup>-5</sup> /annum
COMMENTS	This level of risk is 'ACCEPTABLE'.	Cardno, now Stantec advises that the proposed development will not cause detrimental increases in coastal risks to this or other properties, as such, this level of risk is 'ACCEPTABLE.'	This level of risk to life and property is 'UNACCEPTABLE'. To move the risk to 'ACCEPTABLE' levels the recommendations in <b>Section 12</b> are to be followed.

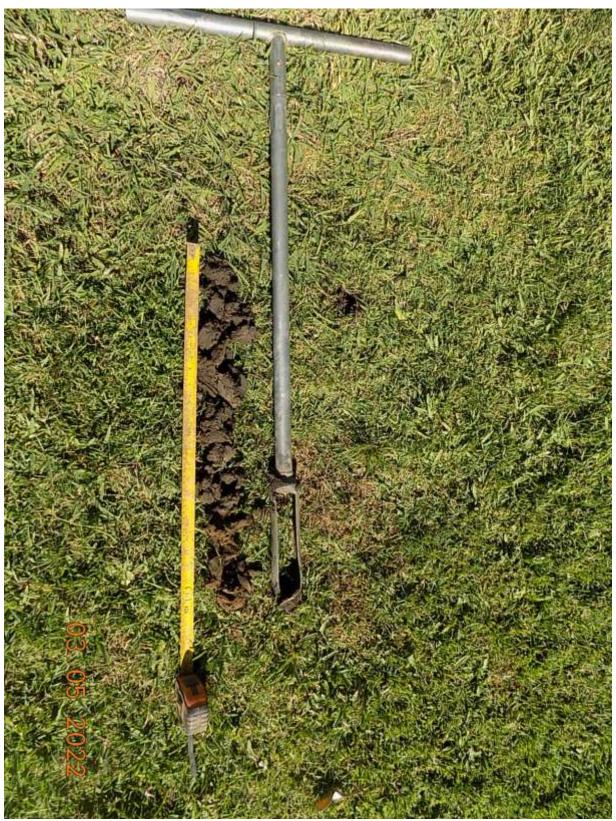
Photo 11 (Top to Bottom)

### **AUGER HOLE 1** (~RL39.2) – AH1 (Photo 11)

Depth (m)	Material Encountered
0.0 to 0.1	<b>TOPSOIL</b> , dark brown clayey soil, medium grained, loose, fine trace of organic matter, dry.
0.1 to 0.3	CLAY, brown, fine grained, stiff, dry.
0.3 to 0.6	CLAY, yellow and brown, fine grained, stiff, dry.

End of test @ 0.6m. No water table encountered.

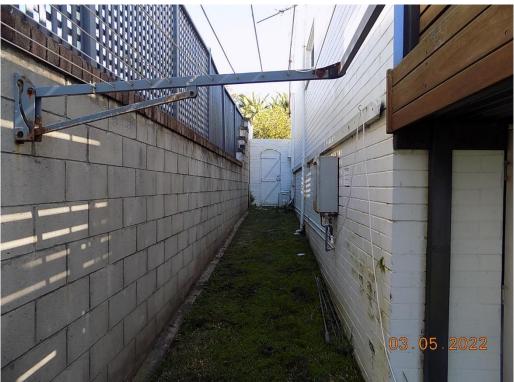
Photo 10

proposed extension acting on the existing N boundary wall is a potential hazard (Photo 10) (Hazard Three).

'ACCEPTABLE'.	'ACCEPTABLE'.	'ACCEPTABLE' levels
			the recommendations
			in <b>Section 12</b> are to be
			followed.

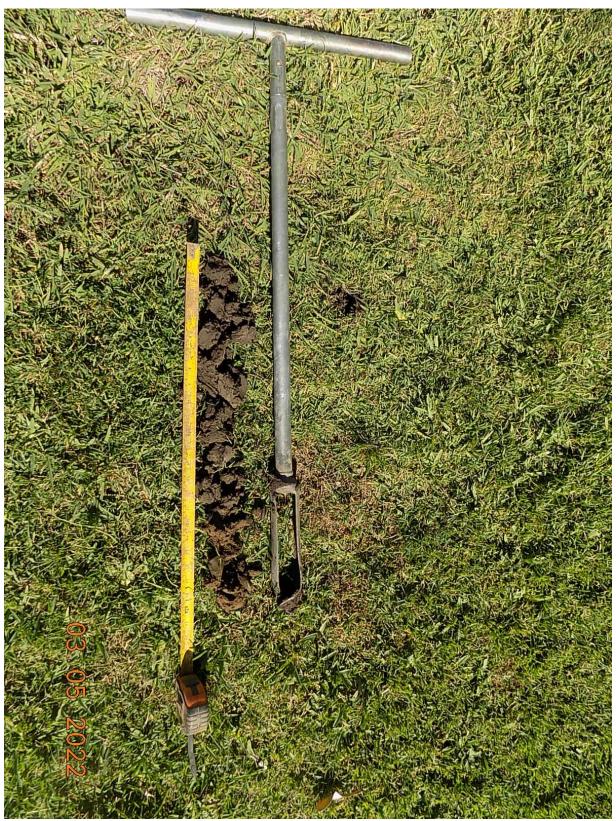
Photo 11 (Top to Bottom)

Depth (m)	Material Encountered
0.0 to 0.1	<b>TOPSOIL</b> , dark brown clayey soil, medium grained, loose, fine trace of organic matter, dry.
0.1 to 0.3	CLAY, brown, fine grained, stiff, dry.
0.3 to 0.6	CLAY, yellow and brown, fine grained, stiff, dry.
