## **Geotechnical Assessment**

**Project:** Alterations & Additions

115 Narrabeen Park Parade, Mona Vale NSW

**Ref:** AG 21075

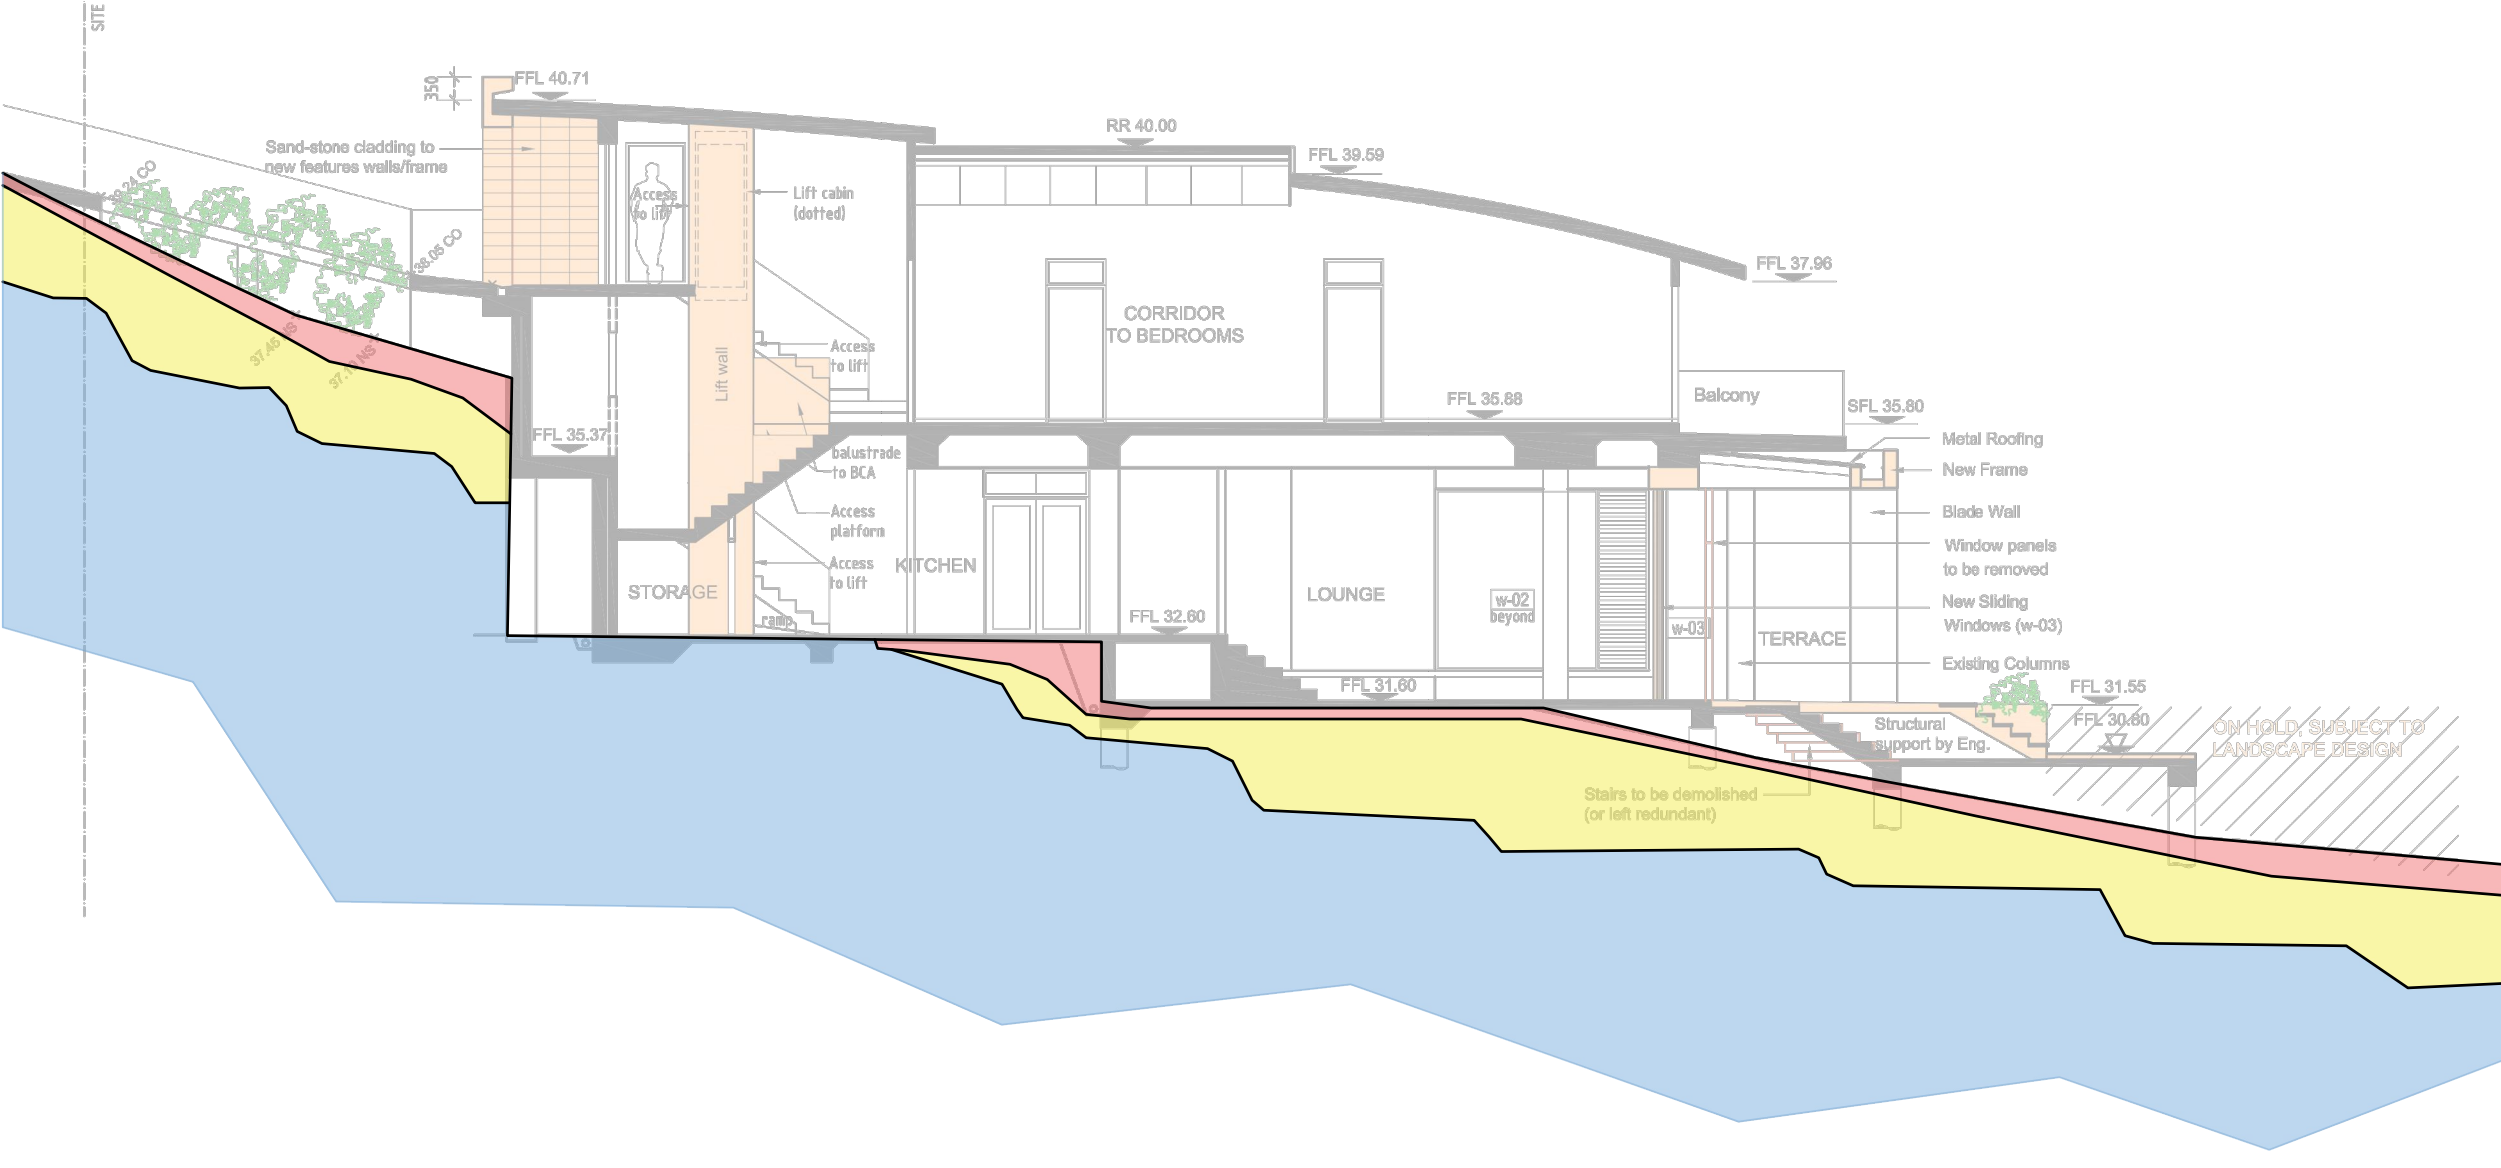
**INFERRED GEOLOGICAL SECTION**  
SCALE NTS

The soil profile consists of bioturbated organic sandy/silty topsoil and shallow uncontrolled fill (O & A Horizons) overlying silty clay (B Horizon) and weathered bedrock (C Horizon). Based on our observations and the results of testing onsite, we would expect competent weathered bedrock to be found within 1800-2500mm from current surface levels across the site.

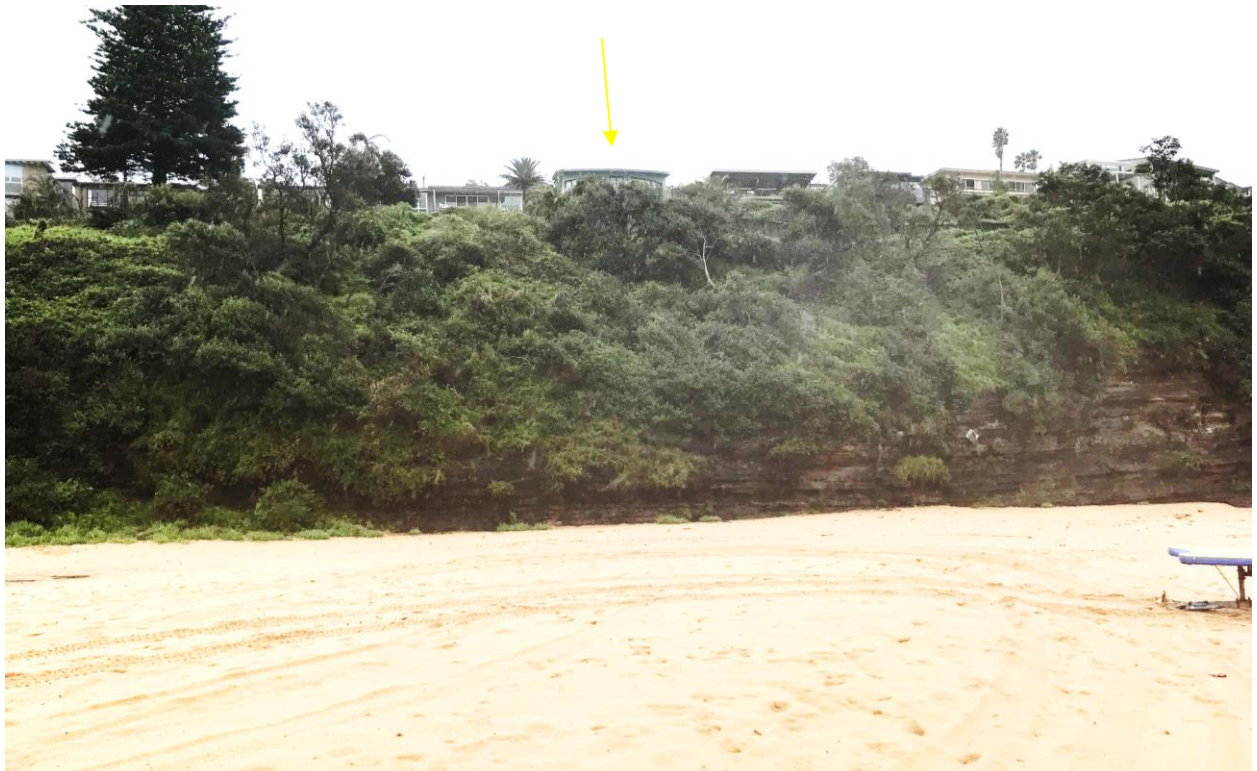
Coffey & Partners (1987) noted that the cliff/bluff at the northern end of Warriewood Beach was comprised of interbedded shales, siltstones and sandstone. Photographs of the cliff seaward of the property are provided in Figure 3 and Figure 4. Dense vegetation partly obscures the near-vertical lower cliff face. Based on Airborne Laser Scanning (ALS) data held by Horton Coastal Engineering that was collected in 2020, elevations along Section A (from Figure 1) perpendicular to the cliff face are depicted in Figure 5.

**Figure 3: Broad view of cliff face SE of subject property (at arrow) on 25 February 2022, facing north**

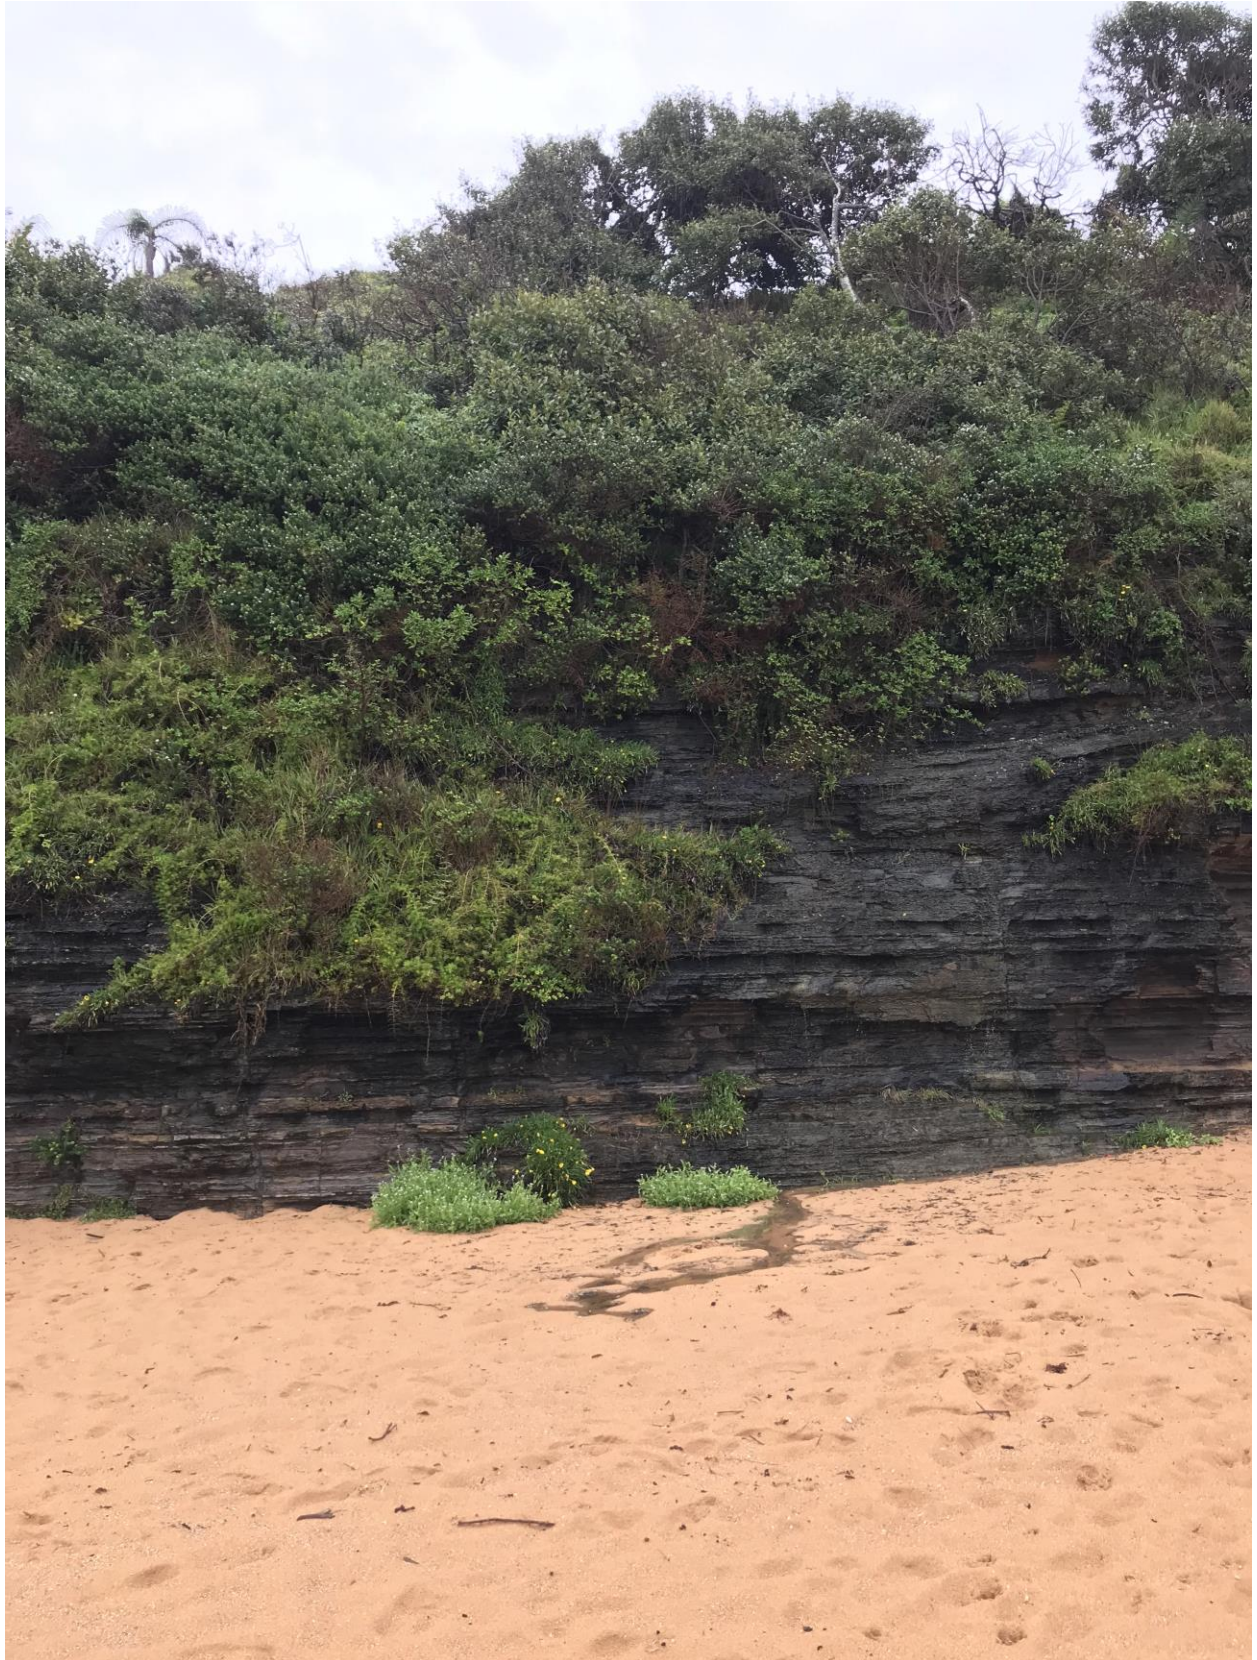
**Figure 4: Close view of cliff face SE of subject property on 25 February 2022, facing NW to NNW**

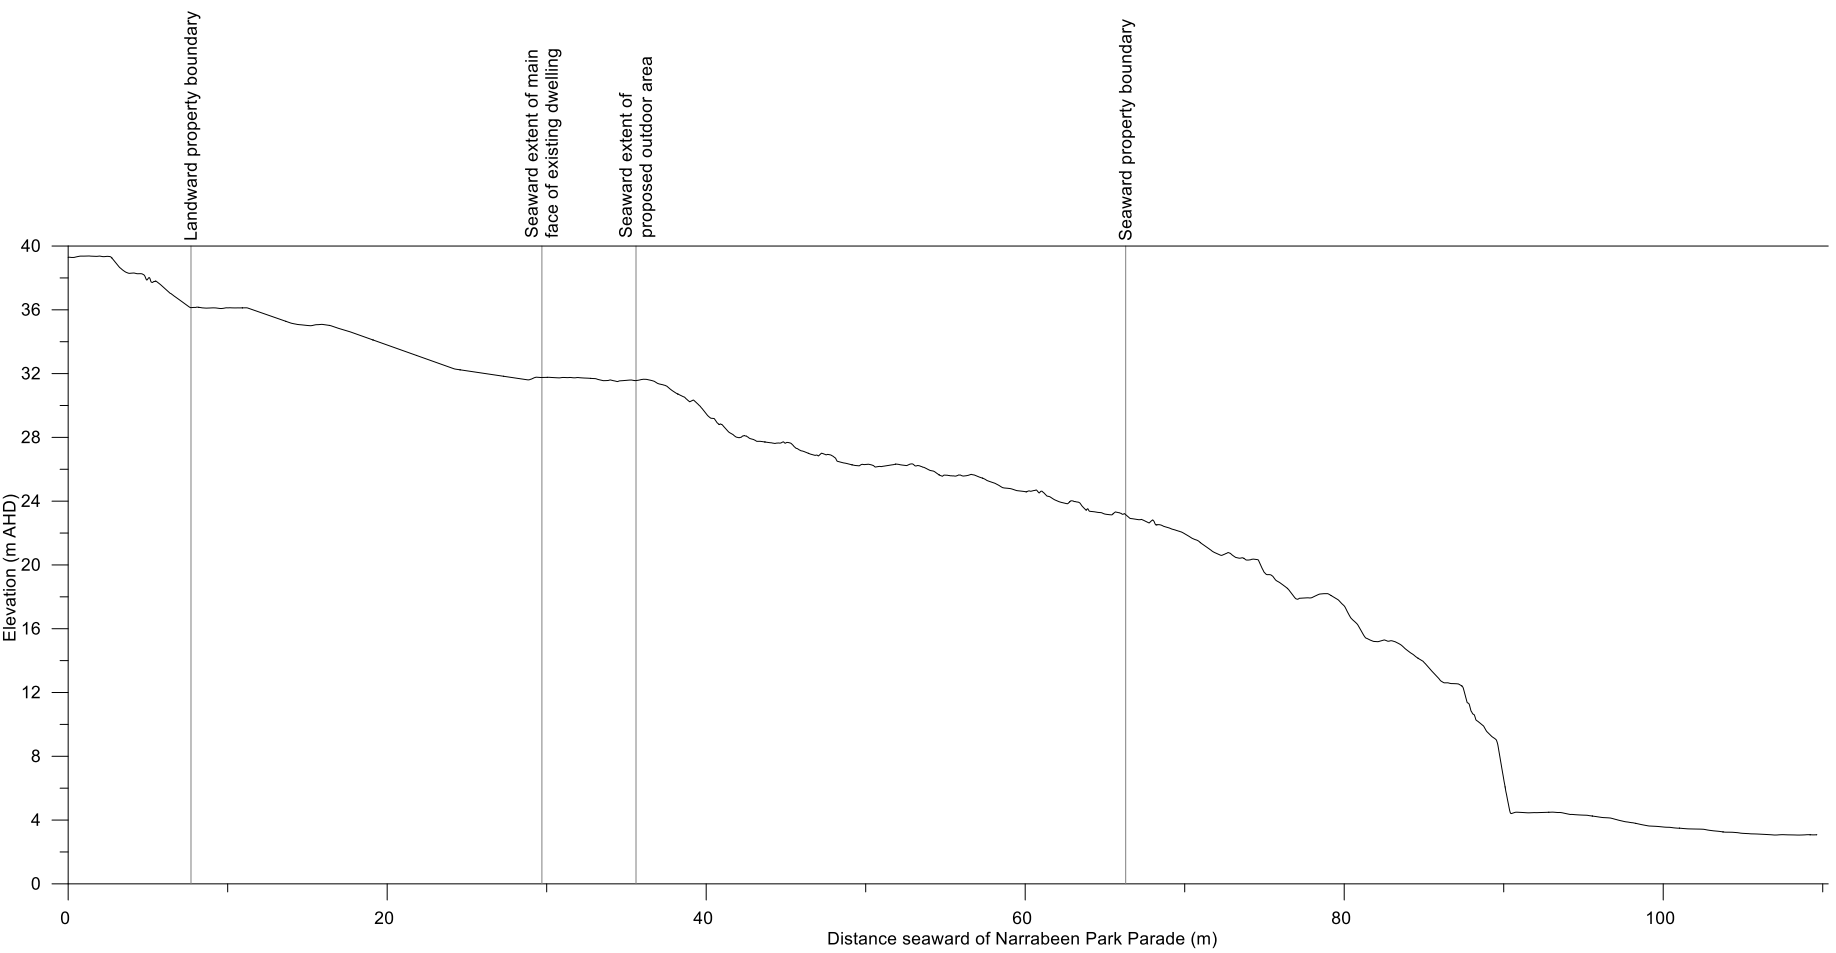
**Figure 5: Section A through cliff SE of subject property**

Ground elevations along Section A approximately vary from about 39.3m AHD at Narrabeen Park Parade, 23.2m AHD at the seaward property boundary, and 9.0m and 4.4m AHD at the top and bottom respectively of the near-vertical (average slope of 79°) cliff portion at the base (with the portion above the top of the near-vertical portion to Narrabeen Park Parade having an average slope of 19°). Sand levels at the base of the cliff may vary in response to coastal erosion and subsequent post-storm recovery.
